**QUINQUENNIAL INSPECTION REPORT - MAY 2026**

# **ALL SAINTS CHURCH**

**LOW MOOR ROAD, LANGLEY PARK, CO. DURHAM, DH7 9TZ**

**ADAM VAUGHAN**

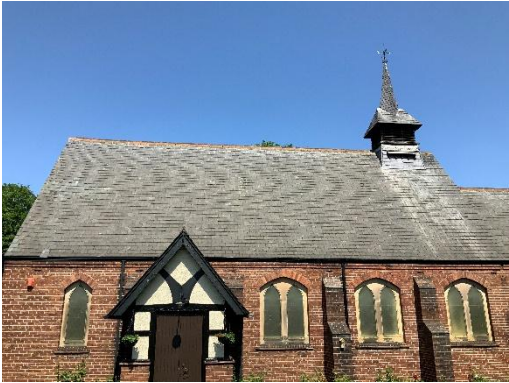
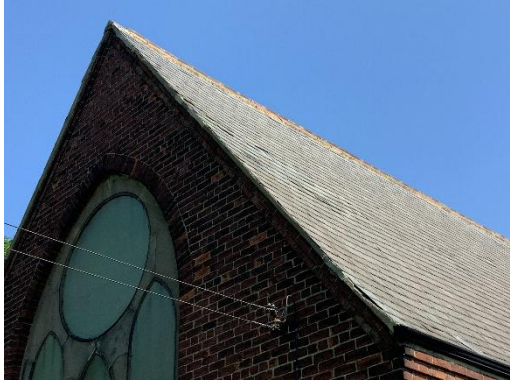
### Southern Pitch of the Nave Roof

| | <p><b>Condition</b></p> <ul style="list-style-type: none"> <li>• Generally in good condition. There is one missing slate to the left of the porch and it is sitting in the gutter.</li> <li>• Mortar pointing and bedding to the ridge tiles appears sound. Westernmost ridge tile does not match the others.</li> <li>• Pointing to the western verge is complete and appears to be stable.</li> </ul> | |

| | <b>Repair Needs</b> <ul style="list-style-type: none"> <li>• Refix slipped slate.</li> <li>• Monitor slates and refix any which continue to slip, or are blown off.</li> <li>• Replace westernmost ridge tile with a closer match to the others.</li> </ul> | B<br>M<br>E |

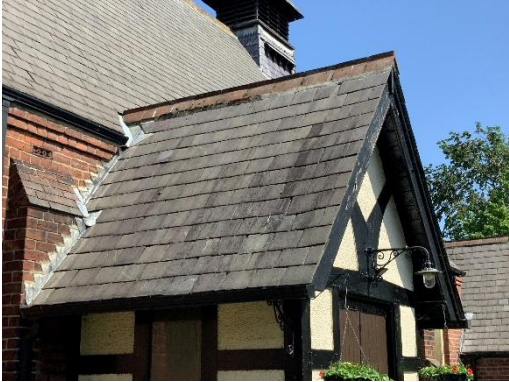
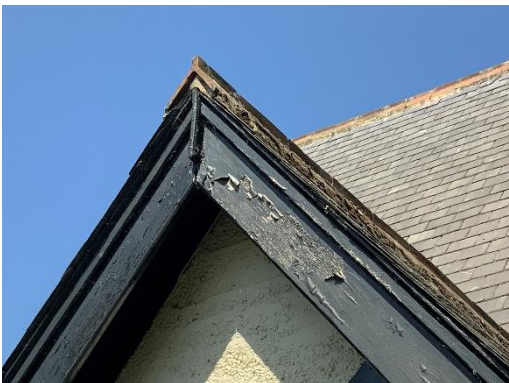
### Porch Roof

| | <b>Condition</b> <ul style="list-style-type: none"> <li>• Generally in good condition. No missing slates, although one or two are slipping and others have chipped corners.</li> <li>• Mortar pointing and bedding to ridge tiles is sound, although beginning to weather out of the joints at the top edge.</li> <li>• Lead flashings are in good condition.</li> <li>• The coating on the barge boards is breaking down</li> </ul> | |

| | <b>Repair Needs</b> <ul style="list-style-type: none"> <li>• Remove degrading paint to barge boards and repaint.</li> <li>• Monitor slates and refix any which continue to slip, or are blown off.</li> </ul> | C<br>M |

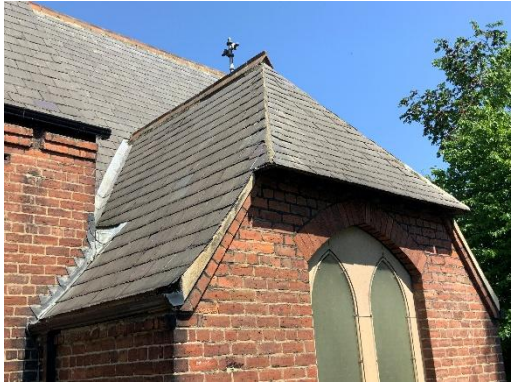
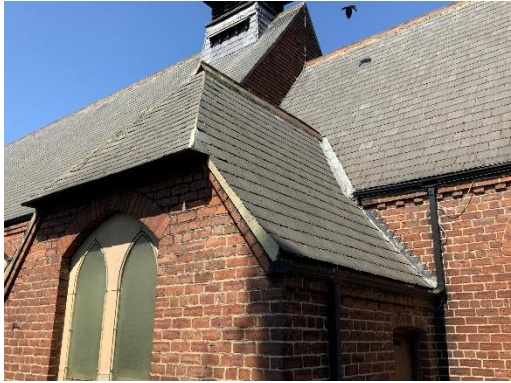
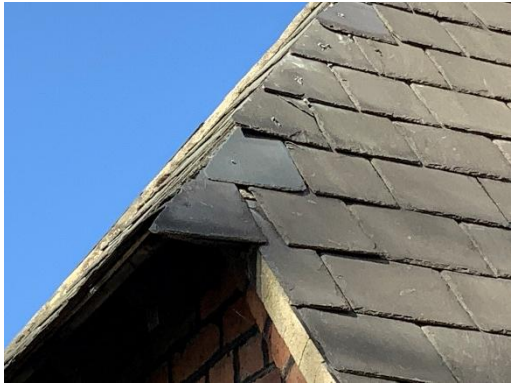
## Roof over the South Vestry

| | <b>Condition</b> <ul style="list-style-type: none"> <li>• Generally in good condition, with slates secure although some have chipped corners. The slipped slate on the East slope, identified in the last report, has been stabilised with a mortar fillet on the hip.</li> <li>• Mortar pointing and bedding to ridge tiles is sound, although beginning to weather out of the joints at the top edge.</li> <li>• It is peculiar that no lead roll flashings were originally installed at the hips and the slate to slate junction is a vulnerable construction method and warrants careful monitoring.</li> <li>• Minor cracking in pointing to the verge.</li> <li>• Lead flashings are in good condition</li> </ul> | |

| | <b>Repair Needs</b> <ul style="list-style-type: none"> <li>• Monitor slates and refix any which continue to slip, or are blown off.</li> </ul> | M |

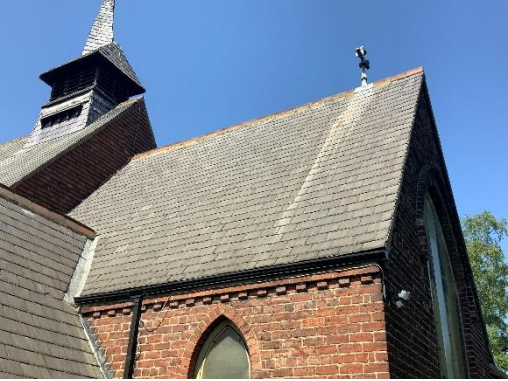
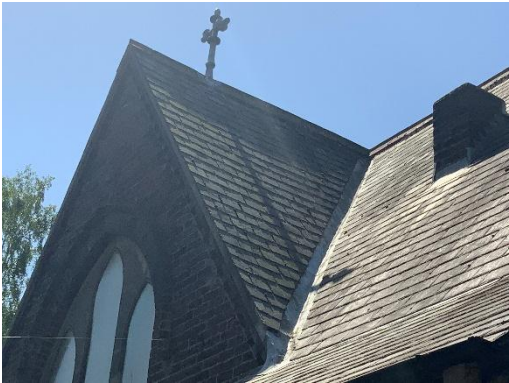
## Roof over the Chancel

| | <b>Condition</b> <ul style="list-style-type: none"> <li>• Generally in good condition. No missing slates, although one or two have chipped corners.</li> <li>• Mortar pointing between ridge tiles is weathering out in some areas.</li> <li>• Ridge tile bedding has cracked away at the East gable.</li> <li>• Minor cracking to the mortar verge at the East gable.</li> </ul> | |

| | <b>Repair Needs</b> <ul style="list-style-type: none"> <li>• Monitor slates and ridge tiles and refix any which continue to slip or are blown off.</li> <li>• Monitor cracks in mortar verge and carry out repairs should any fall out before the next inspection.</li> </ul> | M<br><br>M |

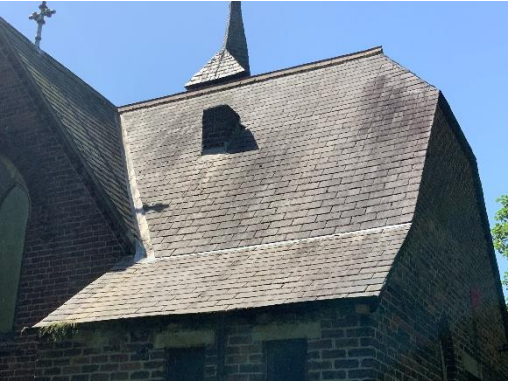
## Roof over the North Vestry

| | <b>Condition</b> <ul style="list-style-type: none"> <li>• Generally in good condition. No missing slates, although one or two have chipped corners.</li> <li>• Mortar pointing between ridge tiles is weathering out in some areas.</li> <li>• The vicar reports that the flashings to the rear of the stub chimney on East slope have been cleared out since the last inspection, with plant growth removed.</li> <li>• A short length of timber moulding is still missing at the verge leaving roof timber exposed to driving rain.</li> </ul> | |

| | <b>Repair Needs</b> <ul style="list-style-type: none"> <li>• Timber moulding on verge should be completed.</li> </ul> | C |

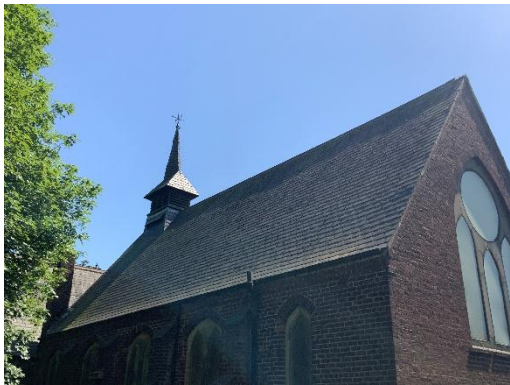
## North Pitch of the Nave Roof

| | <b>Condition</b> <ul style="list-style-type: none"> <li>• Generally in good condition. No missing slates, although one or two have chipped corners.</li> <li>• Mortar pointing between ridge tiles is weathering out in some areas.</li> <li>• Pointing has weathered out of the chimney in some areas. This now warrants attention to prevent any water damage or dislocation.</li> </ul> | |

| | <b>Repair Needs</b> <ul style="list-style-type: none"> <li>• Repoint the chimney and check that capping is sound.</li> </ul> | D |

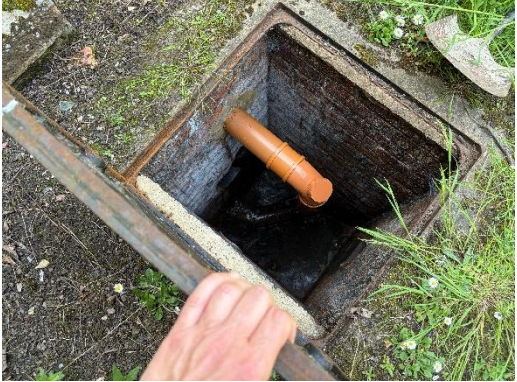
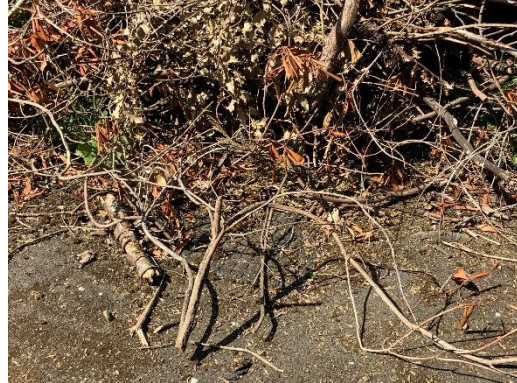
**10.5. BELOW GROUND DRAINAGE**

| | <p><b>Condition</b></p> <ul style="list-style-type: none"> <li>• The benching and pointing to the deep manhole by the steps appears to be in a sound condition.</li> <li>• The new polypropylene chamber was covered by garden cuttings at the time of the inspection and so the cover couldn't be lifted.</li> </ul> | |

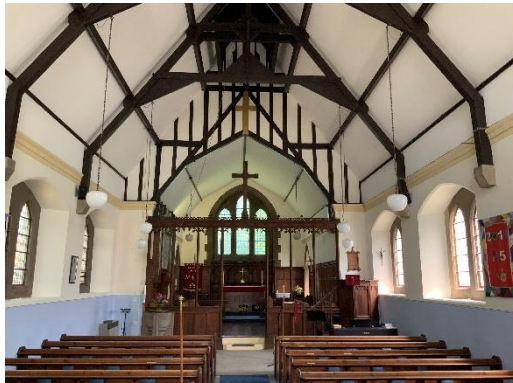
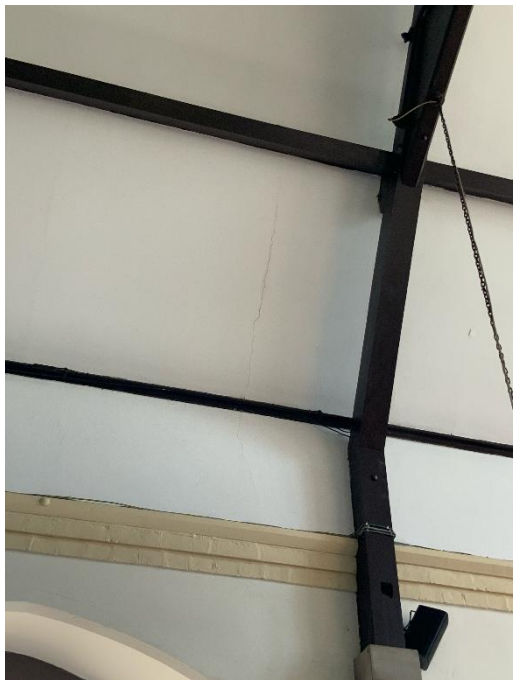
## 11.2 ROOF STRUCTURES AND CEILINGS

| | <p><b>Condition</b></p> <ul style="list-style-type: none"> <li>• The 2004 QQ report highlighted that some of the nuts of the straps and bolts holding the trusses together were loose or missing altogether. The inspecting architect at that time concluded that these defects were of a minor nature and that no action was needed.</li> <li>• The ceilings and trusses were all redecorated as part of the community space contract in 2019. One or two of the hairline cracks noted in the last inspection have opened up again, presumably evidence of general movement in the roof structure.</li> <li>• No cracks have opened up in the redecorated ceiling to the Chancel.</li> </ul> | |

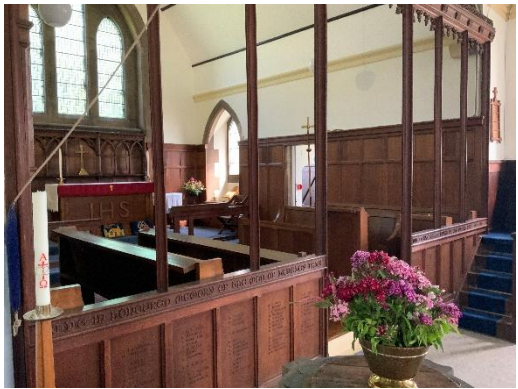
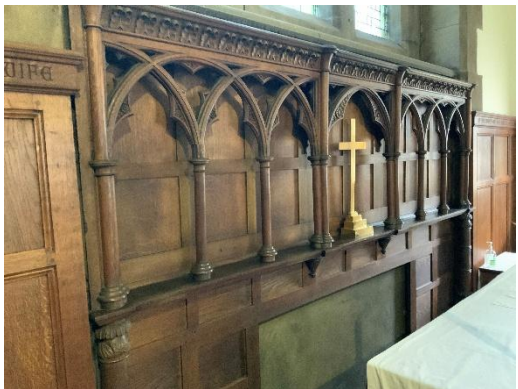
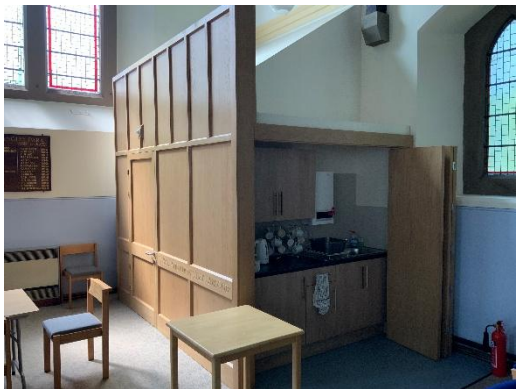
## Partitions, Screens and Panelling

| | <p><b>Condition</b></p> <ul style="list-style-type: none"> <li>• The screen between the Nave and the Chancel is in sound condition with no loose elements evident.</li> <li>• The oak panelling in the Chancel and Sanctuary is also in sound condition and is in no need of attention.</li> <li>• The new oak panelling around the WC/kitchenette is in sound condition.</li> </ul> | |

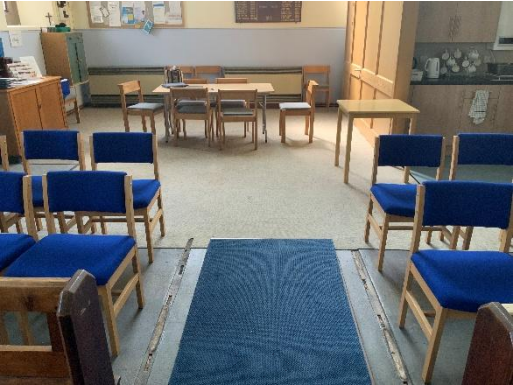
## 11.5 FLOORS AND PLATFORMS

| <br><br> | <p><b>Condition</b></p> <ul style="list-style-type: none"> <li>• The West end of the Nave and area around the pulpit have been carpeted as part of the community space contract. The original runner up the aisle has been modified to suit. There is new barrier matting inside the lobby door, and vinyl around the kitchenette and WC.</li> <li>• Two further rows of pews have been removed on a trial basis, being replaced with loose seating. If this is to be made permanent then timber infills should be installed to tidy up the floor.</li> <li>• One or two cracks in the concrete floor of the Nave are evident, but these are no doubt historical and aren't of any concern.</li> <li>• The previous QQ reports highlighted some rocking in the grill behind the altar and this has been partially dealt with using wedges.</li> <li>• No floor boards were lifted in the North and South vestries, and it was not been possible to inspect the sub-floor void.</li> <li>• In the North Vestry, the floor beside the WC was previously reported as being soft. This is no longer apparent so it is assumed that a repair has been carried out.</li> </ul> | |

| | <b>Repair Needs</b> <ul style="list-style-type: none"> <li>If the additional rows of pews are to be removed permanently, then timber infills should be installed to tidy up the floor.</li> </ul> | C |

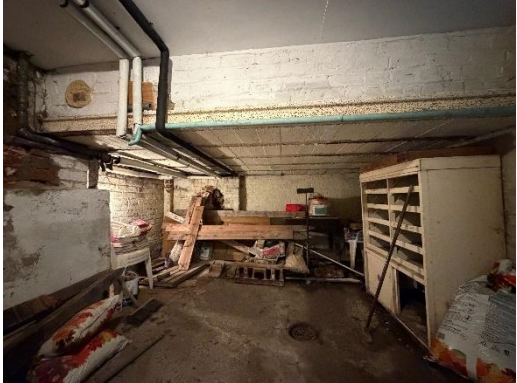
## 11.6 BASEMENT HEATING CHAMBER

The church remains in good condition, and ongoing repairs are being carried out to maintain this. The only item of concern is a split opening up in the RSJ above the door to the basement heating chamber, coupled with some distortion of the beam. This doesn't show in photos taken in earlier inspections, so it warrants an inspection by a structural engineer in the near future.

| | <b>Condition</b> <ul style="list-style-type: none"> <li>The fireproof plasterboard ceiling continues to show dampness and flaking paint, particularly above the door, but this does not appear to be getting worse and the board remains sound.</li> <li>The concrete floor is damp, although no standing water was observed.</li> <li>The steel RSJ's framing the lowered ceiling below the organ and the RSJ door lintol are all rusting due to the damp environment, and anti-corrosion painting is required.</li> <li>The door lintel (RSJ) is starting to fail at its bearing with a split, and there is some distortion in the beam. This doesn't show in photos taken in earlier inspections, so it warrants an inspection by a structural engineer in the near future</li> </ul> | |

| | <ul style="list-style-type: none"> <li>The exposed heating pipework will benefit from having all joints in the insulation taped up to minimise thermal bypass, helping efficiency.</li> <li>There is a considerable build up of leaves on the steps which could be a safety risk.</li> </ul> | |

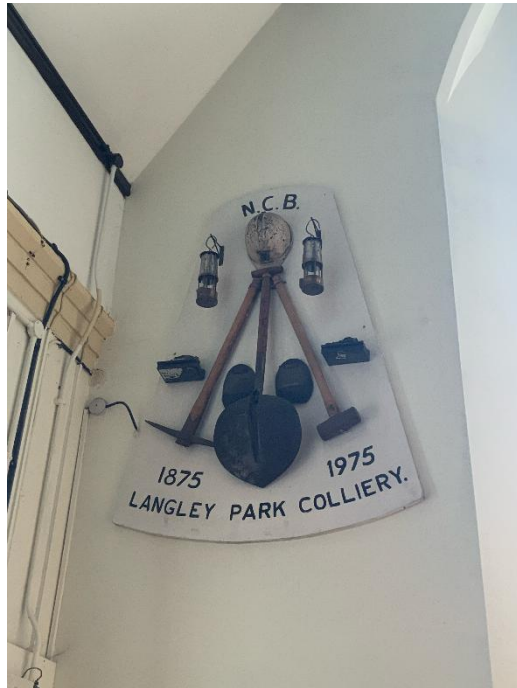
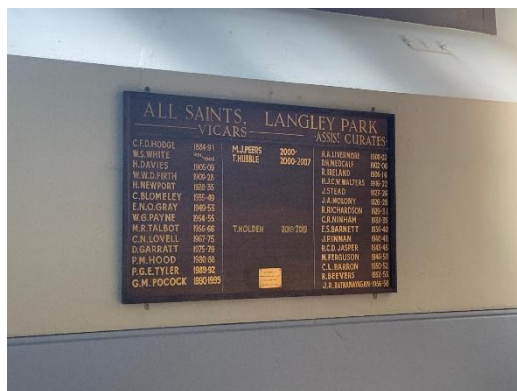
## 11.7 MONUMENTS AND TOMBS

- There are a variety of memorial plaques and signs throughout the church, including a hardwood sign commemorating the names of vicars and assistant curates beneath the West Window.

- All in good condition.

- None

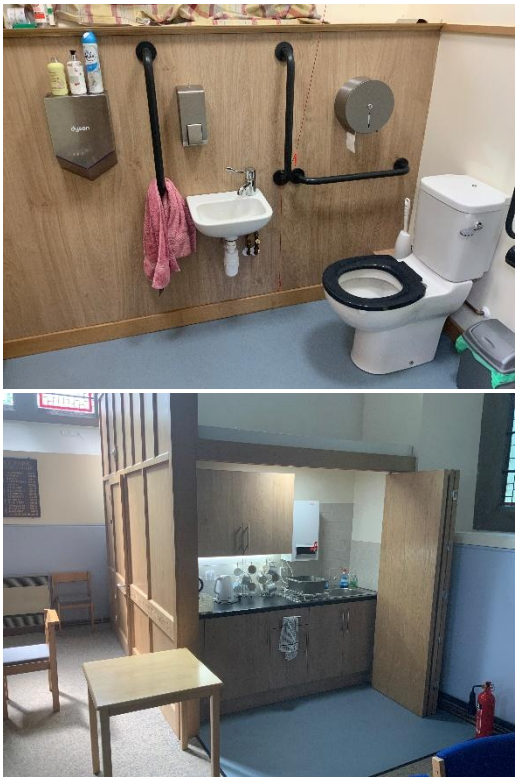
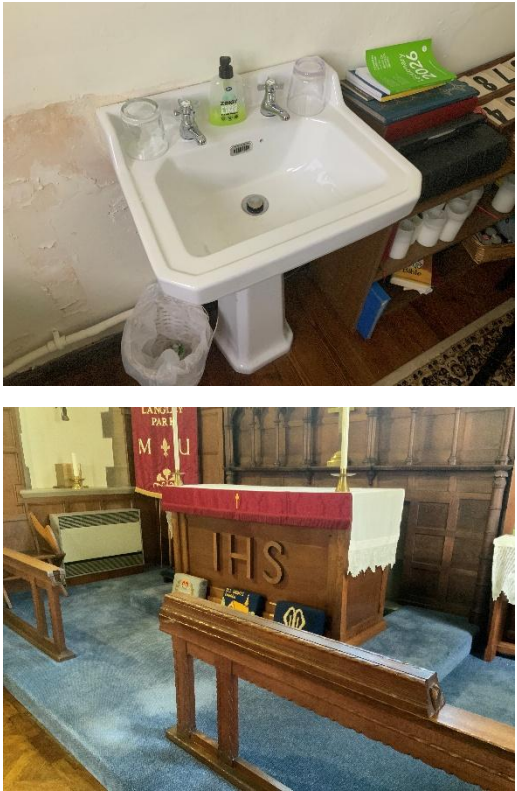
## 11.8 FIXTURES, FITTINGS AND FURNITURE

| | <p><b>Description</b></p> <ul style="list-style-type: none"> <li>• Hardwood pews, fixed down to the ground, and with low screens in front of the pews in the Chancel</li> <li>• Hardwood pulpit, with lectern.</li> <li>• There is an altar rail across the front of the Sanctuary.</li> <li>• Decorative stone font, with hardwood capping.</li> <li>• Wall mounted sink in the South Vestry</li> <li>• There is a new (2019) accessible WC and kitchenette at the rear of the Nave, concealed behind an oak screen and bi-fold doors.</li> </ul> | |
| | <p><b>Condition</b></p> <ul style="list-style-type: none"> <li>• Pews, pulpit and font are all in good condition, as noted previously. Two rows of pews have been removed from the back of the nave as a trial, and they are currently being stored in the North Vestry.</li> <li>• The low screens in the Chancel are wobbly, but this is a design flaw, and no attention is needed.</li> <li>• The author understands that some woodworm treatment has been carried out to the altar since the last inspection.</li> <li>• The sink in the South Vestry is dated, but in working order.</li> <li>• The new WC and kitchenette are all in good condition.</li> </ul> | |

| | <p><b>Repair Needs</b></p> <ul style="list-style-type: none"> <li>• None.</li> </ul> | |

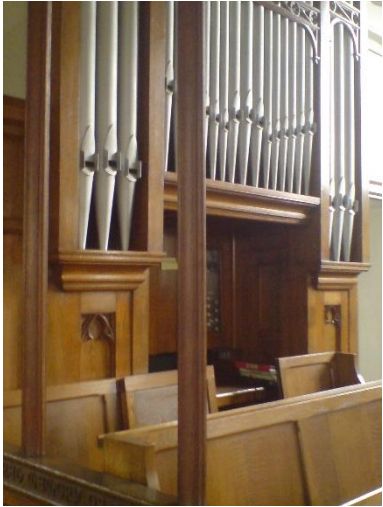
## 11.9 ORGAN

| | <p><b>Description</b></p> <ul style="list-style-type: none"> <li>The organ, labelled Nelson &amp; Co, Durham, is located on the North side of the Chance, with the larger part being housed in the North Vestry.</li> </ul> <p><b>Condition</b></p> <ul style="list-style-type: none"> <li>The logbook indicates that the organ was tuned in October 2016 and the author understands that some further woodworm treatment was carried out.</li> </ul> <p><b>Repair Needs</b></p> <ul style="list-style-type: none"> <li>Continue regular tuning and inspection by a specialist.</li> </ul> | M |

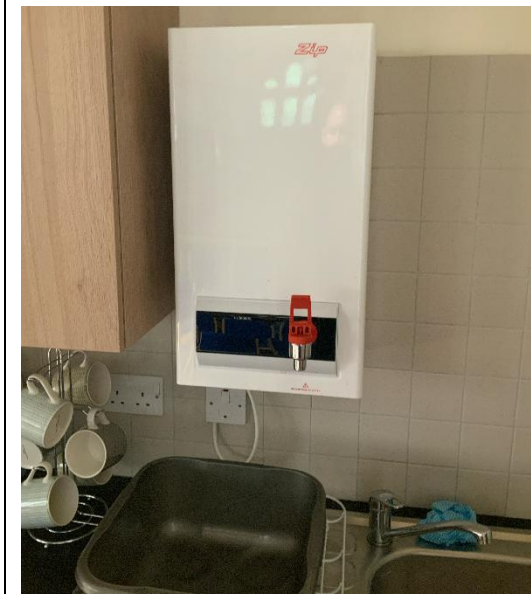
- An outdoor tap is fitted to the outside wall on the North Vestry.
- There is an emergency call alarm in the accessible WC.

| | <b>Repair Needs</b> <ul style="list-style-type: none"><li>• Boiler to be serviced annually. Tape joints to heating pipework insulation in basement.</li><li>• Obtain electrical testing certificate.</li><li>• Arrange annual PAT testing for electrical equipment.</li><li>• Arrange for testing of the lightening protection system.</li><li>• Maintain the ZIP water boiler in line with the manufacturer instructions.</li></ul> | <div>M</div> <div>M</div> <div>M</div> <div>M</div> <div>M</div> |
