**Quinquennial Inspection Report  
Church of St Cuthbert, Redhouse, Sunderland  
North Wearside Parish  
Diocese of Durham**

10 June 2026

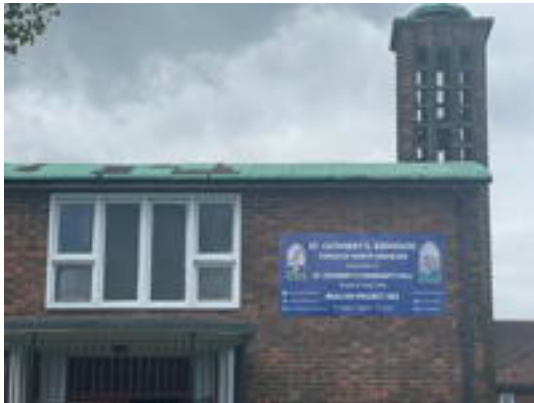
**Patching to North Elevation Roof**

There are multiple areas of patching to the church copper felted roof in black felt. The ancillary flat roofs cannot be seen from ground level. The Hall roof is in reasonable condition with a single displaced slate to the east elevation.

Undertake full inspection of felted roofs and flashings by a reputable roofing company and implement recommendations. Cost Band 2– £2,000.00-£9,999.

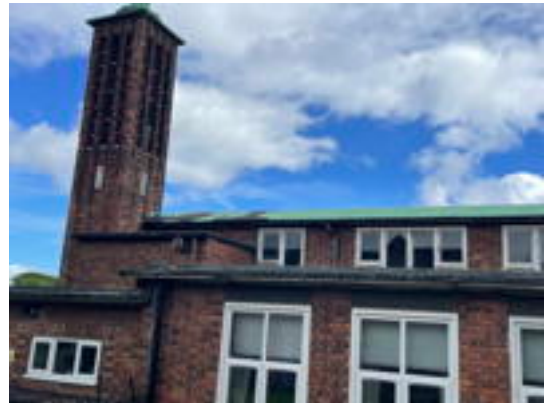
**Patching to South Elevation Roof**

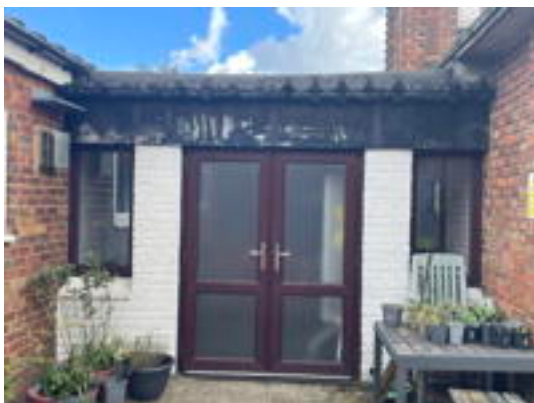
**Felt to Link Lobby Roof**

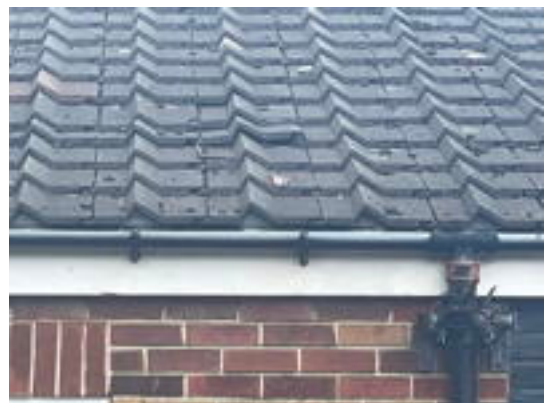
**Displaced Tile to Hall Roof East Elevation**

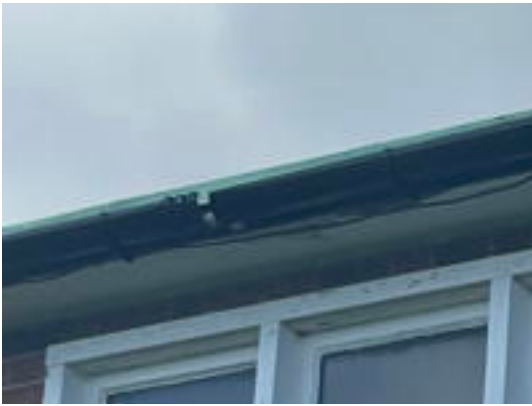
**Open Joint to Gutter North**

It was not possible to tell if everything is fully watertight as it was dry at the time of the inspection. The north elevation gutter needs resealing. There may be an issue with the North Porch hopper head which show signs of leakage.

Attend to leaking sections of gutter and hopper head. Cost Band 1–£0.00-£1,999.

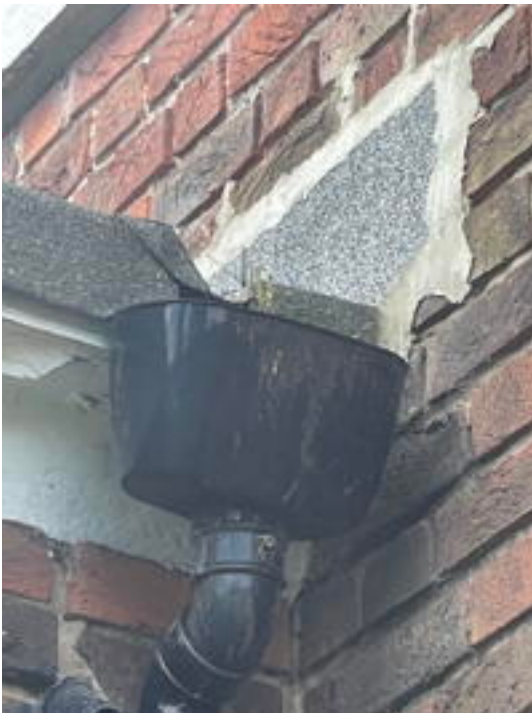
**North Porch Lobby Hopper Head**

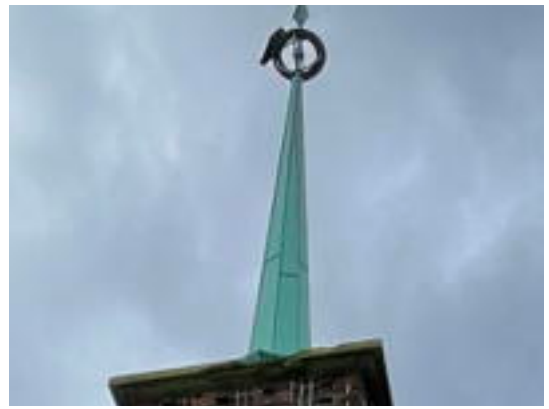
**Spirelet**

Spirelet appears generally sound and in good condition when viewed from ground level. The tower capping has areas of spalling concrete which have worsened since the last quinquennial. Similarly, the church eaves and meeting room eaves. The timber eaves facias and verges to the hall and link lobby require redecoration.

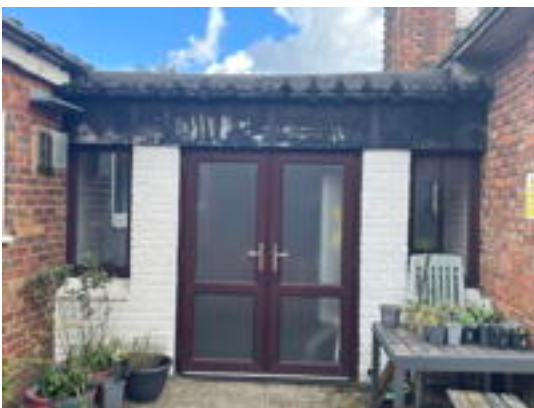
**Link Lobby Facia**

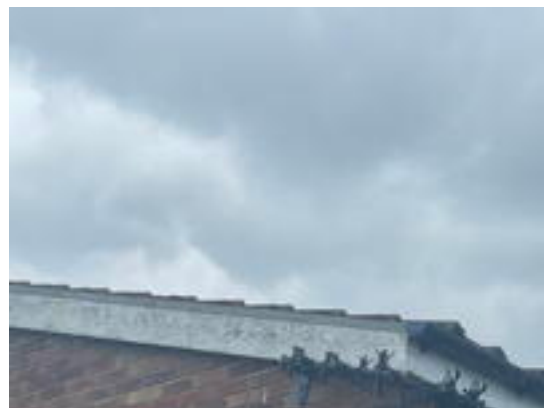
**Hall Facia and Verge**

Replace rotten sections of timber verge and eaves to Hall and decorate all fascia and verge boards to Hall and Hall Lobby link. **Outstanding**

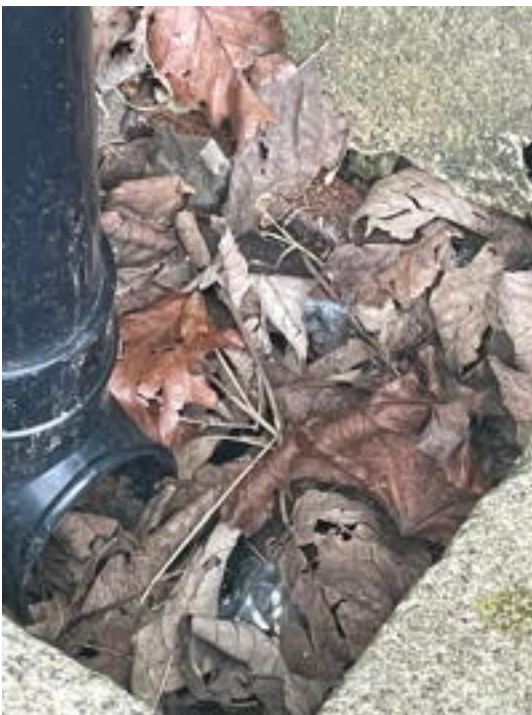
**Blocked Gully**

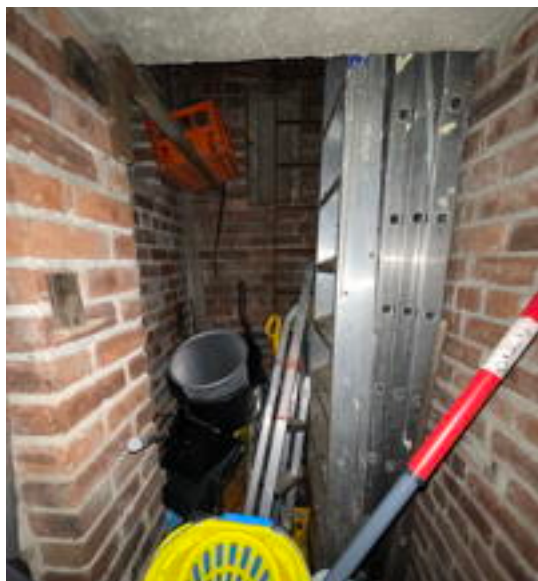
**Ground Floor of Tower**

Area now used for storage at ground floor level. No obvious problems when viewed from ground level but horizontal crack previously noted.

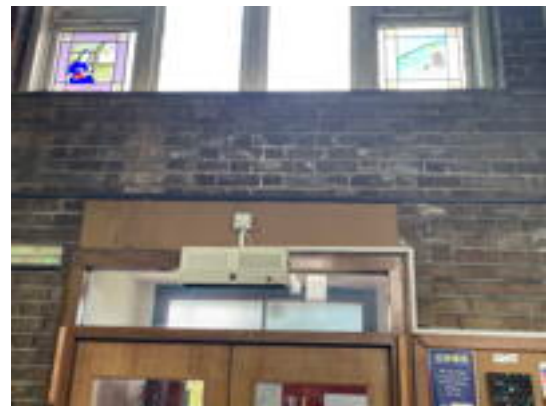
**Salts above North Porch**

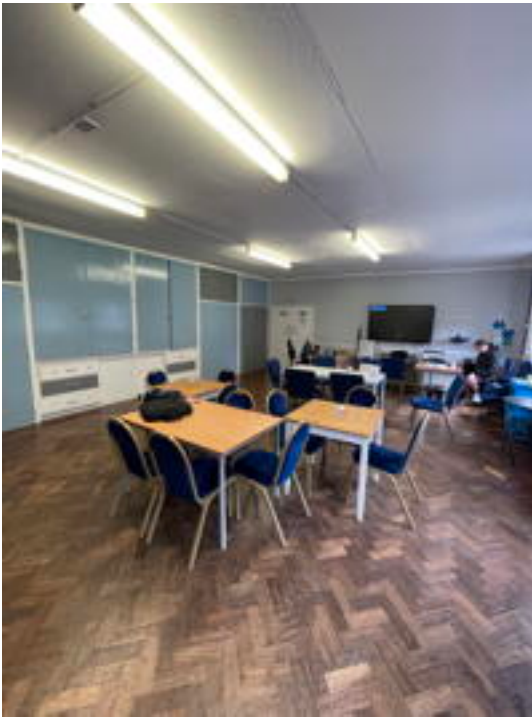
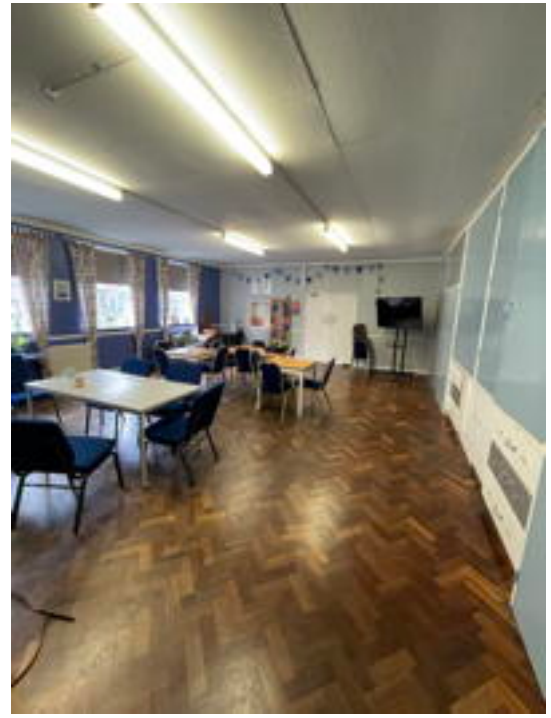
The Choir Vestry/Meeting Room is generally in satisfactory condition but the woodblock floor would benefit from refinishing.

Refinish woodblock flooring to Choir Vestry/Meeting Room. Cost Band 1-£0.00-£1,999.

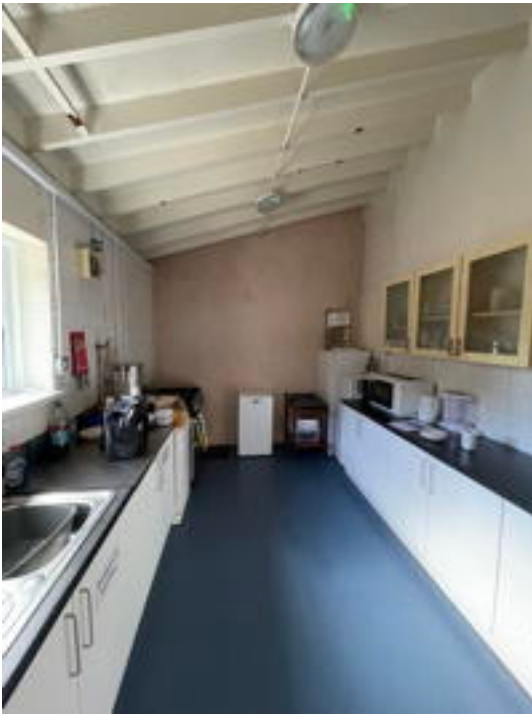
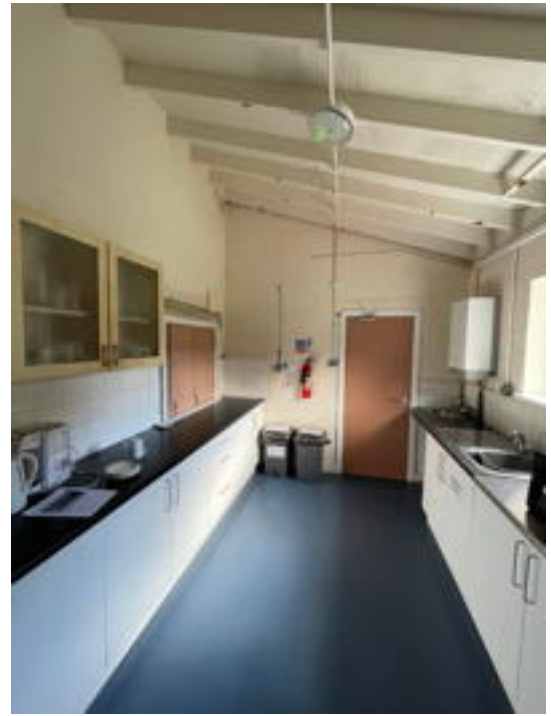
The Hall Kitchen is in generally satisfactory condition. For Health and Safety reasons it would be better fitted with a wall mounted water boiler. New hatch, door and south wall require decoration.

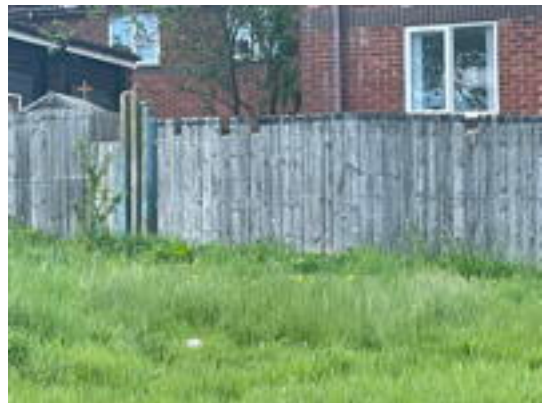
**South Boundary Fence Towards Western Corner**

All mostly in satisfactory condition. South boundary fence towards west end of site looking dilapidated

Consider replacement of South boundary fence towards west end of site. Cost Band 1-£0.00-£1,999.

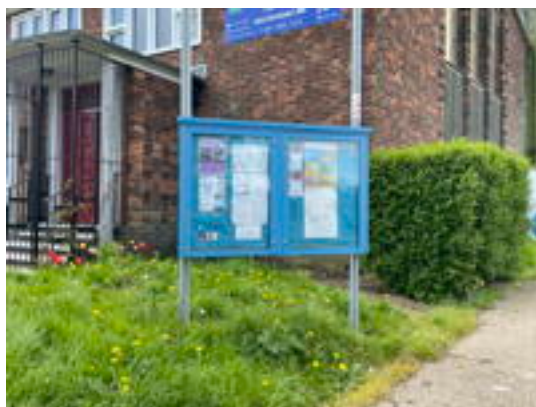
**Noticeboard**

The Noticeboards are in satisfactory condition

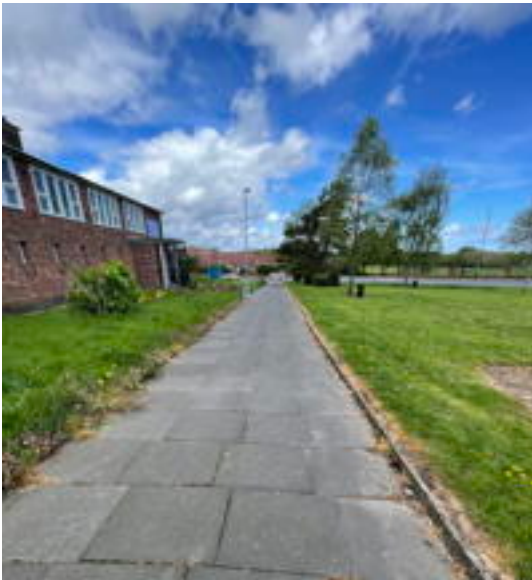
**North Elevation Pathway**

All is generally in satisfactory condition but the grass was not yet cut. I was informed that this was imminent.

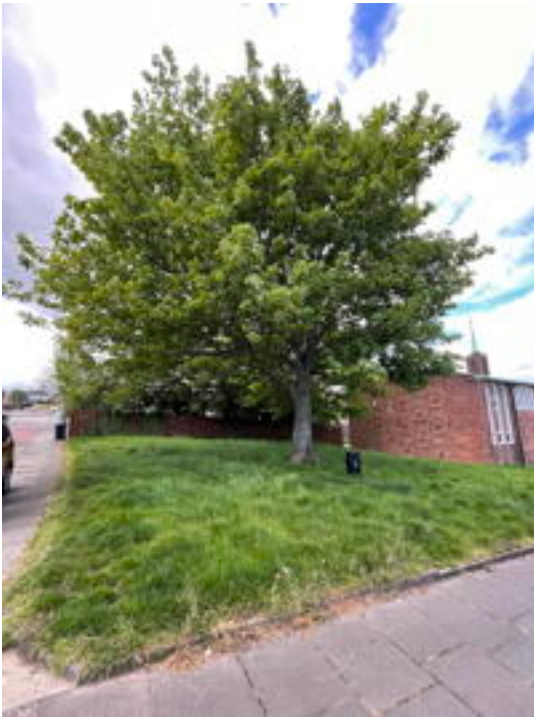
**East End Sycamore**

The trees generally all appear to be in satisfactory condition. The trees should all be inspected by a qualified tree surgeon every five years, and pruned in accordance with their recommendations.

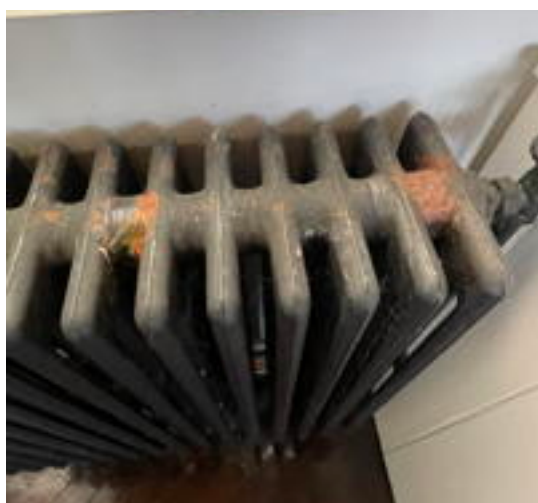
**Church Radiator**

There are signs of leakage to cast iron radiators in the church.

Draw up plan to replace leaking cast iron radiators and associated pipework prior to failure of the system. Cost Band 1–£0.00-£1,999.
