ROWLANDS GILL St BARNABAS
(22A)

QUINQUENNIAL REPORT

4 August 2023

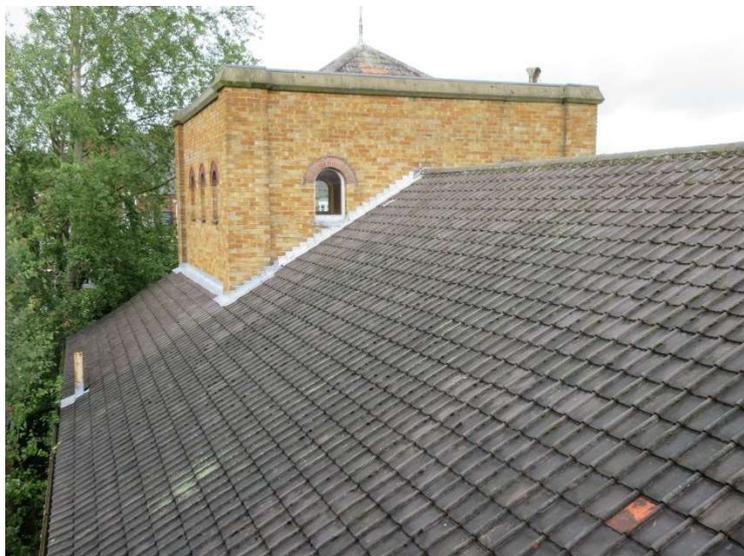
- 17. All pitched roofs have interlocking roll clay tiles on battens on reinforced felt.
- 18. Tower roof a pyramid with a metal cross at the peak and wide stepped gutter inside a deep parapet (no access at this inspection). 2009 repairs included relaying most gutter boards and bearers to better falls and drips. In 2016 most of the gutter lead lining was stolen and replaced in dark grey Sarnafil carried on ply up the insides of the parapets and over their copings. The gutter lining was carried over remaining lead in the two N outlet chutes. No sign of present trouble.

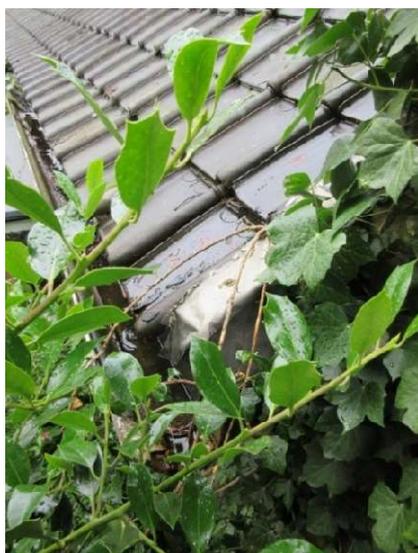
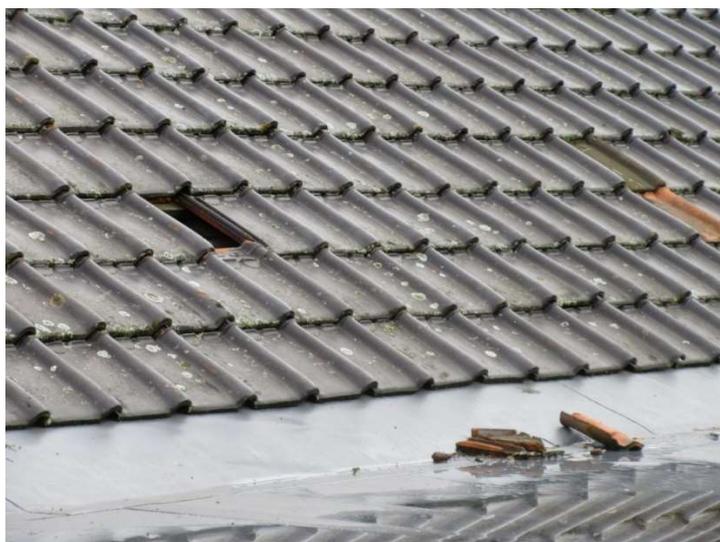
22. The Nave SW corner where the higher Hall dormer abuts the church roof (accessible from the fire escape) was covered in flashband before 2018. Lead cladding would be desirable but interference from the escape is too easy. New battens and an end tile with slate undercloak OR tiles with dry verge lapped over a new upvc fascia might be a permanent solution.
The flashband seems unchanged but is also becoming hidden by ivy and the neighbour's tree so uncertain. Growth must be cut back.

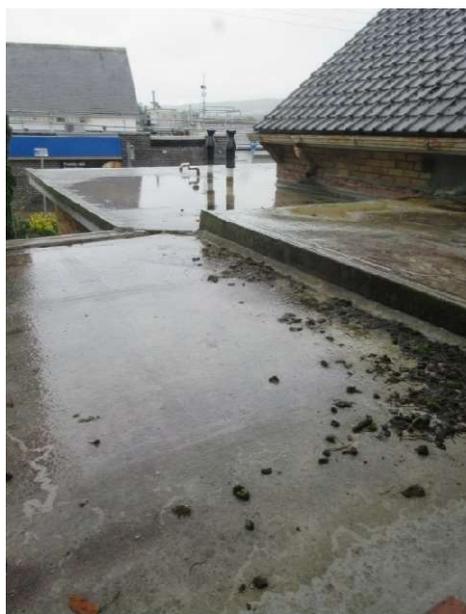
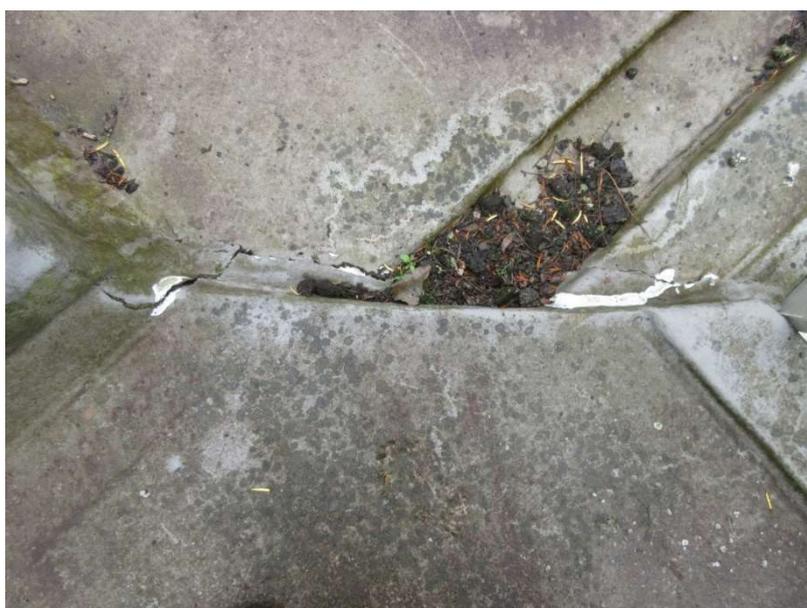
29. Church entrance flat roof is glass reinforced plastic to slight fall, with lead cover flashings against Nave. An integral gutter along the outer edge with two sumps. Again part blocked and cleared at the inspection. The gutter and sumps should be cleared more regularly. The corner by the Hall is raised above the general level. Its high GRP upstands are mortar pointed at the top. The GRP seems sound though some ponding and perhaps some lifting.

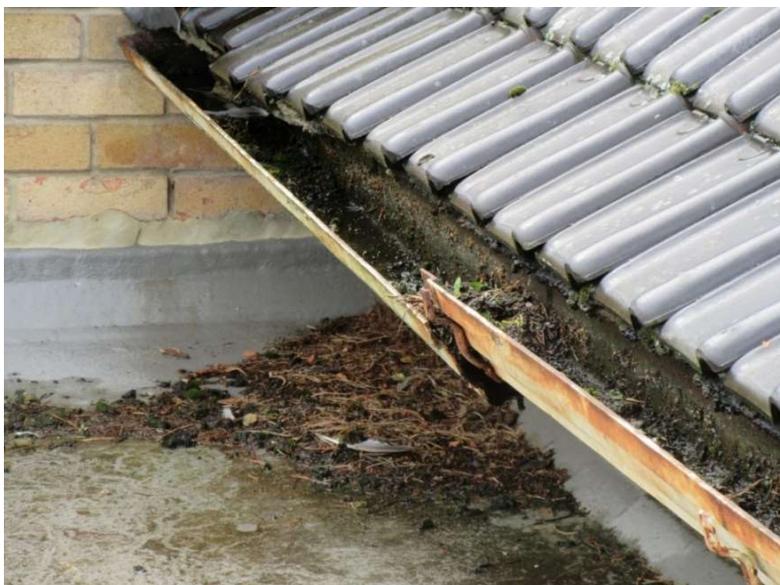
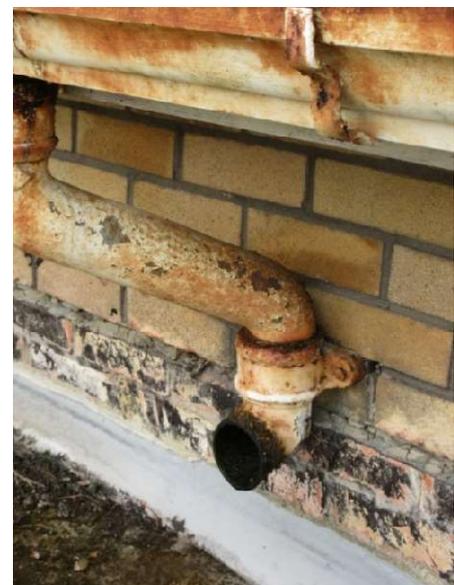
33. Most gutters are level cast iron ogee pattern on rafter straps with swan neck pipes (to pass the wide ply eave soffits) and round eared cast iron pipes to shoes and gullies. Most gutters part blocked. All are rusting, some severely. Unless they are cleaned, prepared and painted soon they will be beyond saving.
34. One joint at the S end is open and dropped.
35. Straight pipes from the church flat roof eave (one iron with bandaged cracks at top and bottom, one plastic). Internal 4" cast iron down pipes from the flat roof at Kitchen and Boiler room with rodding point in Kitchen floor. Cage over Boiler room could not be cleared at the inspection (para 31). In the Boiler room the internal down pipe is rusted cast iron with a broken socket but does not seem to leak.

| Clear all gutters and repair break at S end | 33, 34 |

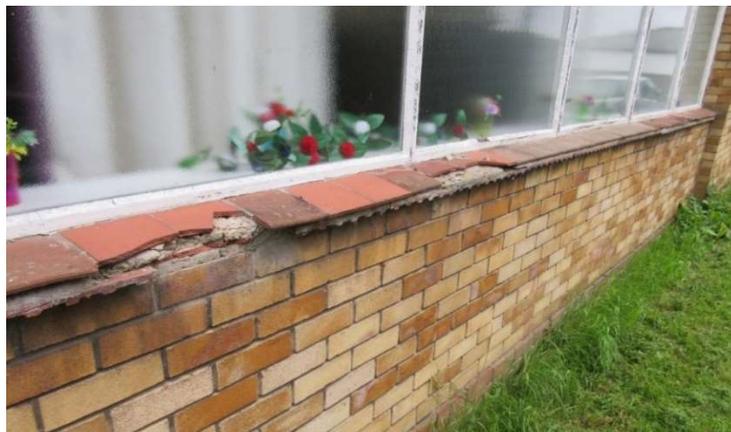
42. Cavity walls faced with good yellow brick, stretcher bond. Inner leaf unknown but almost certainly brick or clinker block and uninsulated. Damp proof course over slight plinth. Recessed pointing sound. A little pointing damage where leaks have been repaired. Scattered open vertical joints at the Vestry gable.
43. Tower thick stone copings on brick parapets. Covered in the recent repairs but joints outside copings still open.
44. Attractive tile corbels at the gable eaves. Segmental tile arches at the main door openings and round arches at the narrow windows and the large upper Hall window.
Running brick over steel lintels at the Kitchen S end. Brick on edge at the long lower Hall window.
Tile sills generally good but several broken at lower Hall should be replaced.

| Replace broken tile sill at S of lower Hall | 44 |

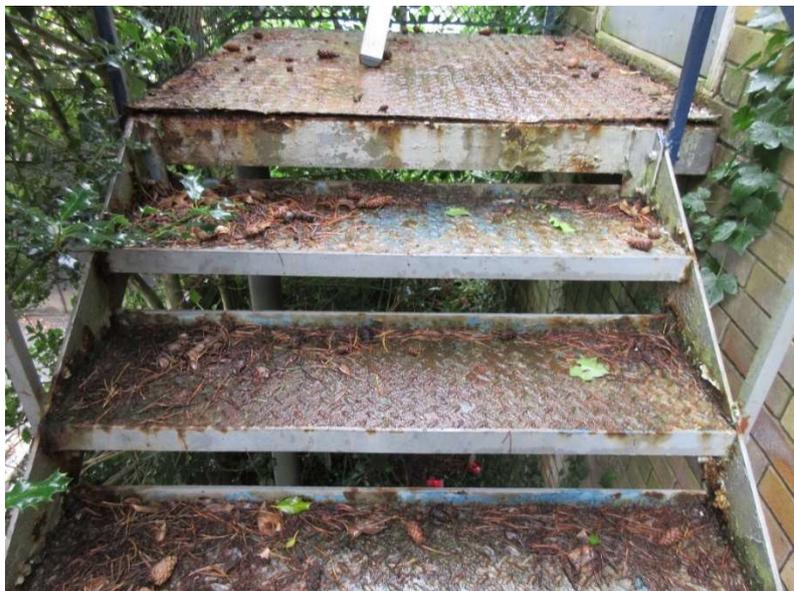
51. The large flush escape door from the upper Hall is tight to the frame. No drip mould and exposed because nearly flush with the brick face. The door and frame will swell in damp weather.
As a minimum the frame needs paint and the hinges oil but resetting further back would improve.
52. Eave fascia paint becoming poor. A white painted fascia at the upper Hall dormer needs paint.
Most external metalwork well painted but paint lacking at some steel windows and putty.
Extensive rust at escape stair from upper Hall.

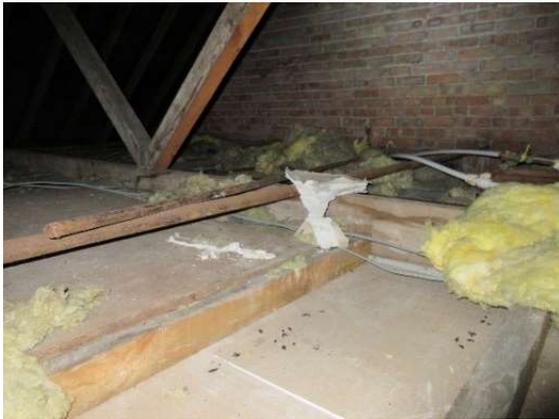
Over Vestry

59. **Vestries** have plaster on softwood joists with thin insulation quilt over part only. Sound except hatch and adjacent plaster damaged by roof leak over.

| Repair ceiling and hatch at Vestry | 59 |

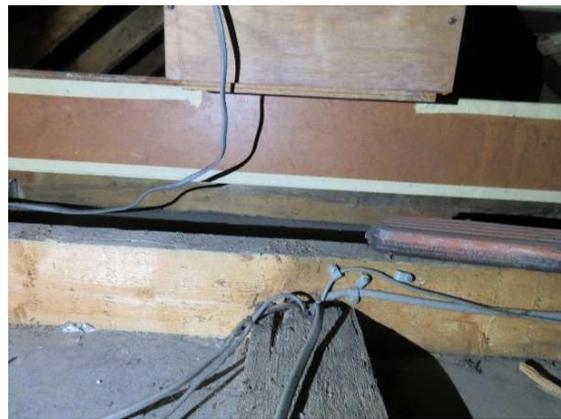
Over landing

56. Upper Hall pitched roof all concealed above flat and sloping ceilings. The roof over the landing, upper stores and wcs is coupled timber rafters accessible by small hatch. No defect visible from the hatch.

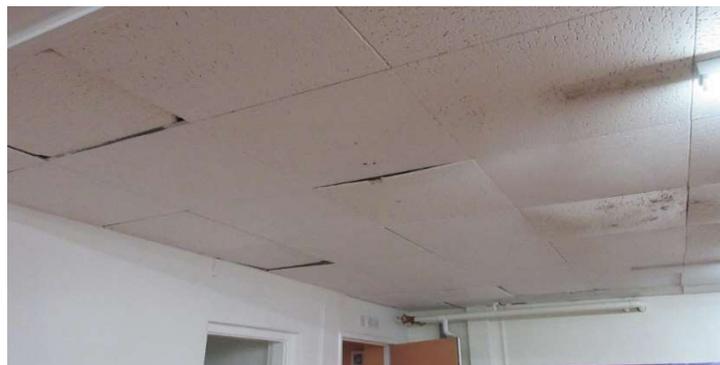
66. In the **lower Hall** large mineral tiles in a grid suspended from the concrete beam and block floor above.
Some tiles missing, water damaged or with broken edges but most sound. General replacement for appearance (with thin recessed lights?) would be an improvement.

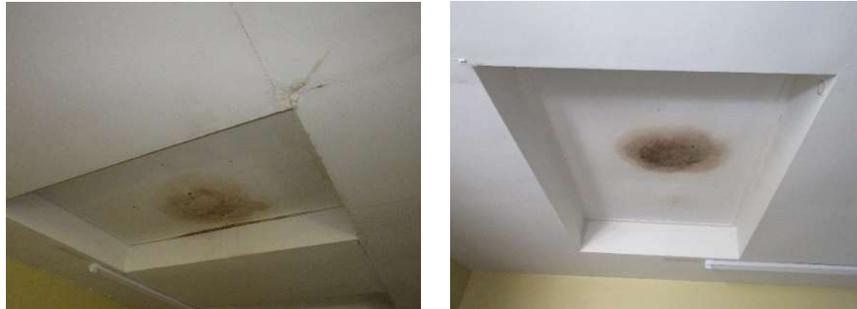
67. The **upper landing** sound flat plaster has no insulation, which could be simply added between the joists. The sloping plaster in the **stores and wcs** each side is also uninsulated but no access to the voids. Insulation could be added as a new thermal lining under the sloping plaster or under the roof tiles if the roof is opened.
68. **Upper Hall** minor cracks in the ceiling plaster under the flat 'dormer' roof. The ceiling inserts at the four former rooflights remain bowed and water marked as if affected by water, perhaps condensation. Similar to last inspection so perhaps historic before the last roof recovering.

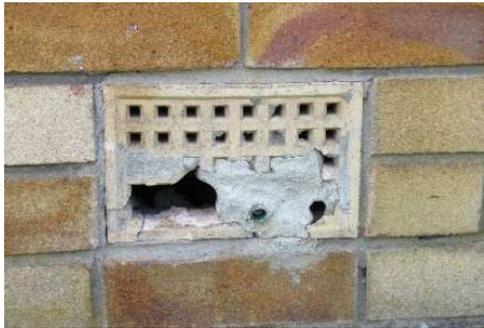
82. Air bricks for permanent room ventilation at low level in the Pantry and high and low level in the Boiler room.
83. The only suspended floor needing ventilation is the lower Hall which seems well provided with air bricks IF the air bricks at the solid floor Kitchen connect by ducts to the Hall floor void. A broken Kitchen airbrick has been mortar patched, part missing which could attract vermin.
Under the fire escape stair the ground level and plants have risen too close to the two (or three?) vents. The air brick under the escape doors is both broken and part blocked by the paving, making it both vulnerable to vermin and less effective in ventilating the subfloor.

| Renew broken air bricks outside Kitchen and Hall | 83 |

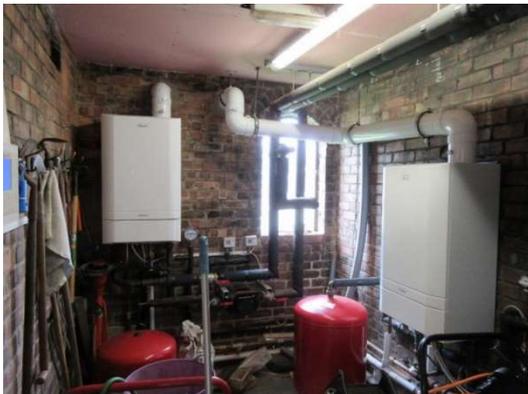
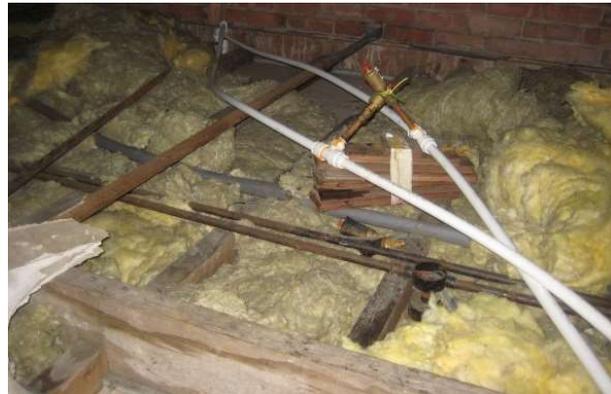
95. Heating reported effective but there appears to be waste of energy due to incomplete lagging of heating circuits and pump in the ventilated Boiler room and uninsulated plastic heating pipes in cold ceiling voids over the Vestries. There may be more in other cold voids. The large exposed heating pipes in the church entry passage and accessible wc are likely to be wasteful. The building itself is almost entirely uninsulated.
