## Church of St Mary the Virgin, Shincliffe

### Quinquennial Report

**11<sup>th</sup> May 2026**

**Sarah Harrison** RIBA

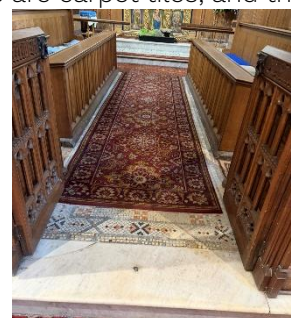
20.3 **Chancel:** The chancel floor is marble and mosaic. The sanctuary step is unstable or loose, and there is cracking at the chancel arch step. The sanctuary floor itself appears generally satisfactory. There is quite a lot of dust on the floor from failing plaster decoration above.

*Figure 34 - Chancel step*
