St HILDA
SOUTH SHIELDS
(110)

QUINQUENNIAL REPORT
on the architect's inspection on

8 May 2024

IAN NESS
ARCHITECT
26 GROSVENOR PLACE NEWCASTLE upon TYNE NE2 2RE
tel & fax
0191 281 2559

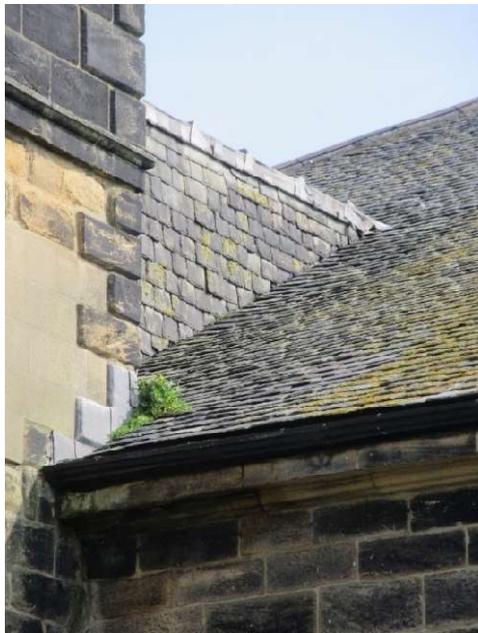
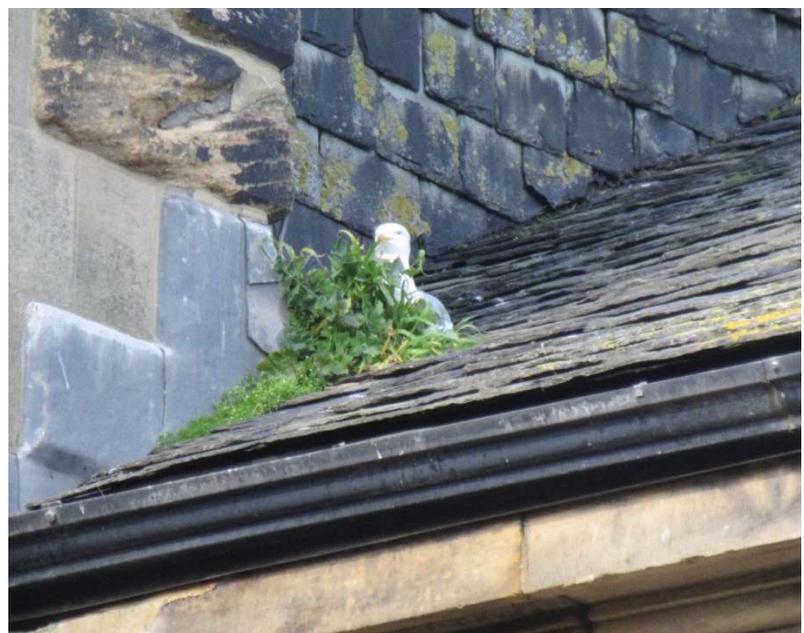
21. A tunnel between the W Tower and W hip has a flat lead roof and slate cheeks all seeming in good order except plants in a mortar fillet between the N cheek and the hip slates must mean the fillet is cracked and leaking. At S side no fillet, indicating concealed lead soakers.

plants in cracked mortar fillet N of the tunnel between Tower and Nave roof and a slipped slate lies on lower slates

22. The Nave W hip slates are mortar torched inside, no felt. Large glass slate. Slate fair with some patching. One slate has slipped out N of the top of the tunnel and lies on the lower slates.
Lead back gutters at the Tower corners, N renewed 2005.
Plants grow in a blocked secret gutter between the S side of the hip and the Tower, a perfect nest site.
23. N slope slate, felted, seems sound except two small slates missing towards top E end.
Top third is old diminishing westmorland, remainder smoother and more even, perhaps relaid after war damage. Bottom course fixed by screws and washers.

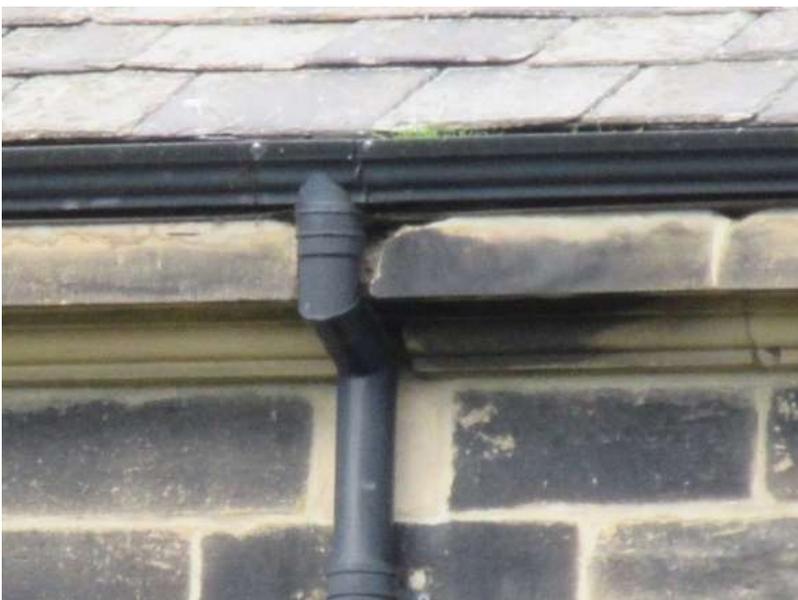
31. Black ogee cast aluminium level gutters on damp proof course on stone cornice. Generally sound but level gutters at height tend to fill with uncleared debris and to overflow unless cleared at least once a year. Two pipes each at N, E and S sides.
32. Nave E appears clear except plants in gutters at outlets each side of the Apse.
33. Nave S gutter good.

Typical Nave gutter - N gutter E outlet

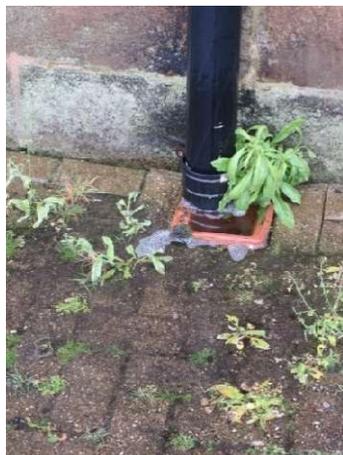
37. At N Nave the W gully does not run well, spilling water over the pavement. Grating missing.

In rain N Nave W gully spills across the public pavement

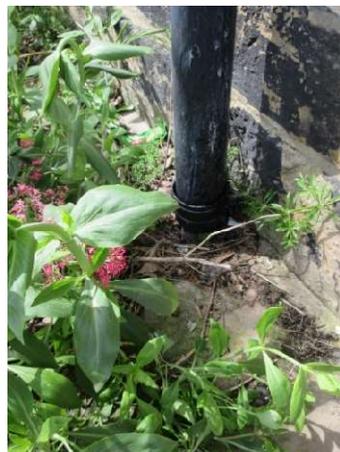
Nave SE

38. At the S Nave E end a modern gully needs to be cleaned.

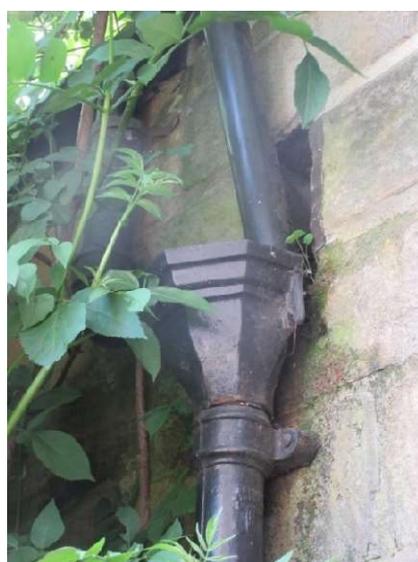
Song Room NE

39. The Song Room has plastic half round gutters, old cast iron hoppers and one rusting pipe at NW. Other pipes plastic, including at the Porch link a pipe still so loose and misaligned that it appears to end in a hole in the stone wall. Now so overgrown by a shrub that difficult to see.

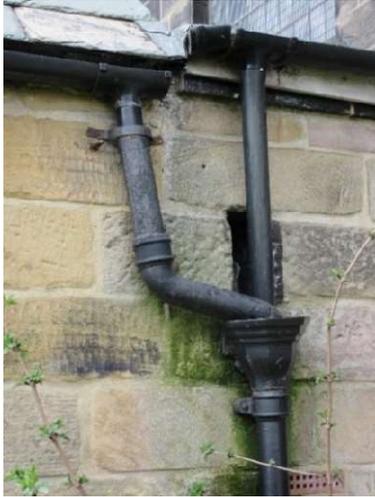
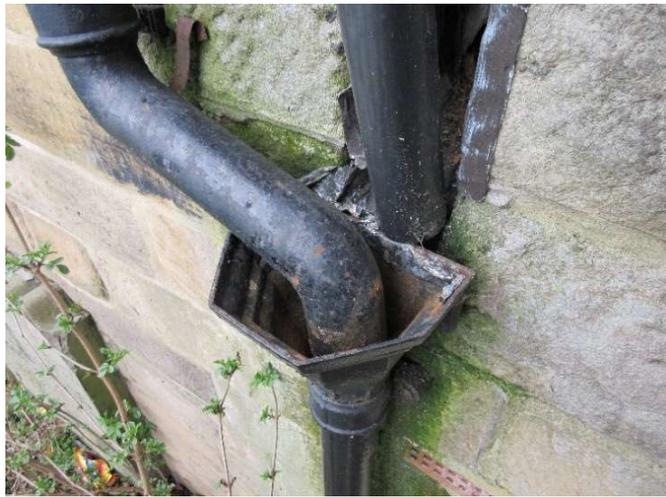
Song Room NE - 2019 photos repeated because now hidden by growth - Misaligned pipe misses the hopper

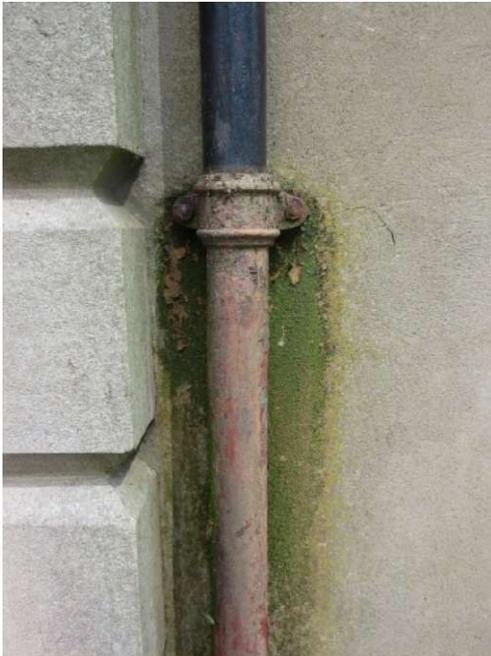
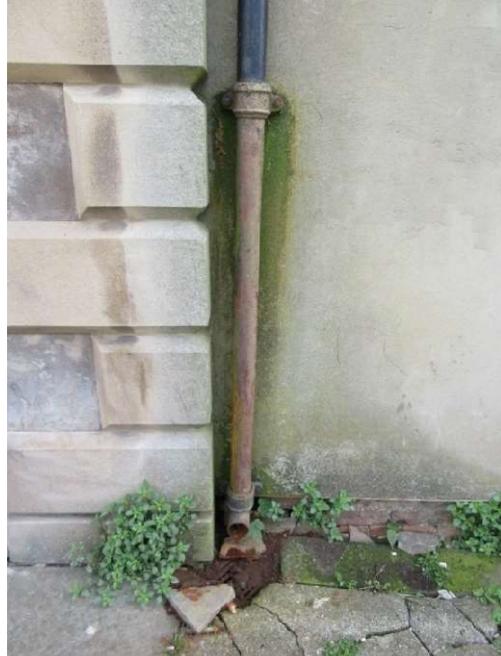
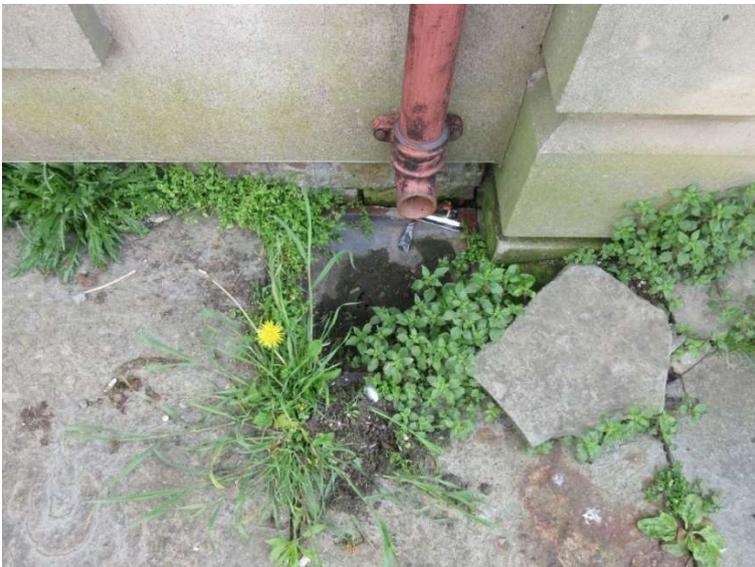
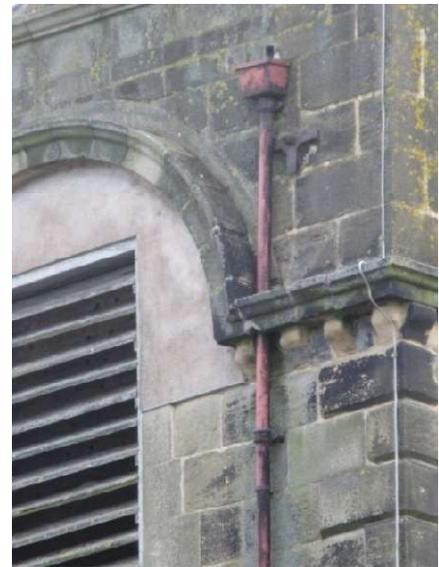
40. The Vestry and Kitchen sump outlets drain to cast iron hoppers, pipes and shoes.
Both hoppers now clear. The Kitchen pipe overflows at its mid joint suggesting the bottom half is blocked,
soaking the wall in heavy rain.
Their gullies are prone to blockage by soil and should be cleared twice a year.

- 41. All hoppers, gullies and drains need to be cleaned regularly to prevent blockage and damp walls. The history of decay in the floor makes clear drainage extra important.
- 42. Remaining cast iron rainwater goods at Tower (E side high level), Vestry and Kitchen are rusting and need preparation and paint.

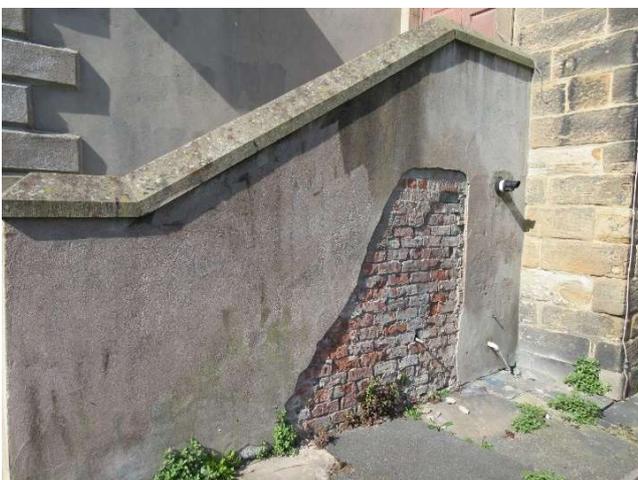
para 47

- 46. A hidden oval tablet over the S Porch erodes from the edges.
- 47. The rendered Vestry, Kitchen and stair walls have tempted spray painters but are clear now. A large patch lost at S end exposes solid brickwork. At W open joints in the exposed brick below the render would be better pointed.

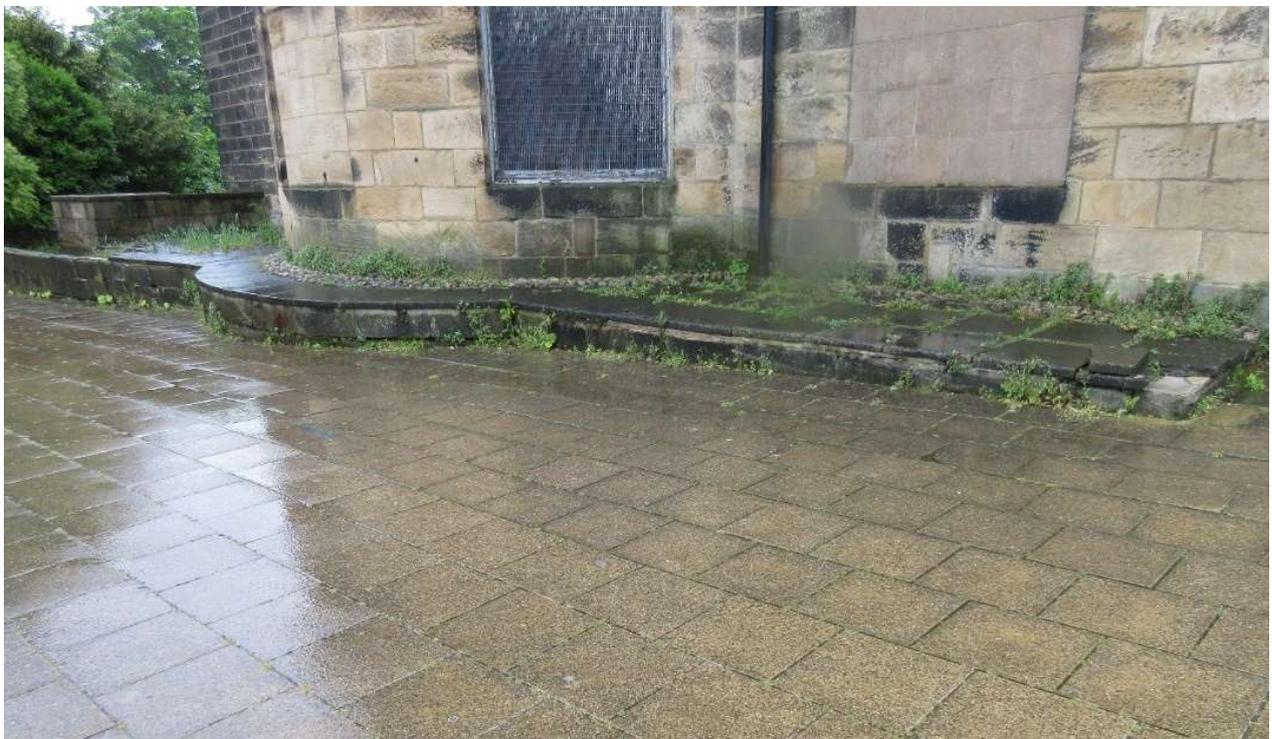
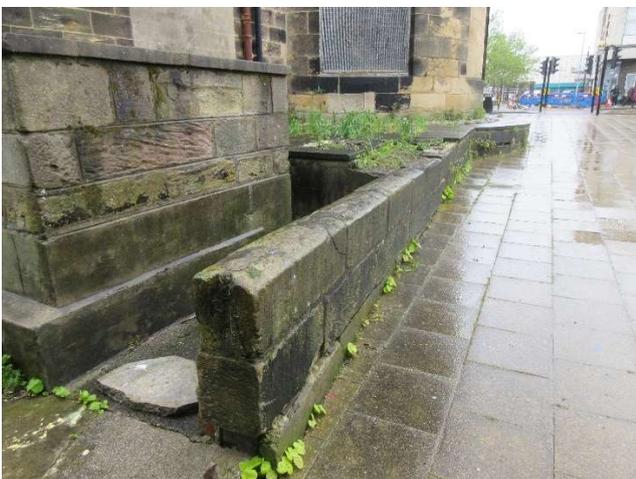
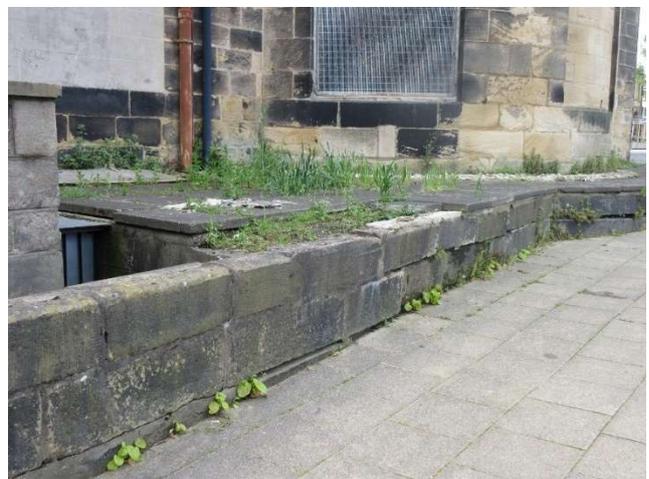
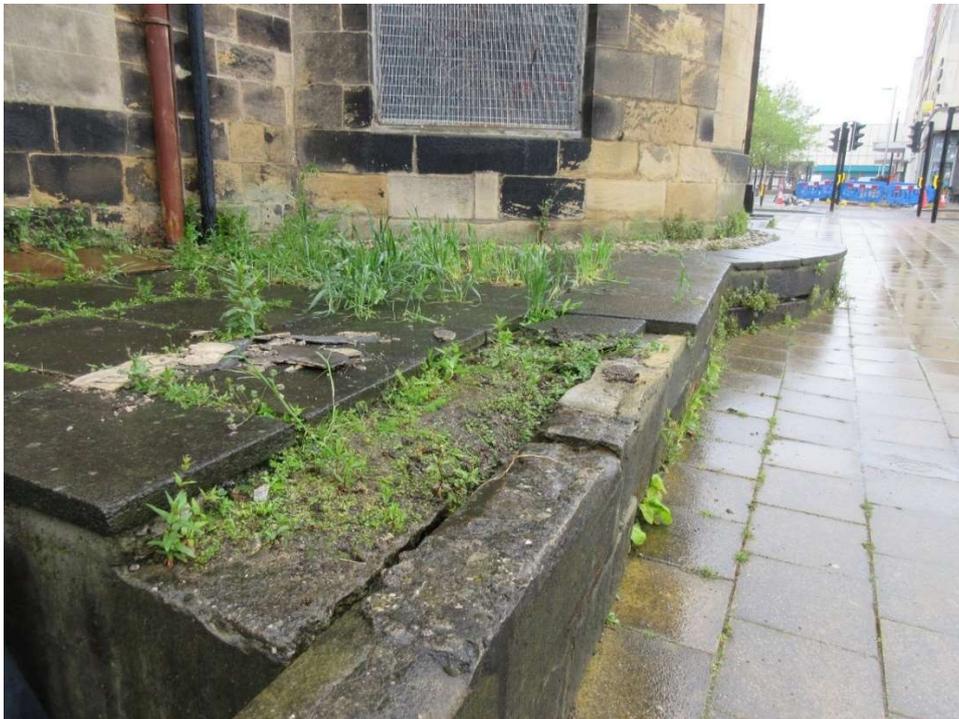
50. Between the E end of the church and a sloping square of public paving a margin of raised concrete paving appears to be part of the church land. The margin is retained by a low stone wall part capped by the paving. Parts of the wall's pointing are missing and the paving has spread with plants between so it is not water resisting. A few pavioours are missing. The overall appearance is poor and it lets rainwater drip into a brick vaulted room under its S end.

56. For public appearance alone there is a clear case to rebuild this whole E end margin more durably, perhaps including final clearance of the decaying remains of the boiler and flue.

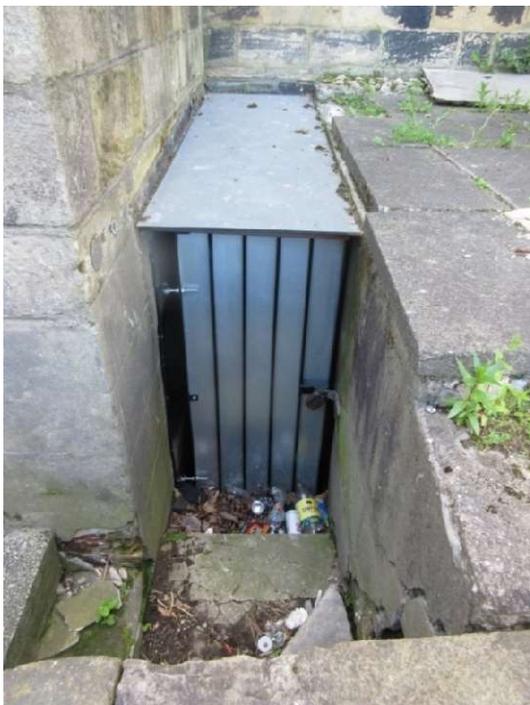
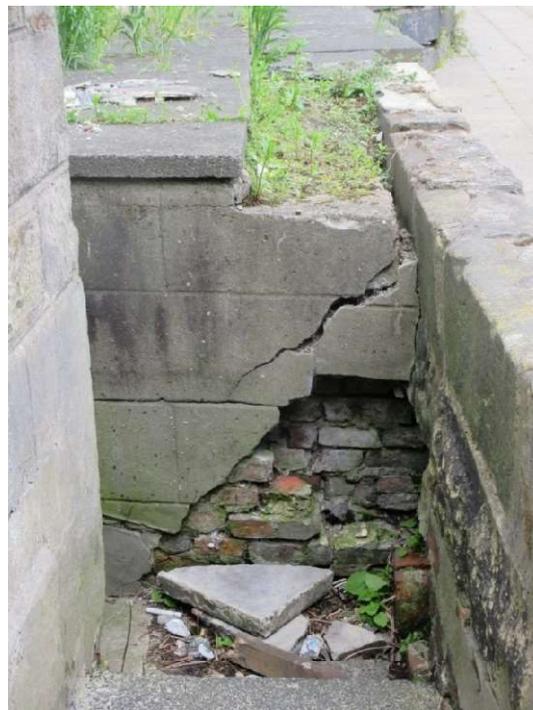
51. At the SE corner two semi-basement rooms lie each side of an external stair. Most of the stair is now covered by a sheet metal roof and a locked metal gate, which improve the security of the rooms but still allow wet rubbish to fill the remaining stair. Regular clearance still required.
52. One wall enclosing the stair is rendered, part missing. Its cracks and loose brickwork behind show some movement. The stone wall itself shows some lean outward and minor displacement of stones. Not known whether the lintel at the (now concealed) former coal drop under the stone wall is sound. The dilapidation is not markedly worse than at the last report but the fabric will decay further. The exterior makes a very poor appearance to a public space which may become increasingly busy if the cleared sites are developed.

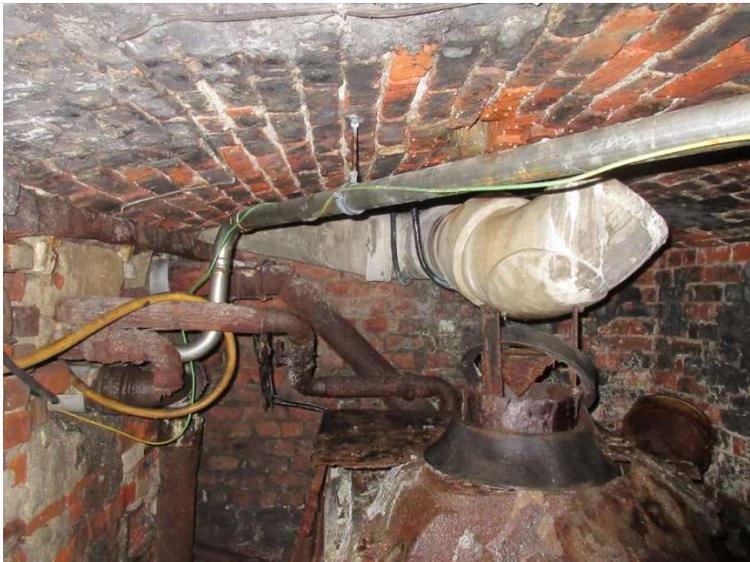
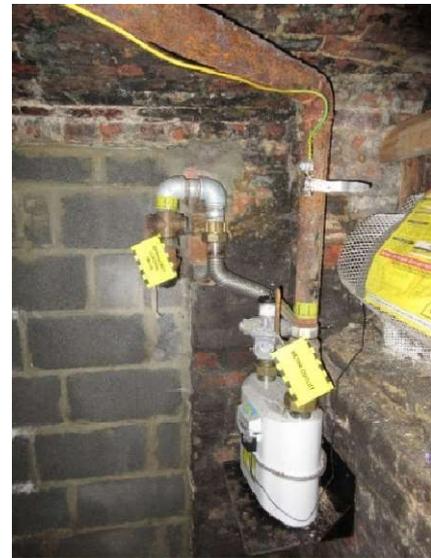
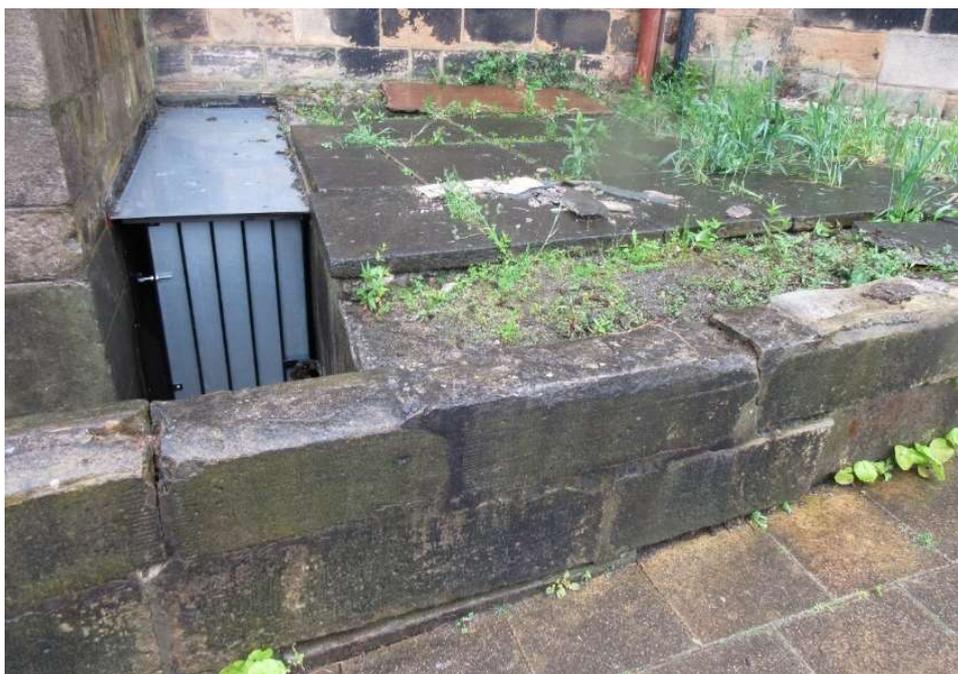
54. N of the stair are two brick vaulted chambers under the raised paving. The E chamber (former coal store now with gas entry pipe passing through) is now completely walled up with blockwork because decayed lintels at openings in the stone wall between chambers were removed and blocked to prevent collapse of the vaults.
55. The still accessible W chamber with rain dripping through its vault contains a disused boiler, disconnected asbestos cement flue pipe, rubbish and a live gas meter and supply pipe though the Nave wall. Remote reading of the meter has been attempted. The former flue pipe rises half way up the church E wall.

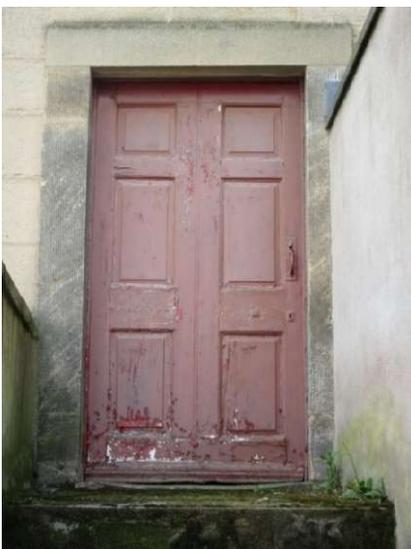
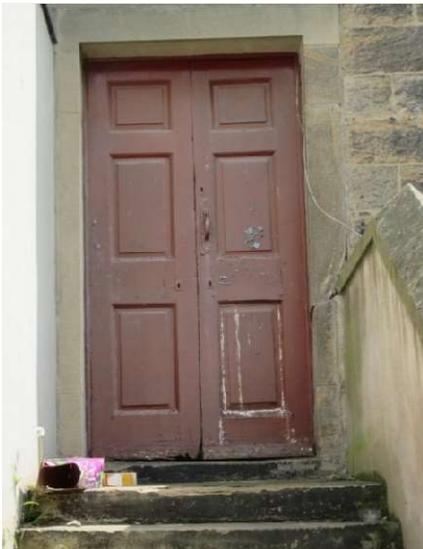
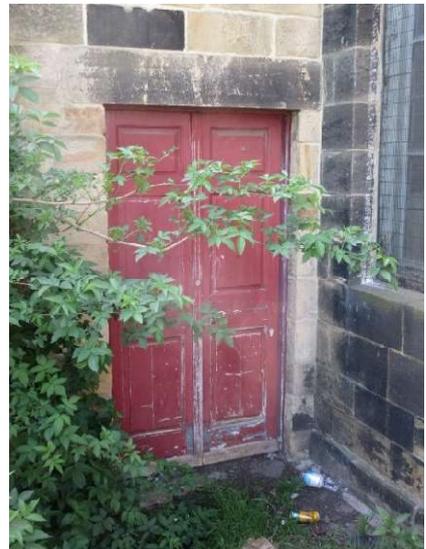
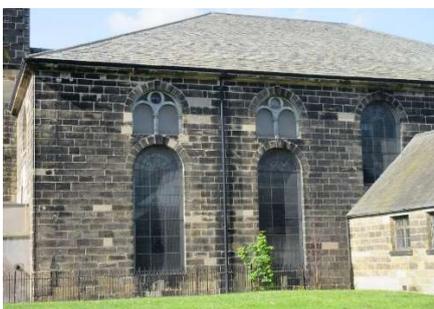
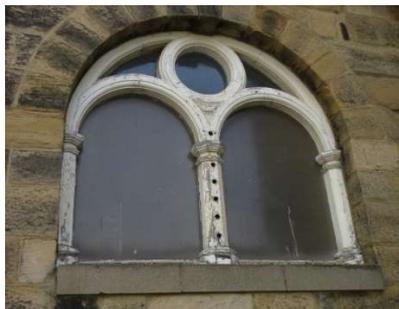
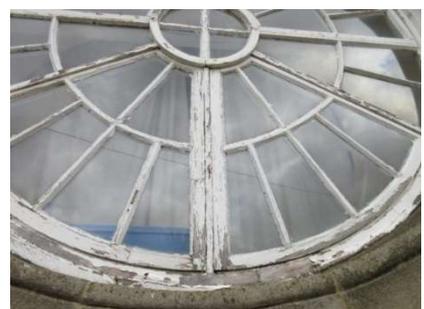
65. Painted timber Tower louvres, Vestry and Ringing chamber windows, Nave upper windows and lower window subframes and doors at the arched W entrance, the Vestry, the Nave Gallery stairs and the Song Room Porch all need thorough preparation and repainting, for both appearance and preservation of timber. The S Gallery doors lack a weather mould and the bottom of one door decays.

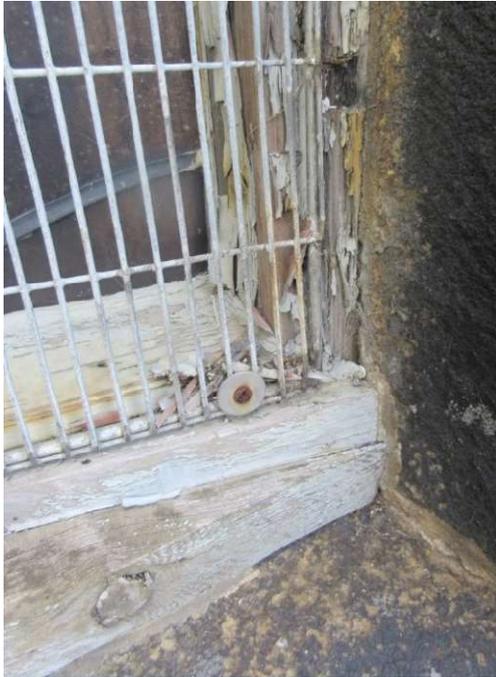
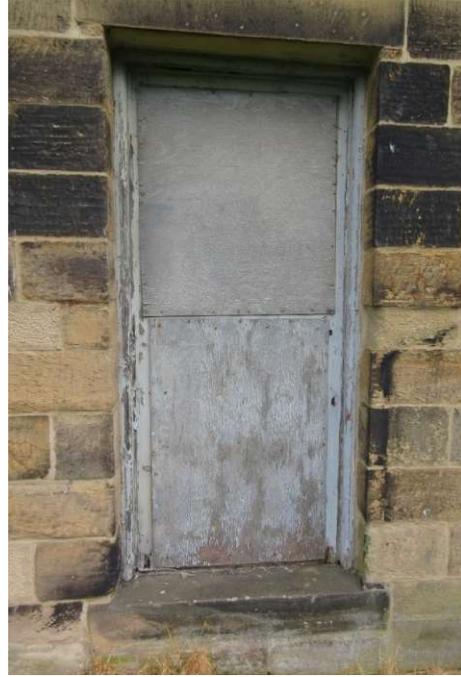
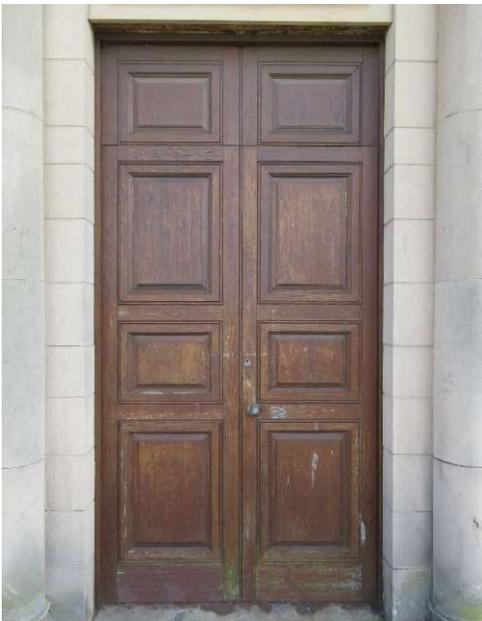
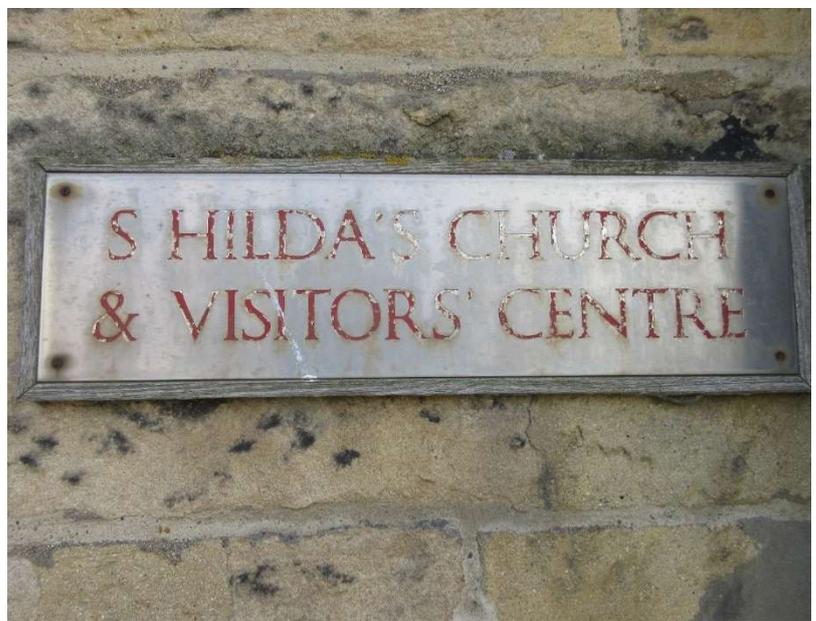
66. The Nave lower windows and the longer upper windows over the N & S doors have leaded glass in painted iron frames in hardwood frames and sills.
The three Apse windows have painted timber frames with two external rusted iron bar transoms at each.
Paint flaking and poor at all frames.
67. The Song Room windows have timber frames and lintels, appearing sound. Paint is poor at all windows.
A ply cover over the W door deteriorates and the whole needs repair and paint.

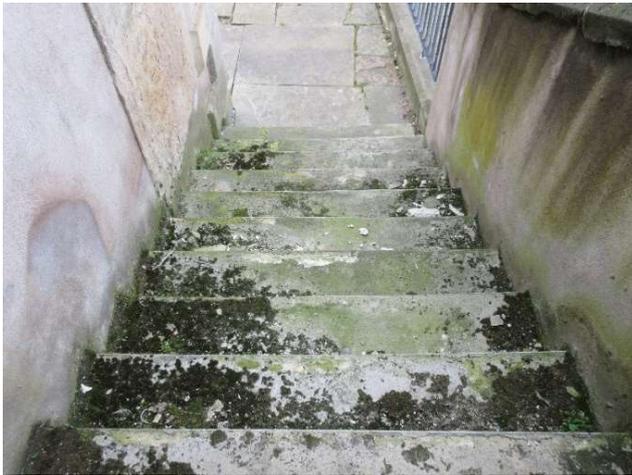
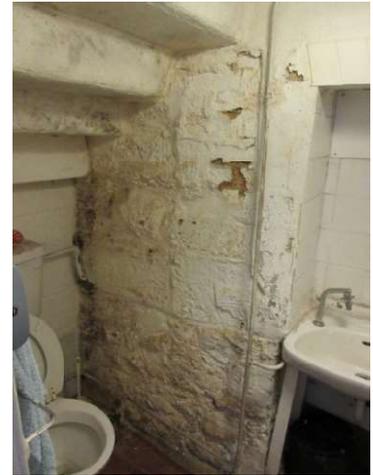
para 76

76. There are single wcs under both NW and SW external stone landings and stairs, which have no waterproofing. Cement skim on the NW stair is crumbling. The solid outer walls are rendered (part missing at S) but may have no dampproof courses preventing rising damp. Both wcs are damp.
77. The S wc has fully tiled walls and floor, beginning to loosen.

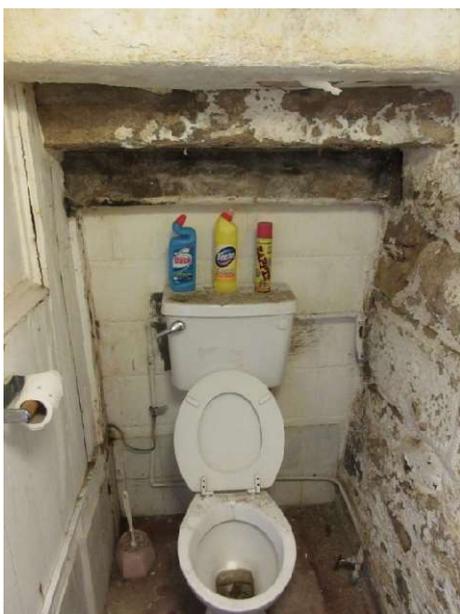
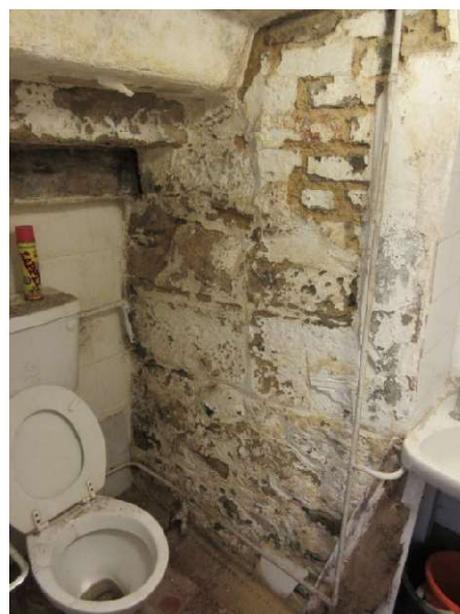
NW wc (Vestry) 2019

78. The N (Vestry) wc has masonry painted stone walls and ceiling, now very poor. A small amount of wood panelling now has dry rot.

90. In the Vestry wc masonry paint all damaged by damp.
91. At Song Room NE corner top of wall and part of ceiling discoloured under the worst roof slate damage.

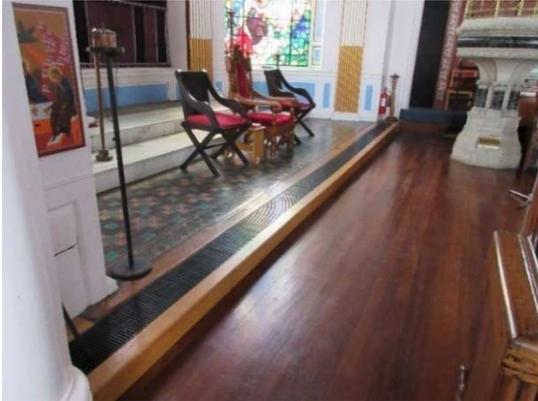
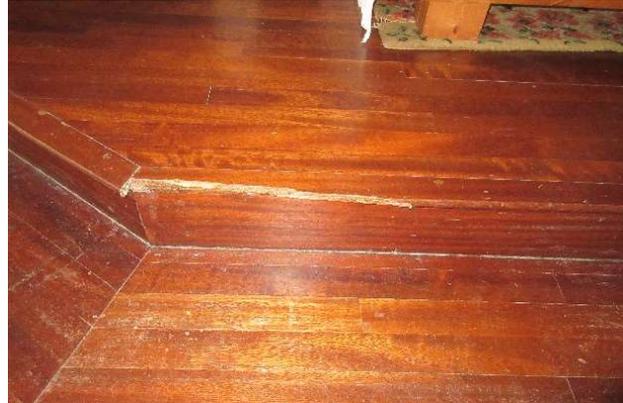
101. In **Apse** small tiles, some encaustic decorative. Rough cement infill where a former altar stood. Two very wide marble steps. Oak step extended with heating grill.
102. Hardwood Nave altar dais on two levels with self supporting kneeler rails.
Part of the upper nosing is missing.

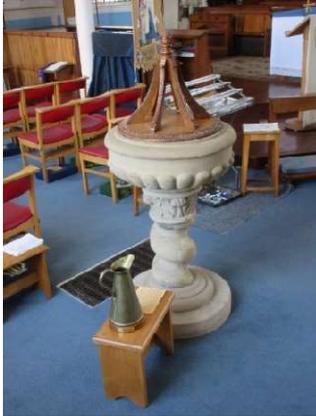
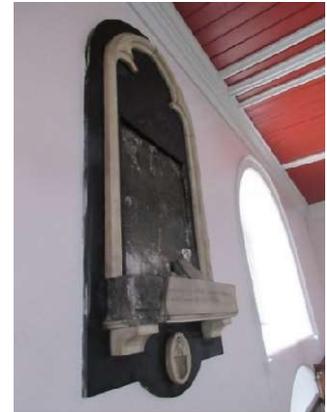
111. In Vestry wall monument part hidden by floor safe.
 In Kitchen large Pemberton monument in painted Doric aedicule.
 In Nave and Visitor Centre 14 marble classical wall plaques all good quality but dirty in places. Five more in Gallery of which four are very high quality and deserve care and publicity to visitors. At S one is patched after loss of some marble.
 The NE Gallery monument is poorer in design, large part missing and may be better removed than repaired.

Example of fine but dirty marble monument

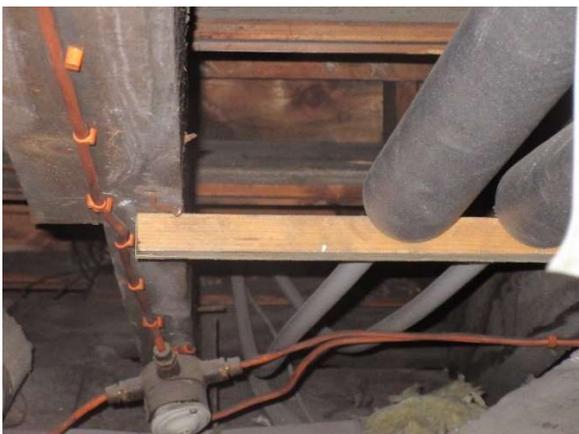
Heating pipework under Gallery part insulated

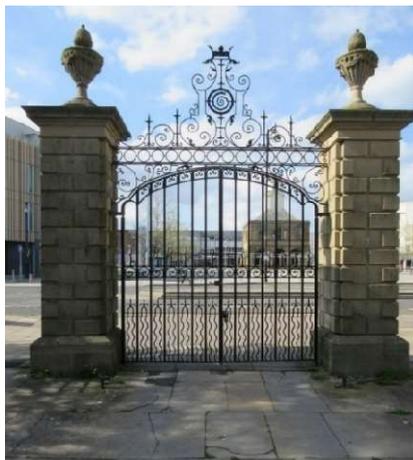
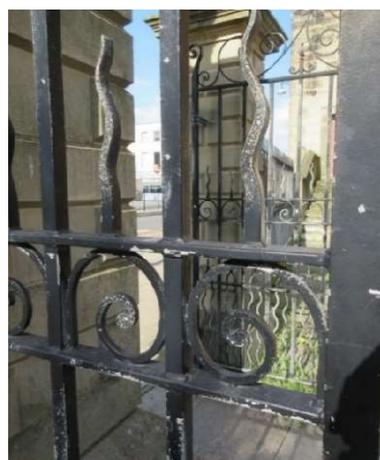
139. Renewed N gates, iron overthrow, stone piers and the sandstone flagged forecourt makes an attractive approach. The renewed N metalwork is galvanised and painted, now need repainting.

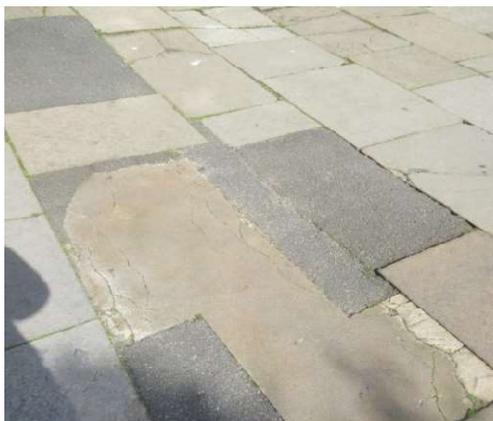
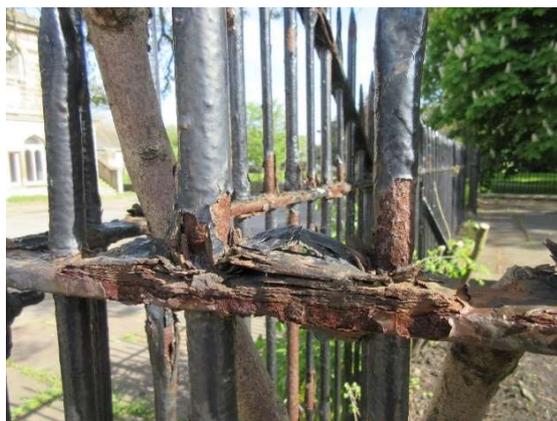
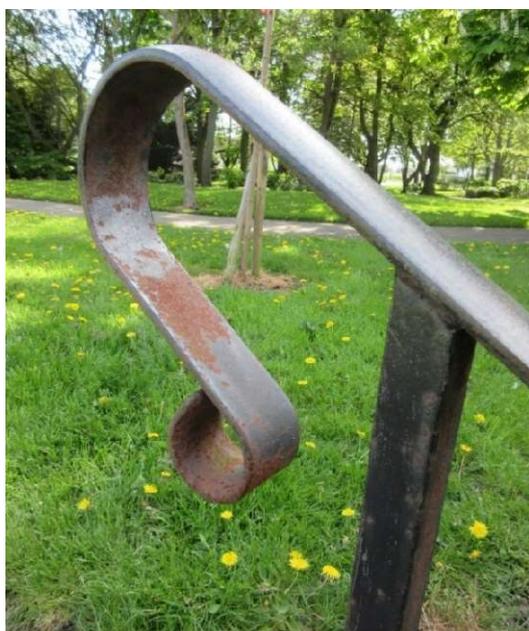
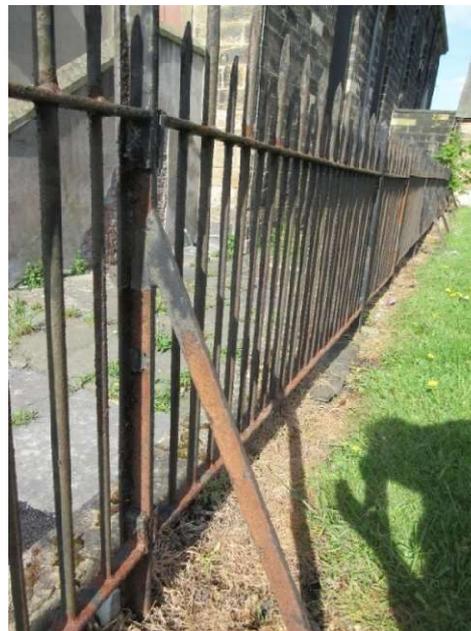
140. Some forecourt flags have been replaced or tarmac patched but vehicles continue to damage the flags. The base must be too weak for vehicles. Better to lift all flags, excavate, lay new base overall suitable for vehicles and relay sound and further replacement flags. May be Council responsibility. There may be archaeological interest in deep excavation in the historic churchyard. See para 144.
