**Quinquennial Inspection Report  
Holy Trinity Church, Southwick, Sunderland  
Diocese of Durham**

David Jowett - Architect, BA, DipArch, RIBA  
25 Roseworth Avenue  
Gosforth  
Newcastle upon Tyne  
NE3 1NB  
Tel: 07788 710 204  
email: [david@davidjowett-architect.co.uk](mailto:david@davidjowett-architect.co.uk)

6 May 2026

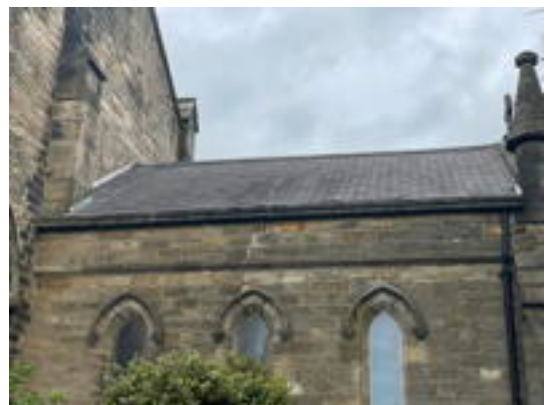
**Chancel South Roof**

Generally in satisfactory condition. There are a few slipped slates to the chancel south elevation and one to the nave north elevation.

Undertake full inspection of hidden valley gutter between Vestry and Chancel and replace all slipped slates. Cost Band 1-£0.00-£1,999.

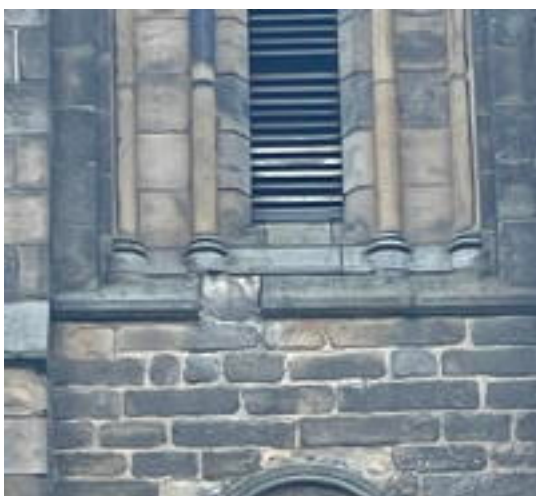
A very recently falling piece of masonry from the tower's west elevation, fortunately, caused no damage. The photos from the previous quinquennial show no signs of any issue with the stone in question. A prompt steel jack inspection revealed two further loose stones and a loose wooden louver to the tower, all now removed.

**Tower West Elevation Fallen Stone**

The tower west elevation has recently suffered from a section of high-level stone falling. A subsequent inspection by the steeplejacks has seen two further loose sections of stonework removed. Sections of the tower buttressing are showing signs of decay.

Arrange inspection with stonemason to advise on schedule of future stonework repairs and repointing in order of priority. Cost Band 1–£0.00-£1,999.

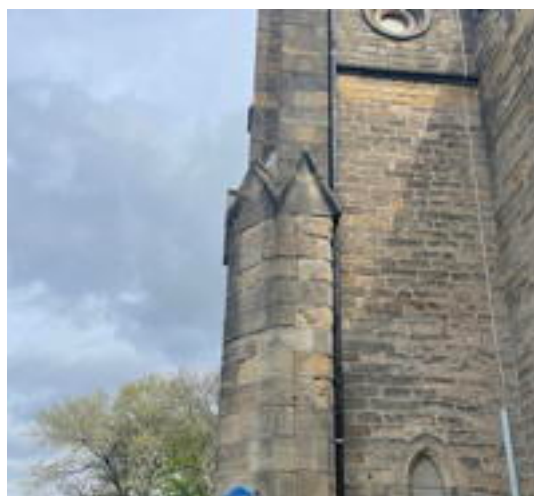
**Tower South Elevation Eroding Stonework to Buttress**

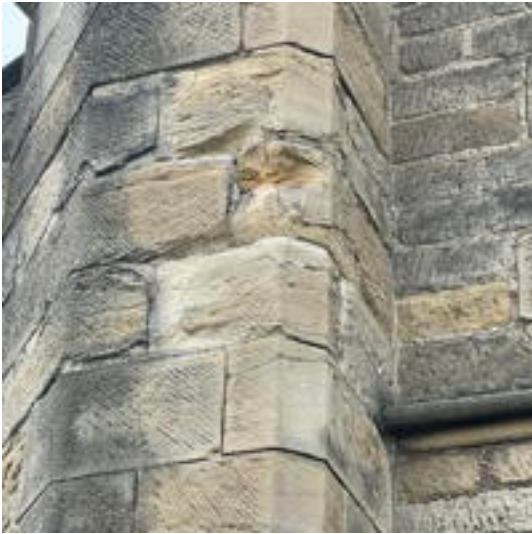
**Tower West Elevation Eroding Stonework to Buttress**

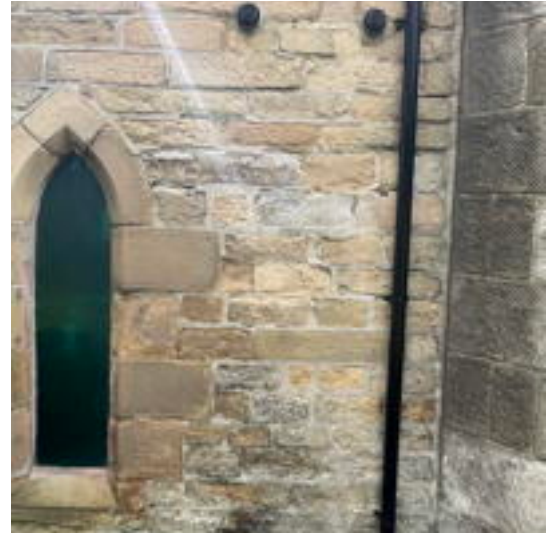
**Vestry North Elevation Eroding Stonework**

Vestry, north, north east and east elevations all have areas of decaying stonework.

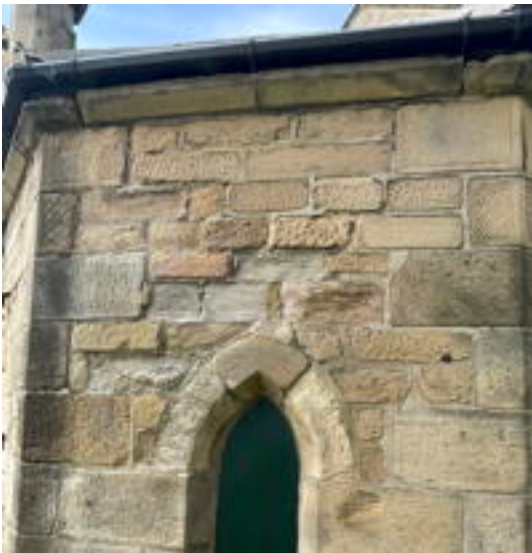
**Vestry North East Elevation Eroding Stonework**

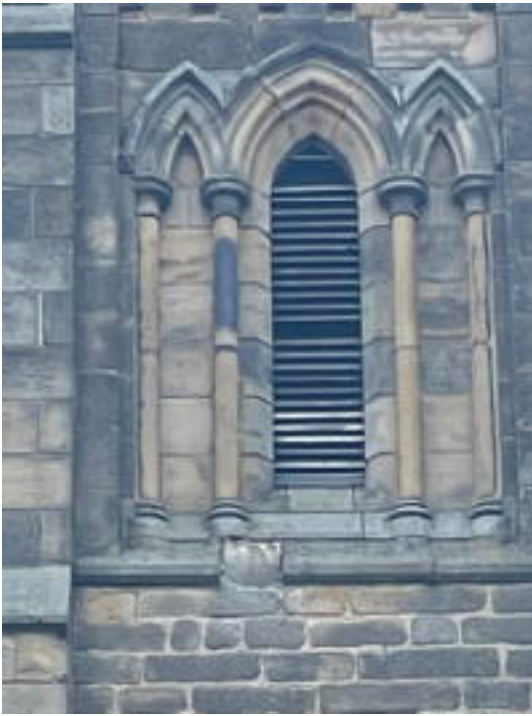
**W27 Gallery Welcome Room West  
Elevation Obscure Polycarbonate  
Sheet**

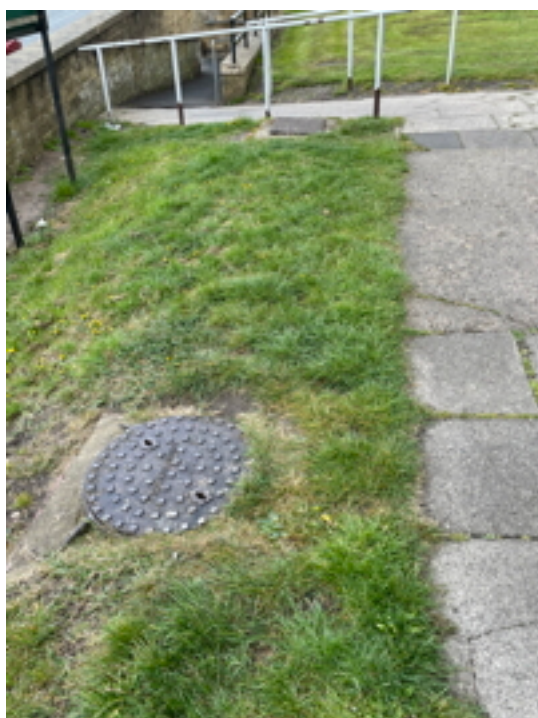
**West End Inspection Chambers**

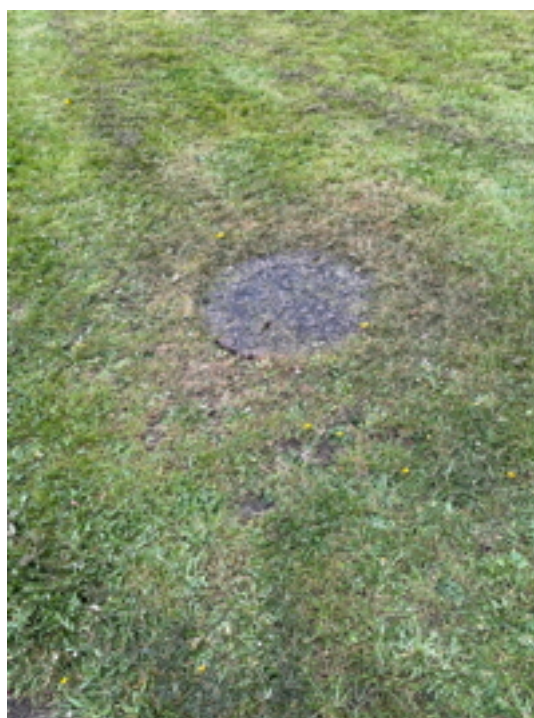
**West End Inspection Chamber**

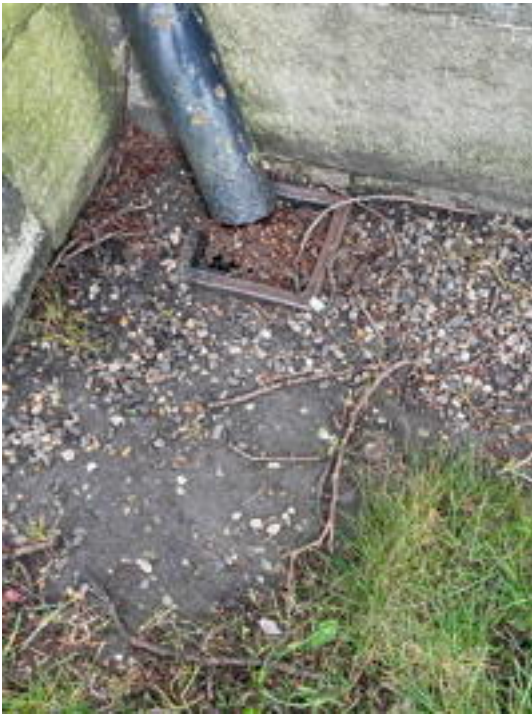
**Gully Partially Blocked by Leaves**

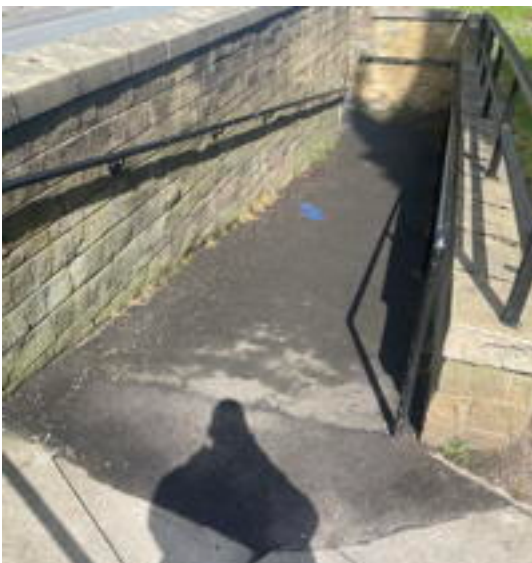
Most is generally in satisfactory condition. The paving to the pathways, especially at the east boundary, has some uneven and broken flags that could cause a trip hazard and should be levelled. There is broken section of concrete pathway adjacent to the Vestry door.

Arrange repair of pathways with the Local Authority. Cost Band 1– £0.00-£1,999.
