QUINQUENNIAL INSPECTION REPORT
Of
**THE MINSTER CHURCH OF SAINT MICHAEL AND ALL ANGELS AND SAINT BENEDICT BISCOP,
SUNDERLAND**

SUNDERLAND MINSTER

QUINQUENNIAL INSPECTION AND REPORT July 2024
David Beaumont BA (Hons) Grad Dip, RIBA, AABC

REPORT ON THE 2024 QUINQUENNIAL INSPECTION

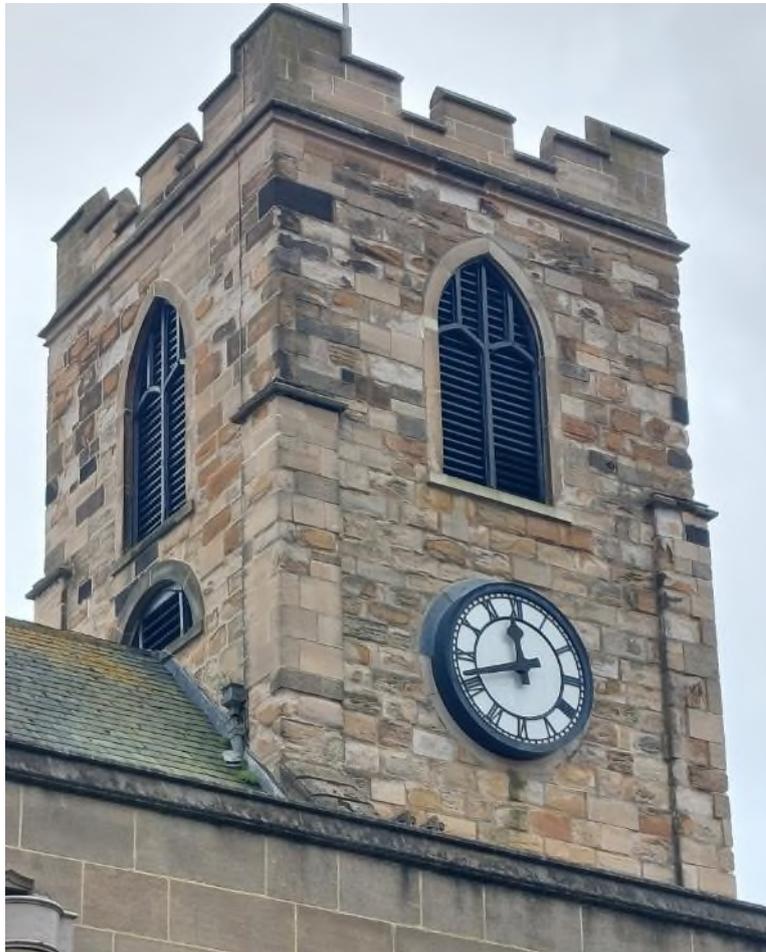
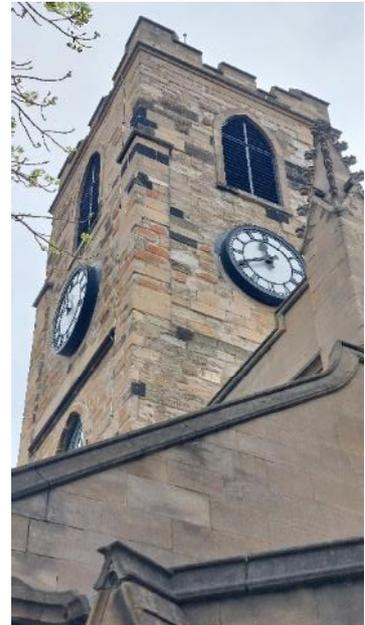
Tower

- The stonework has been deshaled all round, some stone replacements, louvres painted and repointed only on the east and south sides as these are the most complicated to scaffold (the other two sides were unaffordable). The clock dials are in good condition.

Recommendation: none

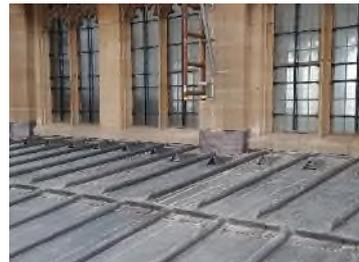
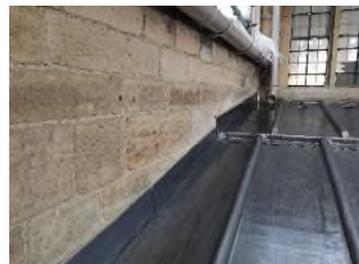
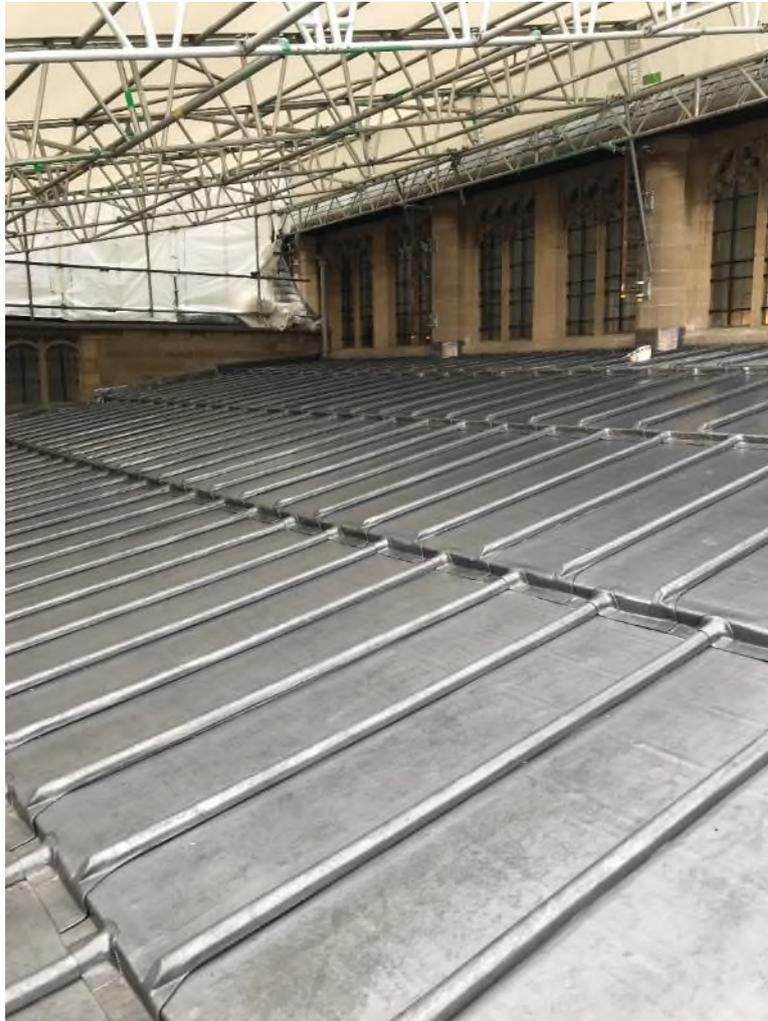
North Inner and Outer Aisle:

Leadwork replaced in 2018. *Images from then.*

Recommendation: none

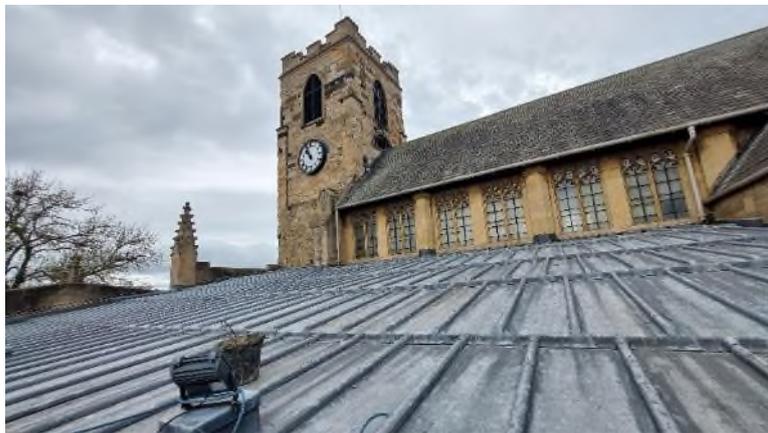
- **South Inner and Outer Aisle:**
Repaired in 2015 and looking ok

Recommendation: none

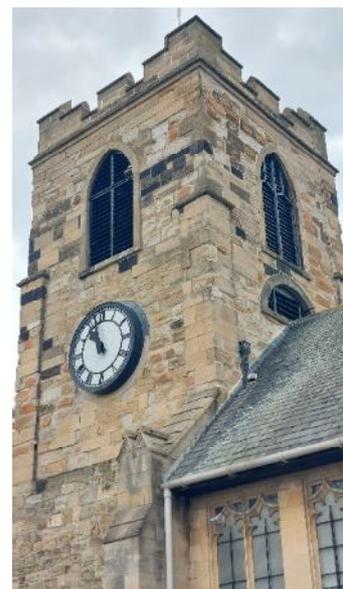
The n side downpipe has a dislodged shoe as it terminates on the nave roof. Which needs refixing. No signs of internal water penetration.

The s side should also be checked as there is staining to roof boarding in the same position.

Above these positions the pipes are internal with bends and it would be wise to check that they are not blocked

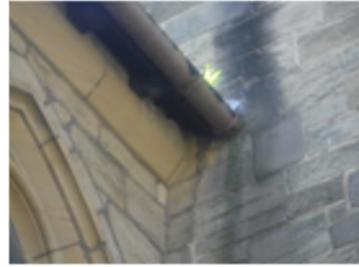
B North Chancel:

Rust to the gutter, brackets and some to the downpipe which discharges into a gulley which has lost its mesh and appears blocked.

Recommendation: renew rainwater goods, clear gully

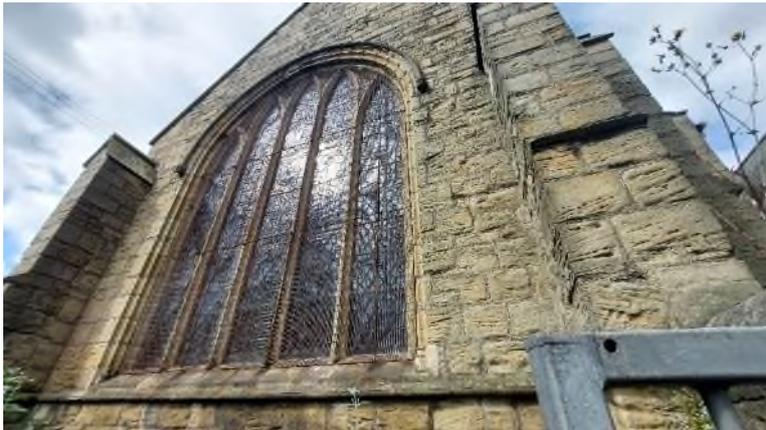
Chancel:

Water table appears ok, apex also. Walling generally seems sounds. Buttresses at corners look in good condition. Five light tracery window with metal grid, rusting more than the last QI, obscuring slightly but the transoms appear ok. The hood mould has been restored with cement but seems to be alright. Base of the wall is weathered but ok. Some plants growing.

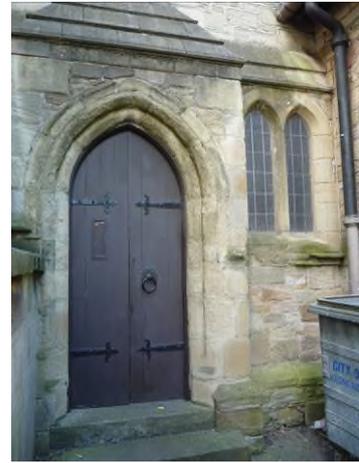
This has a pair of double lights either side of a central doorway, the lights have been glazed in with polycarbonate and cement pointed in. The door surround has lost its moulding and is shaling slightly. The cill is broken to the northern side and showing slight areas of damp but not really a problem, probably from the downpipe that has leaked in the past.

Recommendation: none

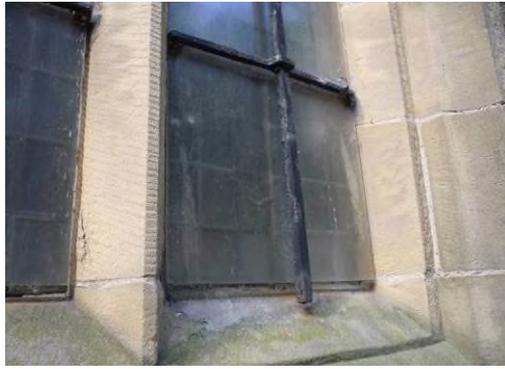
A little more in the way of open jointing on this elevation requiring some attention in the next 5 – 10 years. 2 no. three light windows with ashlar dressings in good condition, slightly rusting ferramenta supporting polycarbonate, probably wise to start to decorate this ferramenta now.

Recommendation: put a plan into place to decorate the ferramenta and polycarbonate of all the windows

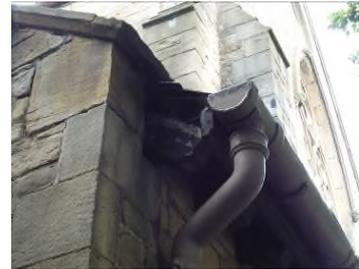
North transept:

East Side –
Partially obscured by the clergy vestry roof. Wall condition fairly good, one stone cracked but no action required, the buttresses have some open joints but not really necessary to repoint just yet.

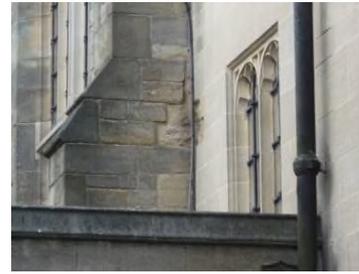
North Side –

Water table is ok, the walling generally is fine, and there are a few stones that have eroded but not problematic, probably best if they were infilled with lime mortar though it's expensive to get the scaffold up just for that. Some open joints on the plinth capping.

Four light window with quatrefoil windows with sexafoil central window. The upper mullions have been replaced (fine grain sandstone) in recent times and they are fine, the lower mullions are ok for the mean time. There has been a horizontal band of limestone inserted when Caroe modified the transept to insert the gallery floor. There doesn't seem to be any chemical reaction to the sandstone surrounding it. Slight open joints to the arch stones and hoodmold.

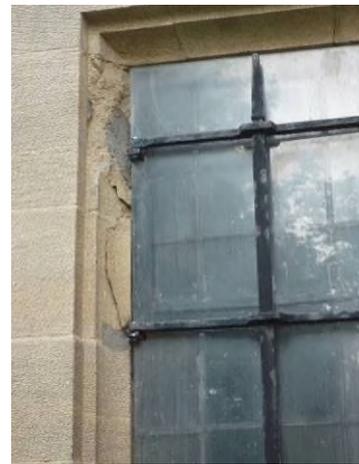
D North Porch:

East Side – Open joints to the upper parts, particularly at the buttress edges. Polycarbonate over glazing with rusting ferramenta. Slight open joints at the junction to the transept showing minor differential settlement.

Recommendation: see general comment of ferramenta repairs and polycarbonate cleaning, repoint open joints

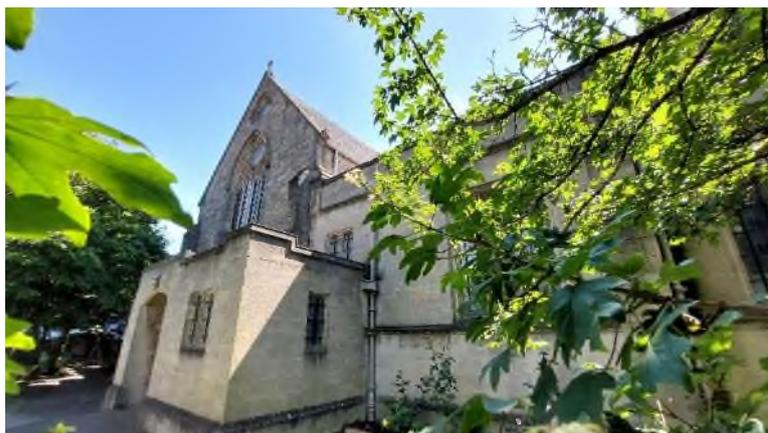
M North Aisle:

Open joints to the parapet coping infilled in 2018 but there are open joints at lower level, particularly behind the overflowing down pipe and it needs cleaning. The elevation has 3 no. three light windows plus 1 no. two lights over the north porch. The north porch window looks ok though it does have a bit of rust to

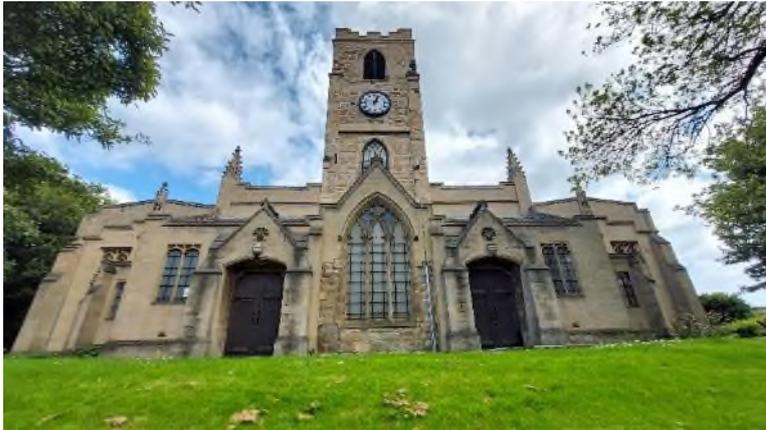
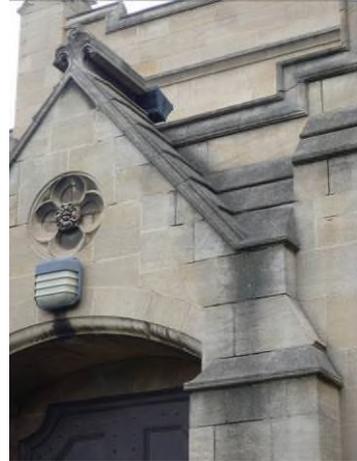
C Narthex:

North Side –
Open joints at high level just above the external hopper.

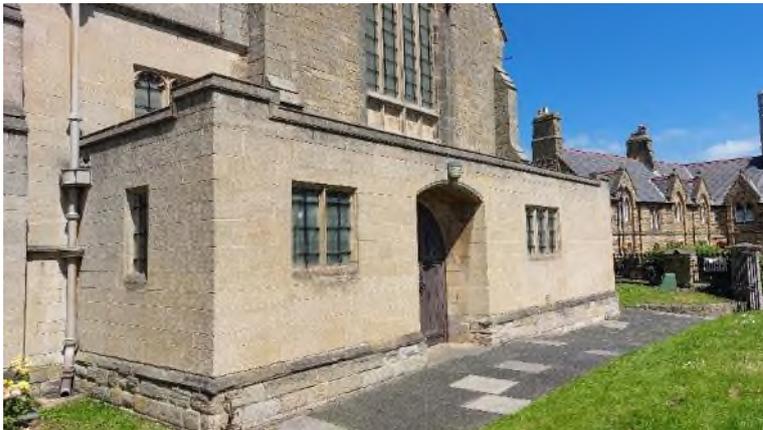
South Porch:

Some open joints at high level. Polycarbonate with slightly rusting ferramenta. Sat on a sandstone plinth which is eroding slightly.

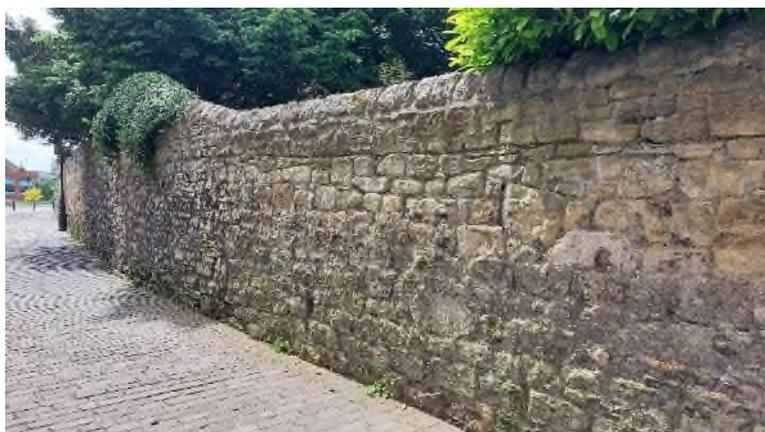
- **East Boundary:**

Northern Side – Mixed sandstone and concretionary limestone (showing coralline concretions) masonry wall in fair condition, repointed the previously reported cracking. New gate piers that are chipped by SCC bin collection skips. Door permanently removed (and on top of the boiler room) to stop loitering.

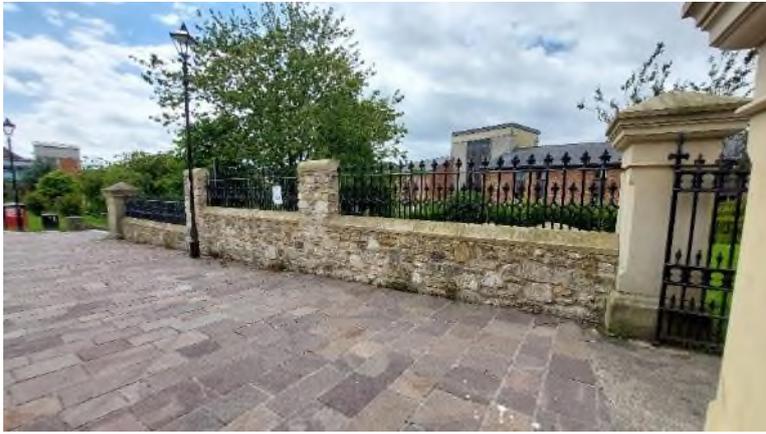
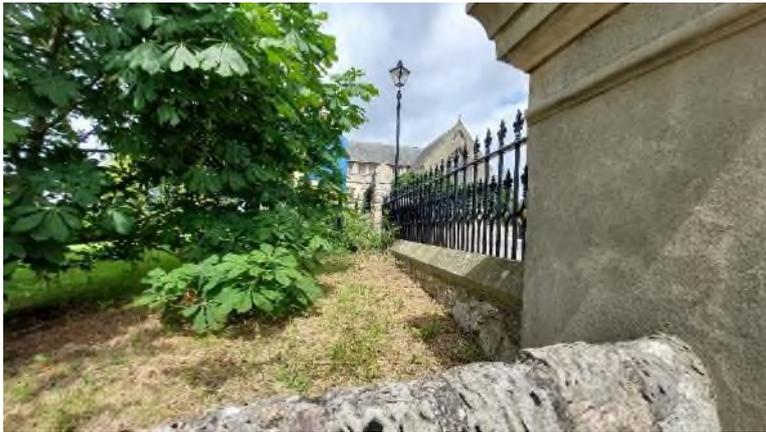
The twin gates have been redecorated but have no ironmongery or restraint. The sandstone pier caps have been replaced. There is rusting metal still in the piers which should have been removed. This entrance no longer makes sense- it was for when the church was accessed at the west end and so to use it makes for a dog leg path within and an indirect approach from The Green.

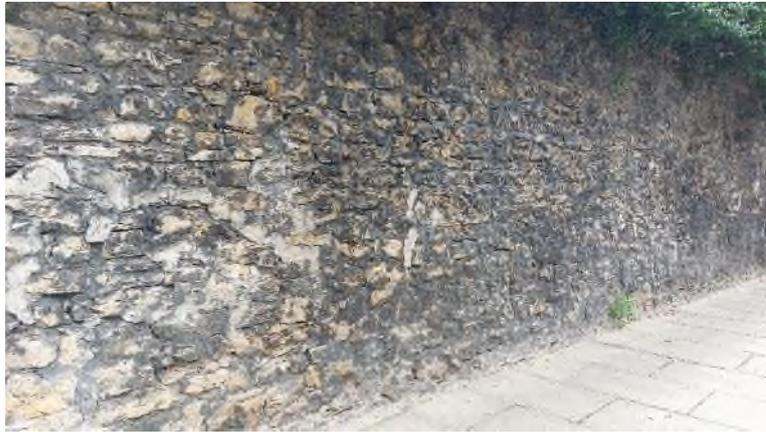
Some of the bushes are growing over the edge, there is one sapling growing at the coping, a lot of ivy has grown over it in the past that, has been cleared off.

Towards the northern end the wall becomes quite dark probably historic pollution.

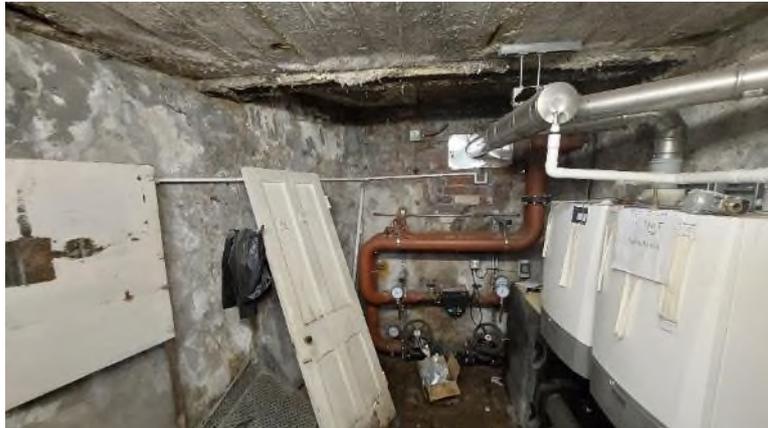
D **Boiler Room:**

Renovated roof in 2016, roof repaired c.2019 no reporting damp coming through.

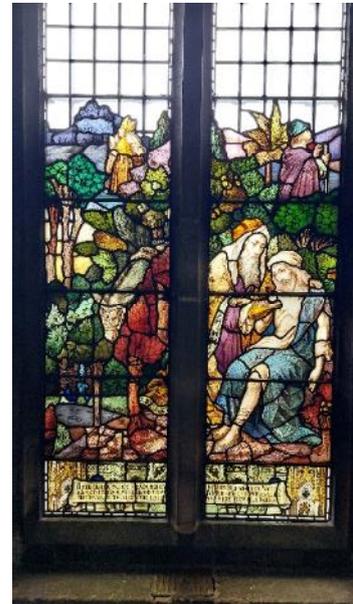
Historic staining to the ceiling at lower reaches dues to water leakage from roof, which was repaired in 2018. Walls are ok, floor has modern carpet. There is one crack on the west wall below one of the windows, approximately 2mm and is the same as last two QI reports. Floor still squeaks slightly. Modern lighting was replaced with spots as part of the 2018 repairs. Fine pictorial glass.

Recommendation: screw down the floor when the carpet is to be changed

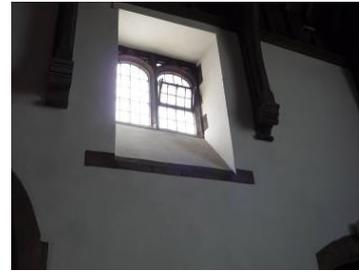
D North transept Gallery:

Crack to the stair wall at the landing approximately 2mm and no different to the last two QI reports.

Underside boarding looks good, walls are ok. Some dust at the stuck open ventilator facing west. The north large window appears ok but both the polycarbonate and the glass are dirty. The area is pewed out and that contains a lot of loose items at the upper levels and the space is used for storage.

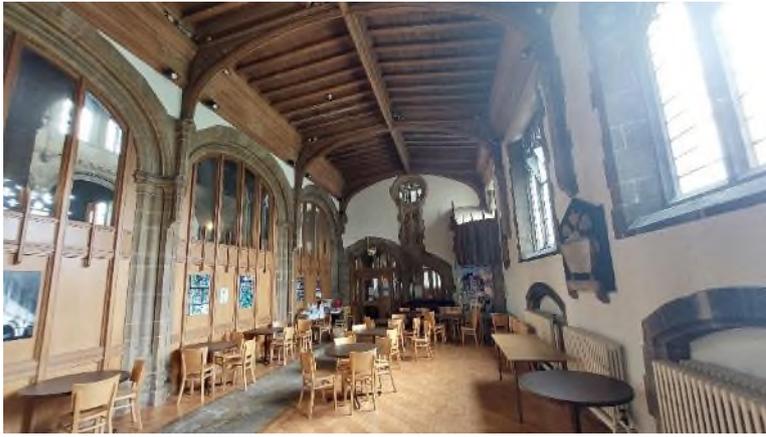
Café:

Ceiling has water marks from previous water entry though there doesn't look to be anything new. Part of the timber cornice was cleaned in 2015, as were the south window internal lintels. Glass is clearer on this elevation, as it was cleaned as a result of the works in 2015. Flooring carpet has been taken up revealing a concrete filled heating duct. The floor now looks patchy. Perhaps put carpet back over the concrete?

The roller hatch has been painted and the counter looks ok. The glass to doors, arcades and the first floor office is dirty.

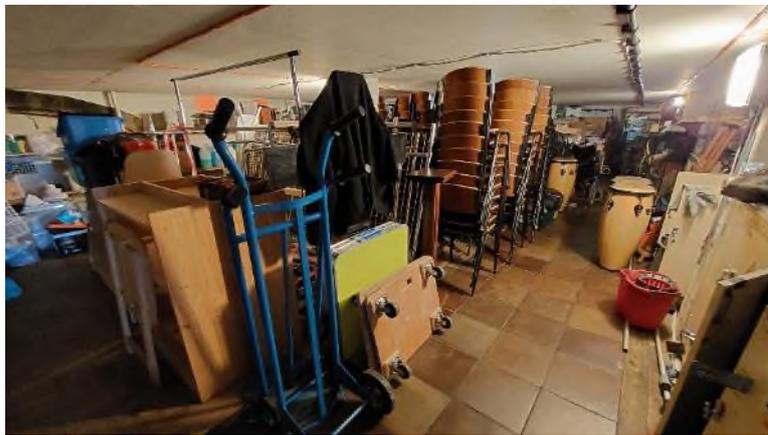
Undercroft:

This room is used for storage. It is as tidy as it can be but rather full.

Recommendation: Consider a clear out of unwanted items.

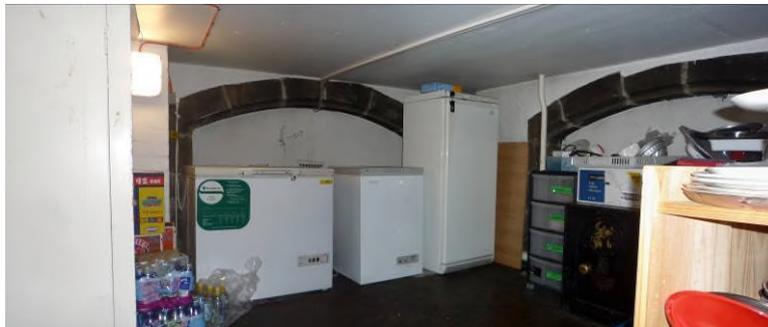
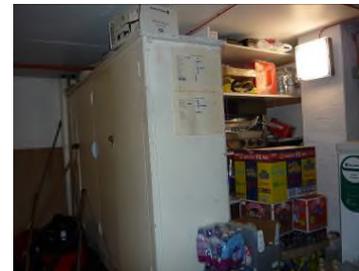
E Kitchen Store:

This room forms part of the undercroft on the north side. No longer used as a store for the kitchen. Now used for textiles and clothes. Too full to see inside properly. Are the old fridges still in the room. Need removing? There is wc drainage pipes in the room and it is important to be able to access them.

Recommendation: clear out room.

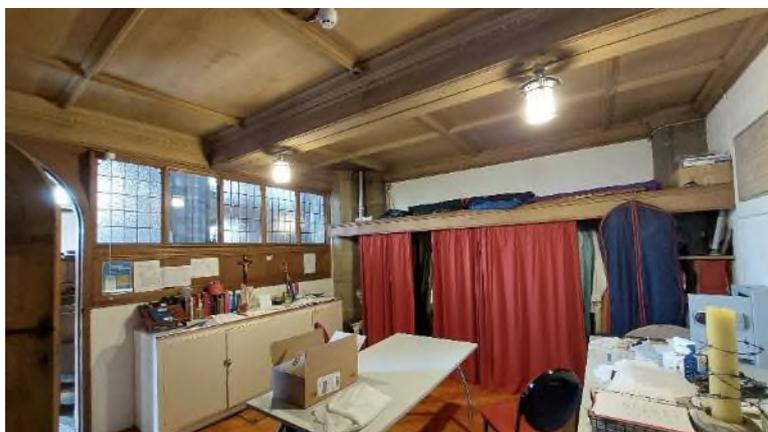
D Sacristy:

This is underneath the organ chamber. Ceiling is in good condition. Walls are all decorated well.

Contains clergy vestments within a curtained area and racking for various hymn sheets etc. Partial ceramic tile and herringbone flooring- matching the general areas, all in fair condition. The door catches on the floor.

Recommendation: ease door

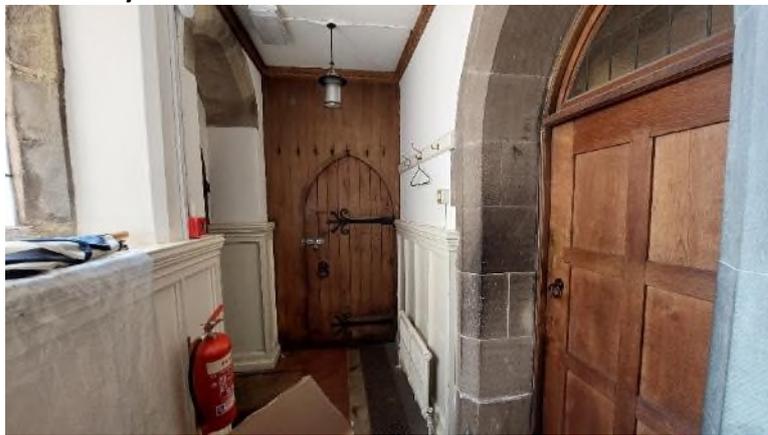
East Lobby:

Some water penetration in the past on the choir vestry side, perhaps is condensation? Wind blowing detritus through the doorway, the door itself doesn't close adequately even though it is adequately bolted up but it does let in rather a draught.

Recommendation: draught proof the door

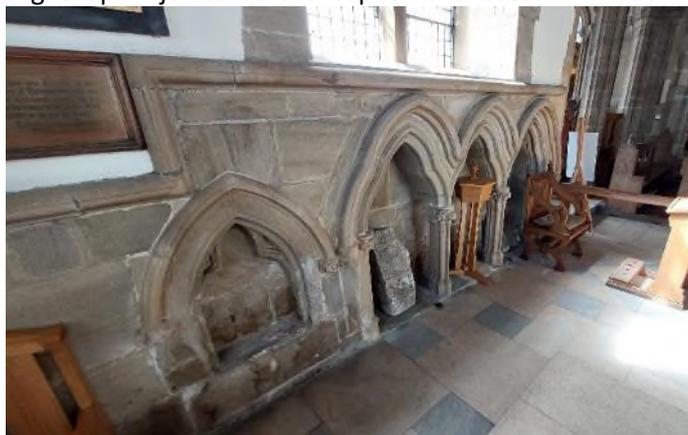
Some salting at sedilia which doesn't look to be advancing. Make sure external ground levels are ok.

Recommendation: check south side external floor levels behind sedilia

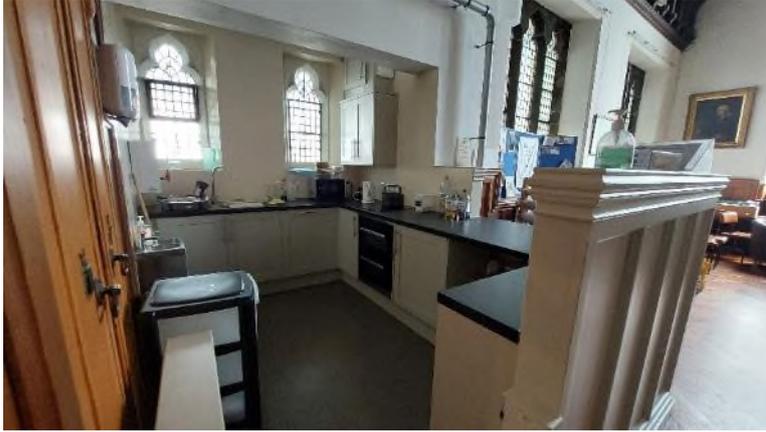
- **Choir Vestry Servery:**

A servery has been created out of the old wc and sink area

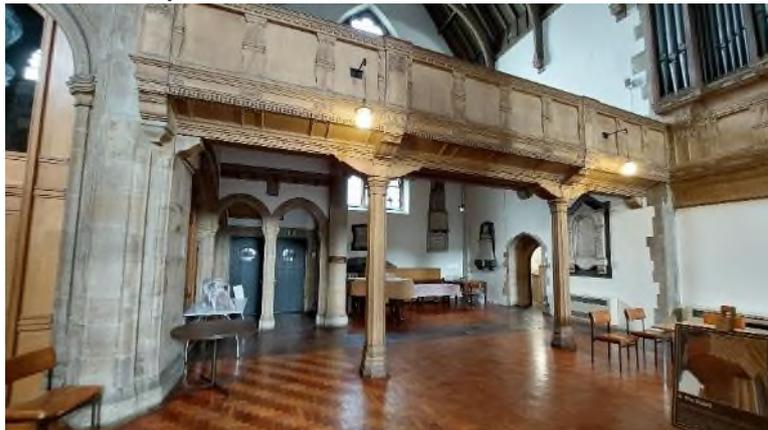
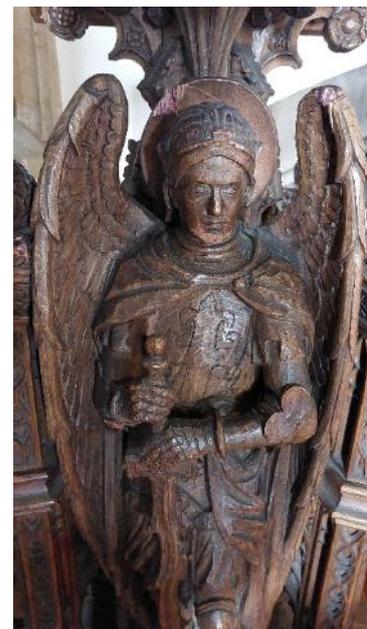
E North Transept Ground floor:

Condition here is ok.

The redundant pulpit in memory to Robert Hudson (who died in the bell tower- hit by a bell) has suffered vandalism to the figure of St. Michael who has lost some elements around his head and to the pedestal upon which he stands. Perhaps it should go in the deafening chamber as a reminder to those visiting the bells?

Recommendation: repair pulpit

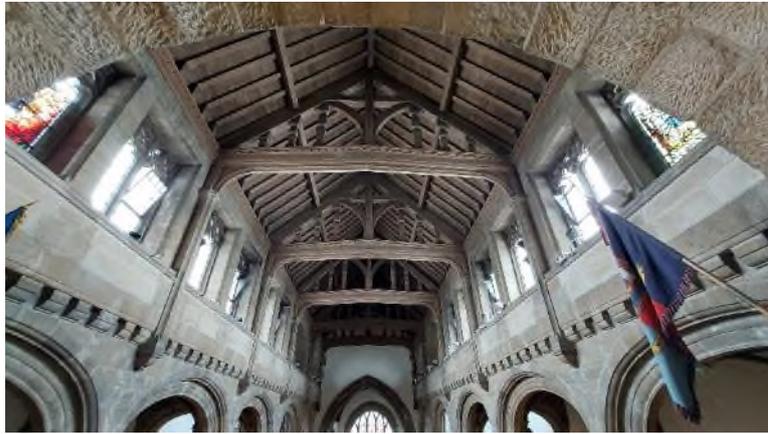
- Nave:

Open rafted ceiling with boarding, generally no water marking recorded in the past apart from one dark board noted in the past.

Both of the arcades are in good condition apart from the inner arcade, penultimate westward one on the south side which has pointing missing and a slight crack through the stone itself suggesting some differential settlement but this is an old crack. The chancel arch is ok. N Side clerestory, easternmost window has a chip out of the lintel bearing. I don't think that it is new but probably missed in the past.

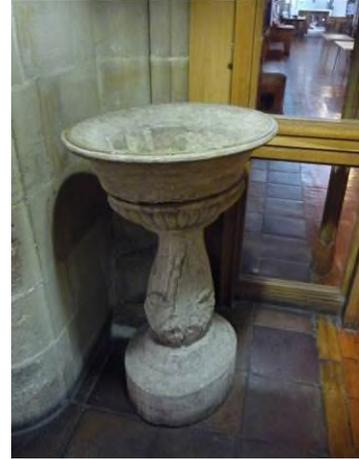
Lobby outside of Gents W.C:

The office is formed above this and it has a low plasterboard ceiling with inset lights in good condition. The walls are mostly enclosed by glazed screens, doors to café etc. Continuation of nave flooring. This space contains the redundant oval font which is cracked in the bowl and pedestal.

Recommendation: consider status of the redundant fonts (including the font under the office stairs)

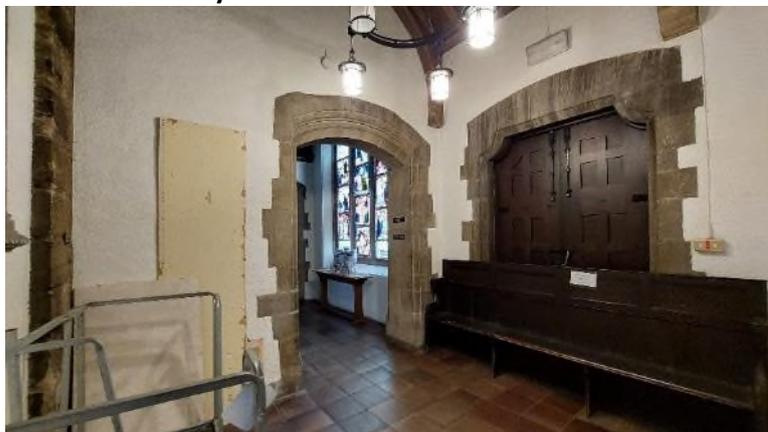
- **Ladies W.C. Lobby:**

Open boarded roof ok, some stain marks on the door head but

no action required. Old pew laid up against the west entrance door so unable to access the door. The bottom of the walls have some damp and this has been patched up over the time. The best thing is to dust it off and repair when it becomes unsightly.

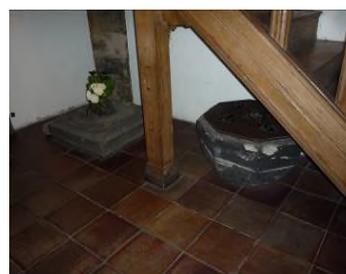
Open boarded ceiling looks ok, as are the walls, no cracking to the arches. Contains the emergency exit door. Some slight historic water marking at the eaves coming down the wall, stonework is dirty in places. All as the last couple of QIs. Tiled floor in good condition. Timber stair leading up to the office. Door at landing repaired due to intruder damage. Redundant font under stair.

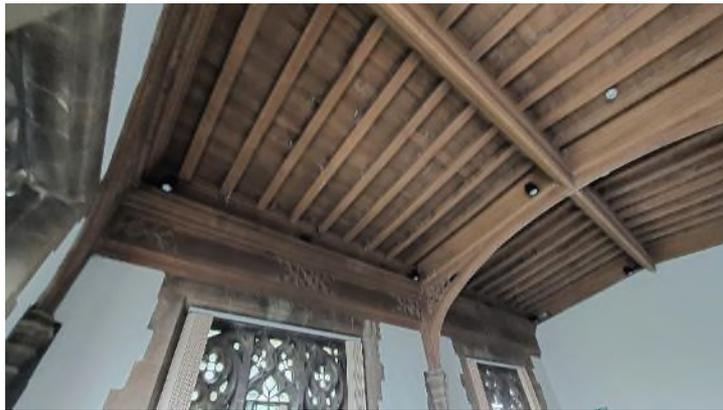
D Office:

This is formed on top of the kitchen. The roof is open boarded and has historic water staining that has also gone down the walls in places. The south entablature has been cleaned as a result of the 2015 south aisle works. The roof joinery at the western end over the kitchen by the two windows and above it is quite badly marked and could do with being refurbished when funds allow.

The glazing has been cleaned on the south side but is starting to dirty up again and one of the windows on the west is left to do. Café glass is dirty. The arch that divides the space has a 2mm crack and this is historic and constant. The carpet to the floor is ok, there are some slight squeaks to the floor. Tap dripping at sink

Recommendation: clean glass, screw down floor when carpet is replaced in time, repair dripping tap

D **Office:** clean glass, screw down floor when carpet is replaced in time, repair dripping tap 100

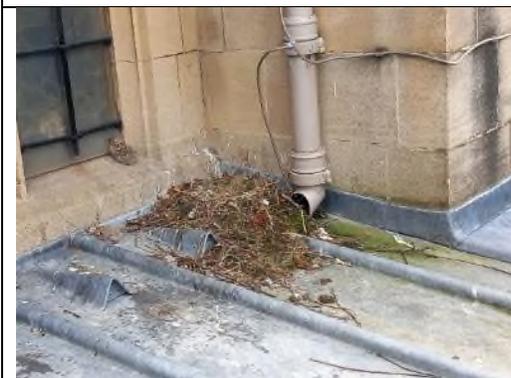
N Aisle gull nest and chicks

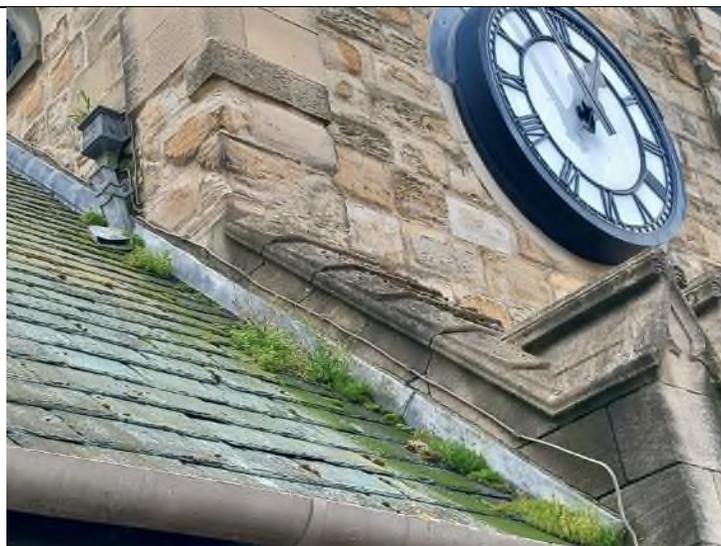
N Aisle tower downpipe
