**Quinquennial Inspection Report  
St Alban's Church, Windy Nook, Gateshead  
Deanery of Gateshead  
Archdeaconry of Sunderland  
Diocese of Durham**

David Jowett - Architect, BA, DipArch, RIBA  
25 Roseworth Avenue  
Gosforth  
Newcastle upon Tyne  
NE3 1NB  
Tel: 07788 710 204  
email: [david@davidjowett-architect.co.uk](mailto:david@davidjowett-architect.co.uk)

2 May 2026

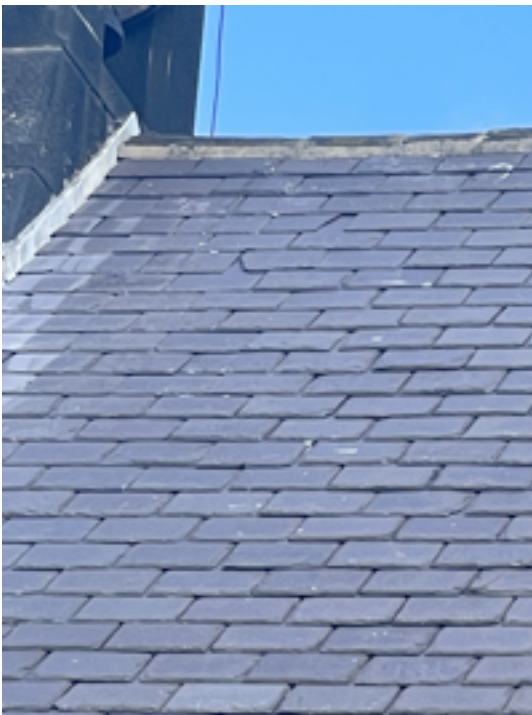
**Broken Slates South Nave Roof**

Several chipped slates, 3no to the south Nave Roof. Two sections of synthetic lead-free flashing have come loose from the nave roof north-west gable and need to be secured immediately. Ridge pointing is missing to the chancel and to the nave south roof and west roof.

Replace all chipped slates, secure loose flashing and make good pointing to ridges. Cost Band 1–£0.00-£1,999.

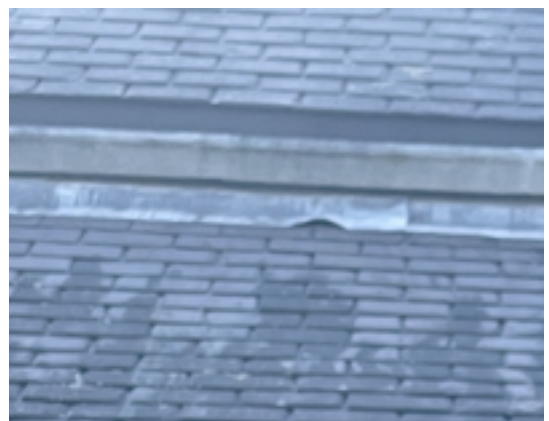
**Lifted Flashings North Roof**

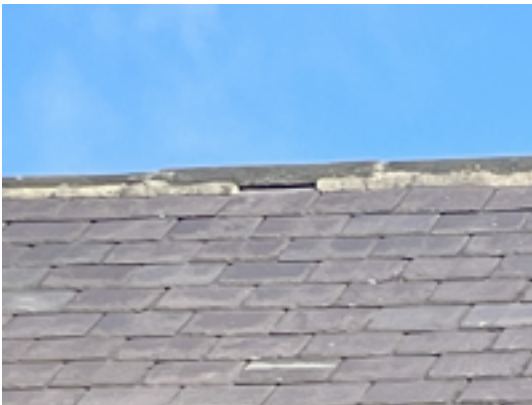
**Chancel South Roof Missing**

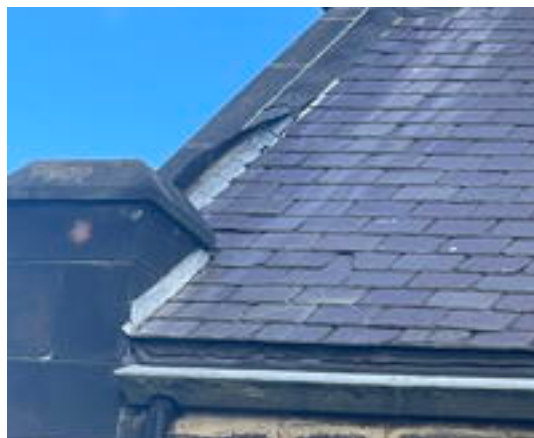
**Loose Parapet Flashing Nave West End South Elevation**

Finials, Bellcote and Chimney all appear generally sound and in good condition when viewed from ground level. Loose flashing to nave west end south elevation parapet.

Secure loose flashing. Cost Band 1–£0.00-£1,999.

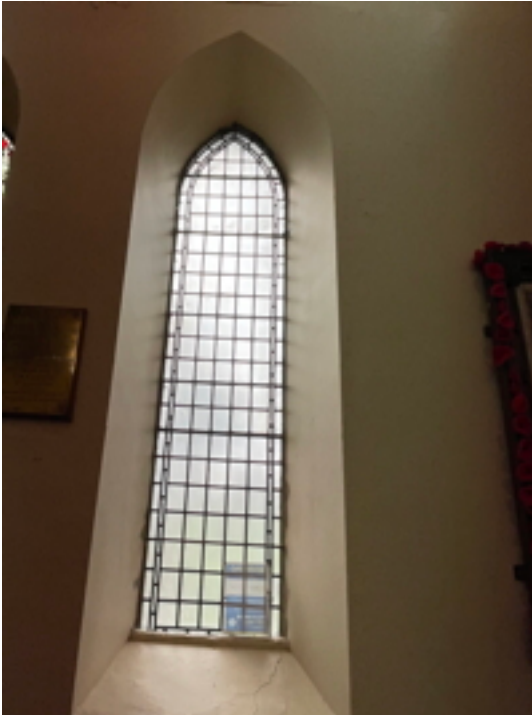
**Window 1 Leaded, plain glass, good condition**

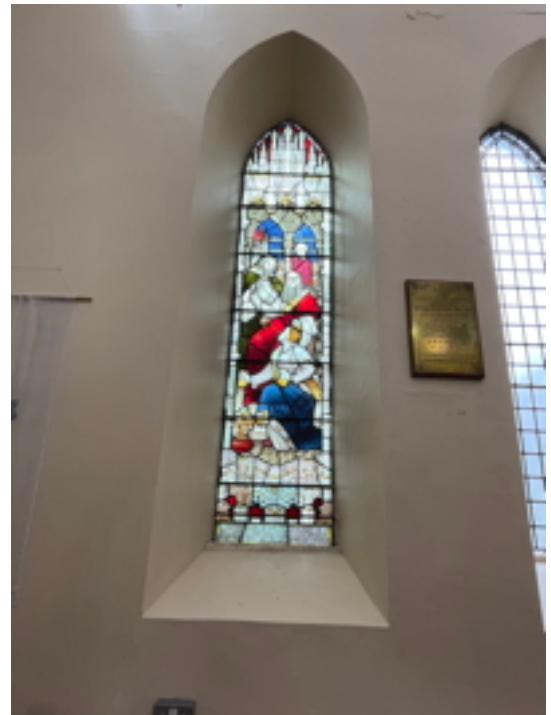
**Window 2 Stained glass dated 1901, satisfactory condition**

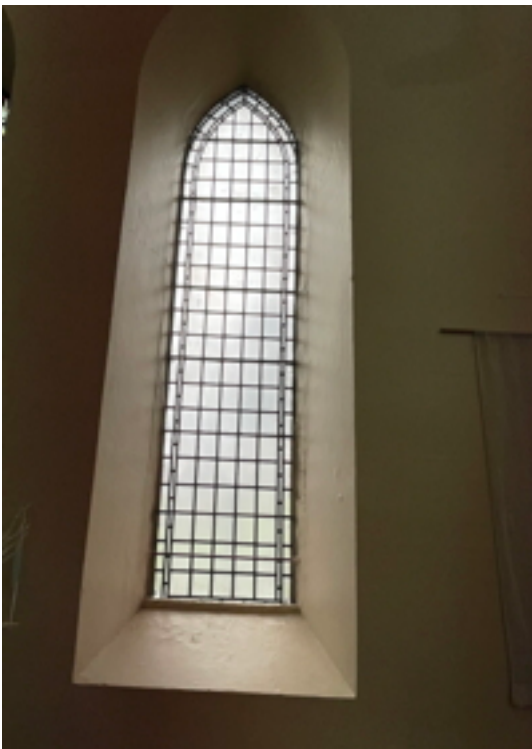
**Window 3 Leaded, plain glass, good condition**

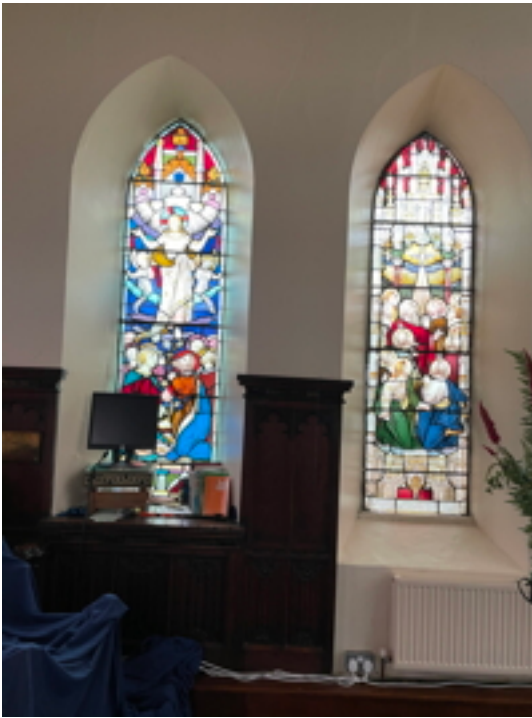
**Windows 5 and 6 Stained glass, signed by Baguley 1891. Good quality windows in reasonable condition**

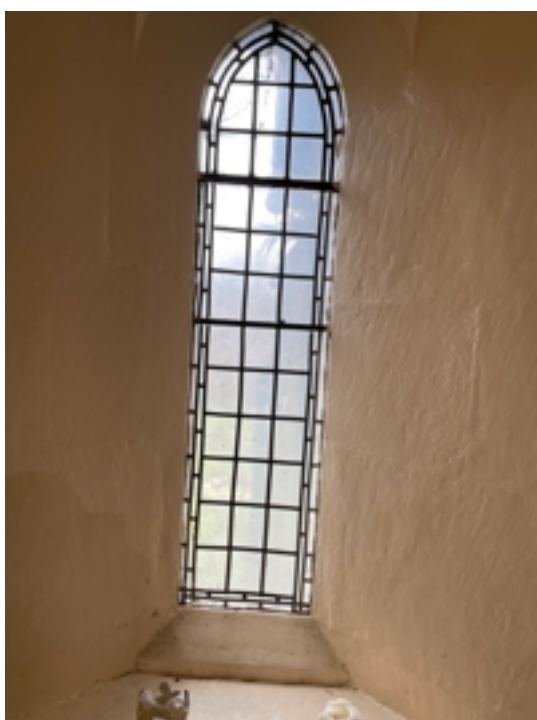
**Window 15 North Aisle, temporary polycarbonate-glazed with applied lead tape.**

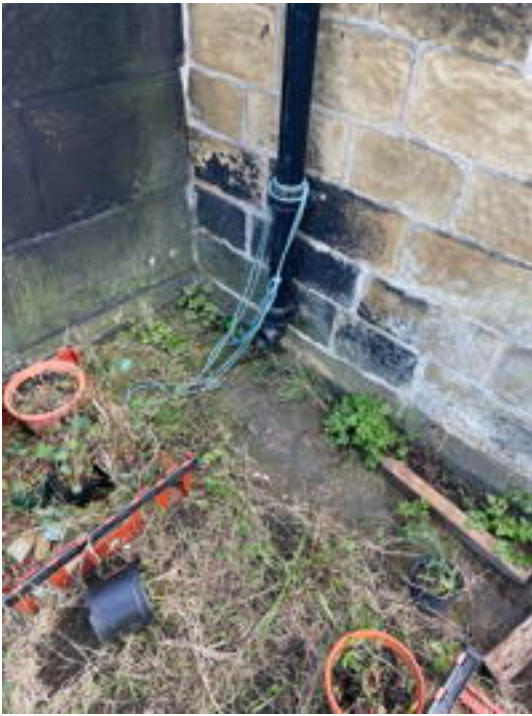
**Overgrown Run-Off**

Some run-offs obstructed and overgrown. One gully is missing.

Remove obstructions and clear overgrowth to run-offs to let water drain to grassed areas and replace missing gully Cost Band 1-£0.00-£1,999.

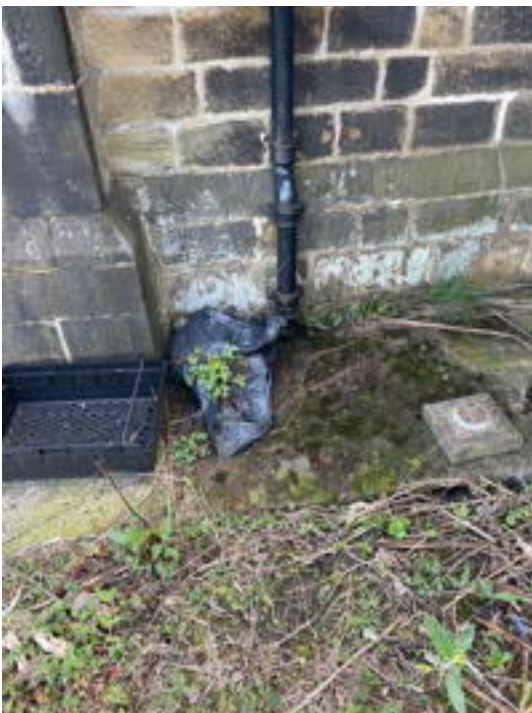
**Overgrown Run-Off**

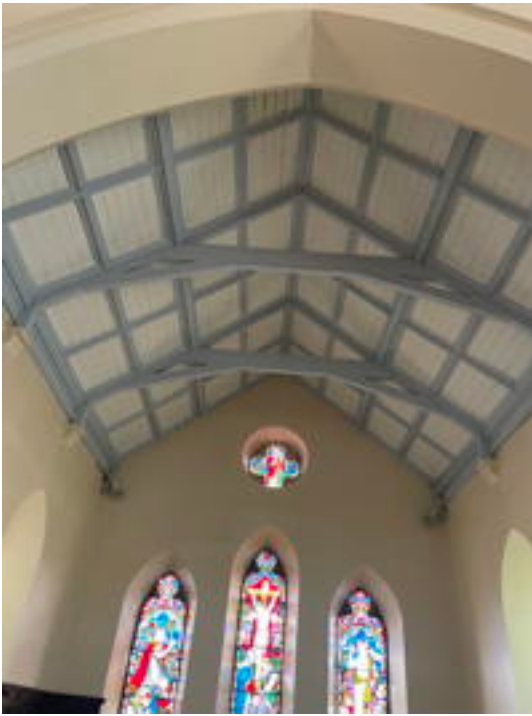
**North Aisle Roof**

All appear in good condition. The minor staining on the chancel roof west end has not changed since the last quinquennial.

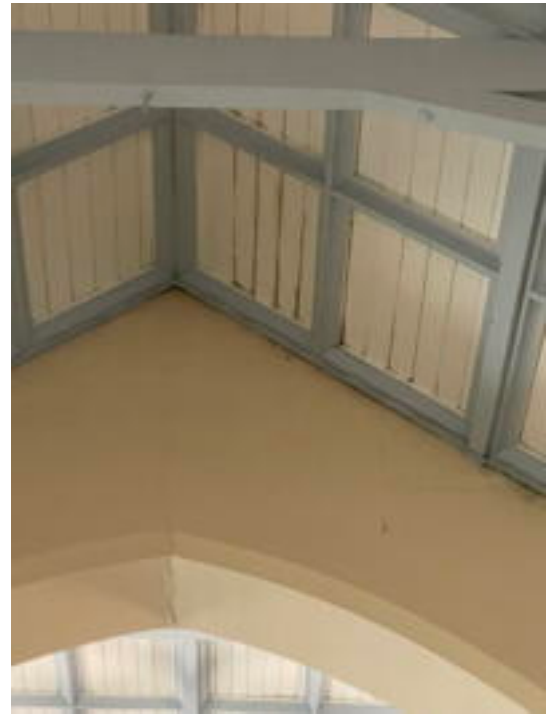
**Chancel Roof**

**Minor Staining to Chancel Roof**

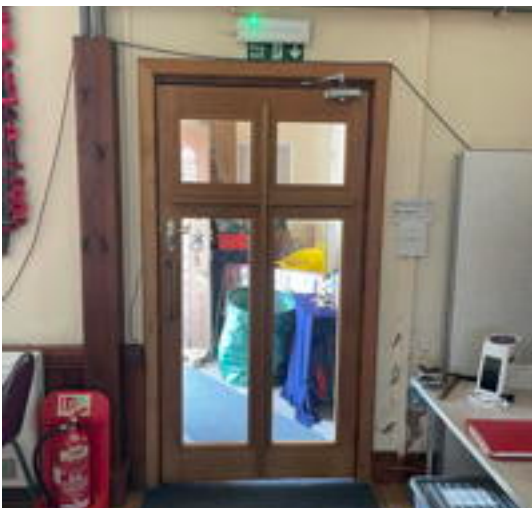
**Porch Door**

Porch door showing considerable signs of rot.

Replace all rotten sections of timber to the porch door and redecorate. Cost Band 1–£0.00-£1,999.

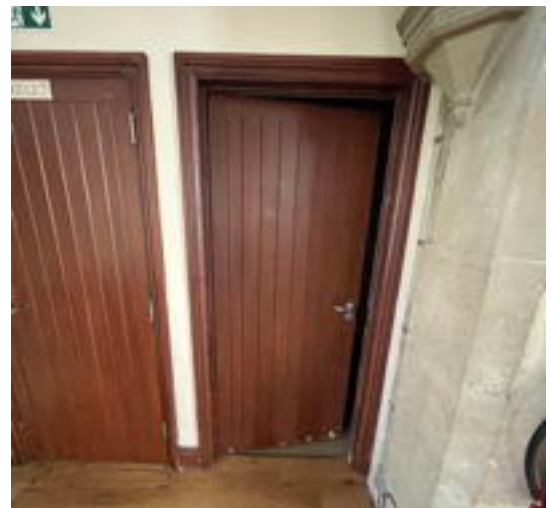
**Lobby and Kitchen Doors**

Doors and screens are all generally in satisfactory condition. Bottoms of the vestry, kitchen and lobby doors are chipped and require redecoration.

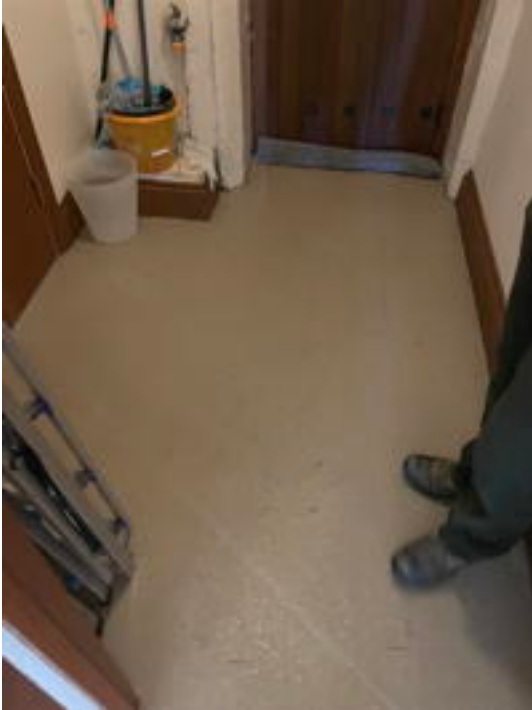
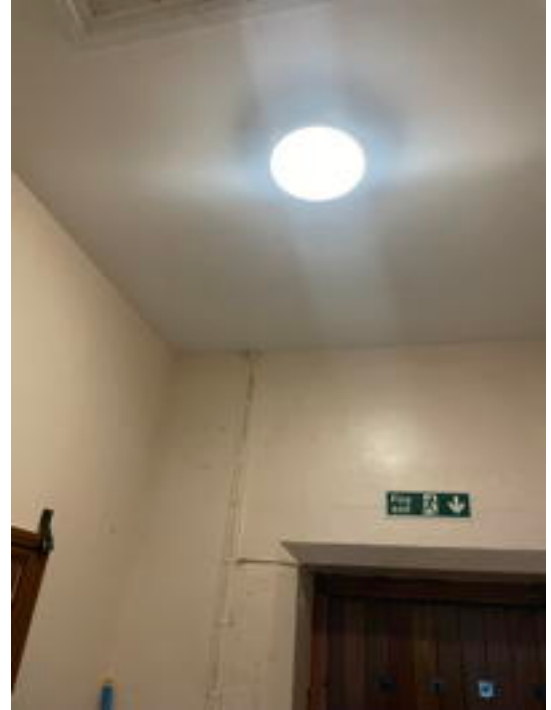
**East End Lobby Looking East**

The East End Lobby is generally in satisfactory condition. Edge seals to the flooring should be replaced to avoid washing water ingress.

Replace edge seals to vinyl flooring in East End Lobby with Dow 785+ clear silicone sealant. Cost Band 1-£0.00-£1,999.

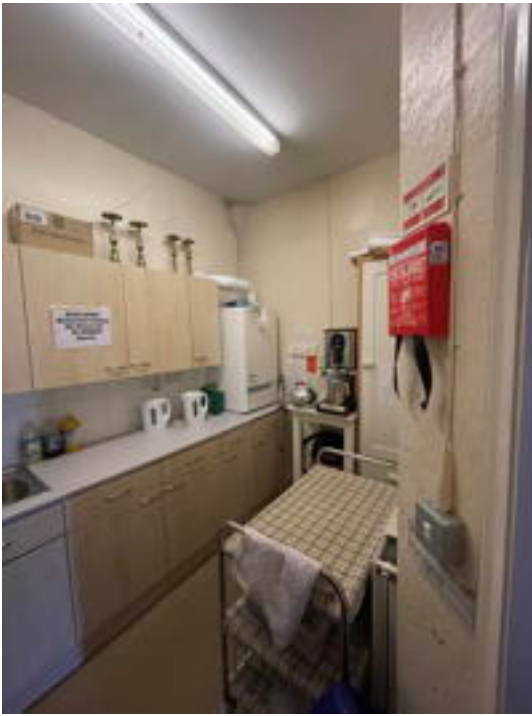
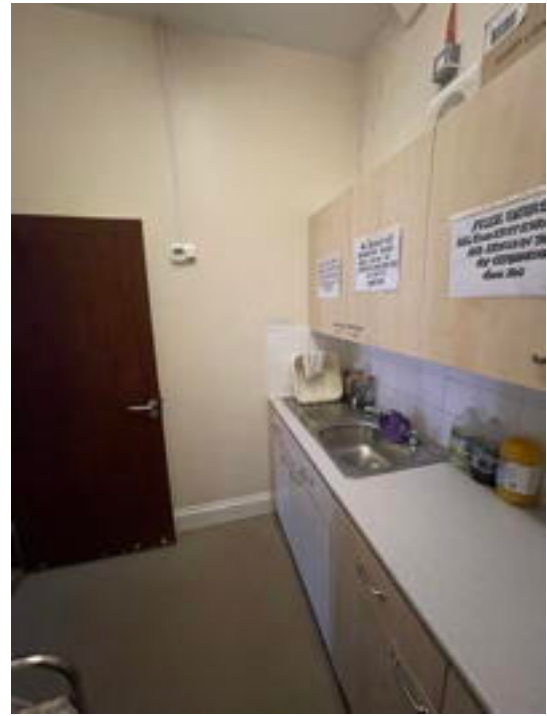
The Kitchen is all in satisfactory condition but needs decoration. Edge seals to the flooring should be replaced to avoid washing water ingress.

Replace edge seals to vinyl flooring in the Kitchen with Dow 785+ clear silicone sealant. Cost Band 1-£0.00-£1,999.

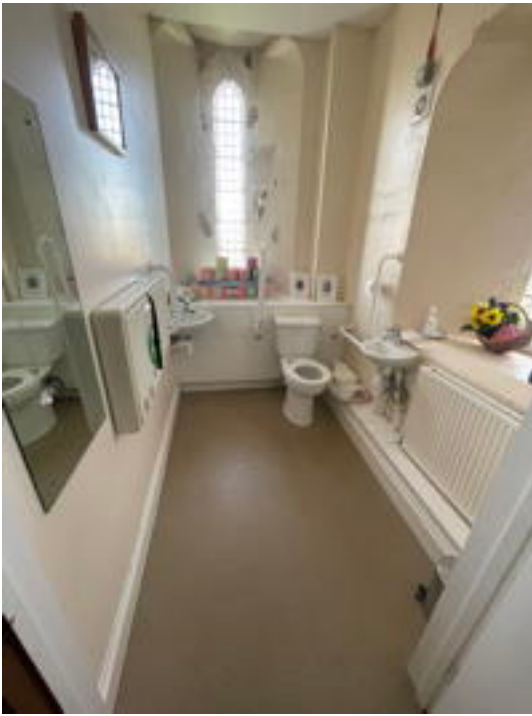
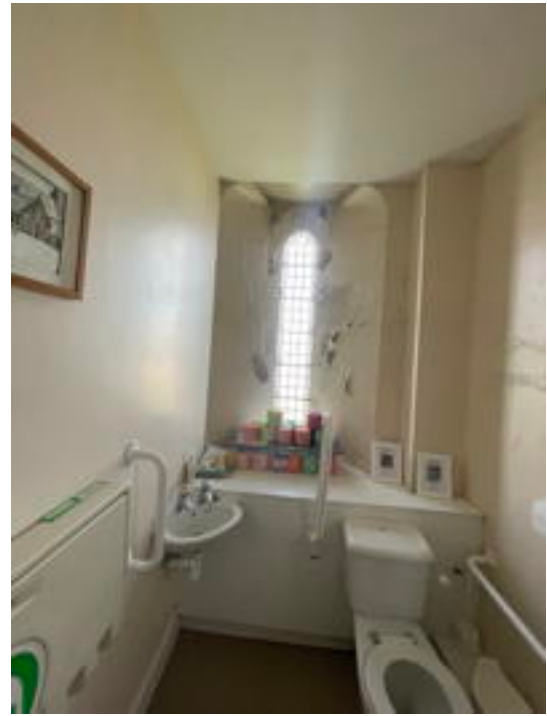
The Ground Floor Accessible WC in generally satisfactory condition but needs decoration. Edge seals to flooring should be replaced to avoid washing water ingress. There is no emergency assistance alarm system.

Replace edge seals to vinyl flooring in WC with Dow 785+ clear silicone sealant. Cost Band 1–£0.00-£1,999.

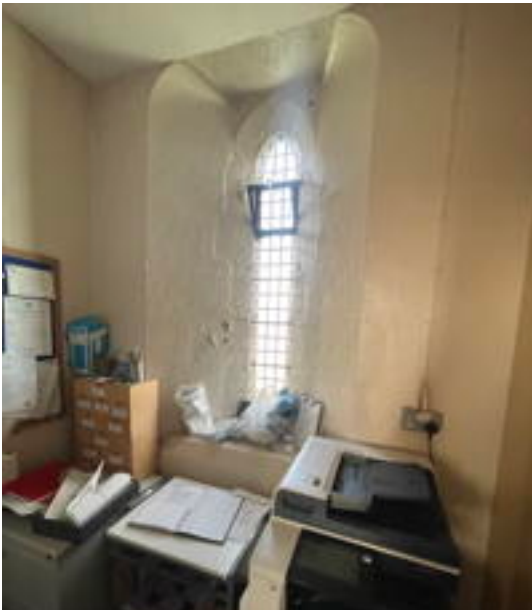
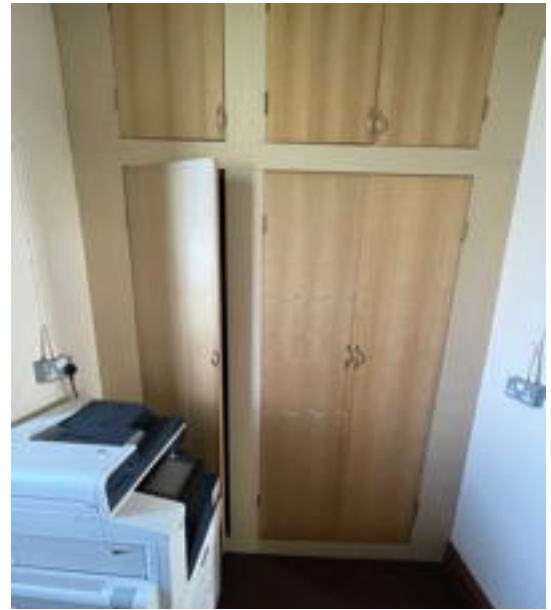
The Vestry is in generally satisfactory condition but needs decoration.

Decorate Vestry walls and ceiling. Cost Band 1–£0.00-£1,999.

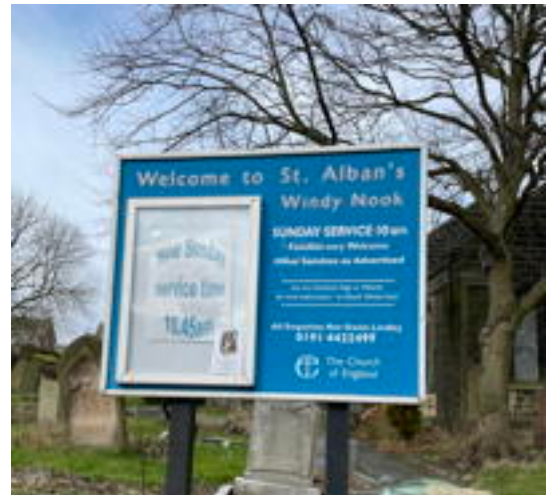
**Noticeboard**

The Noticeboard is in satisfactory condition.

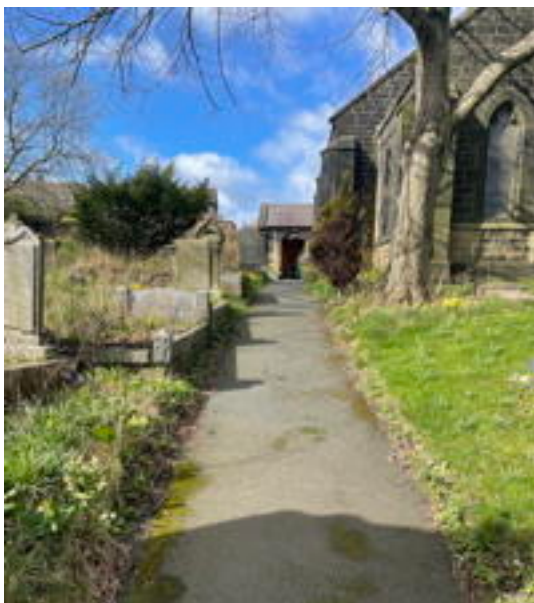
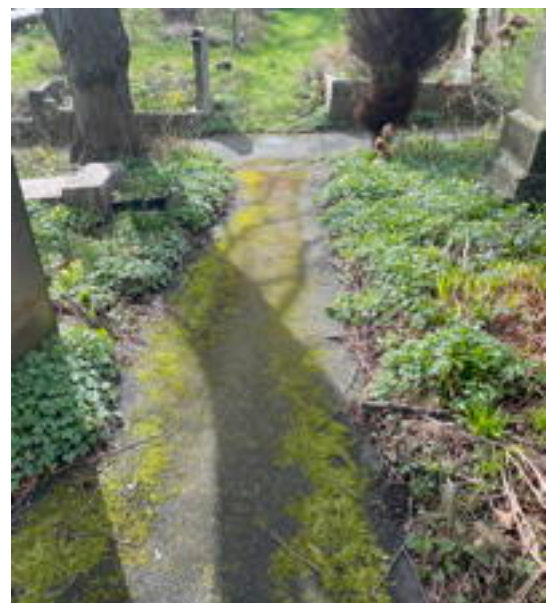
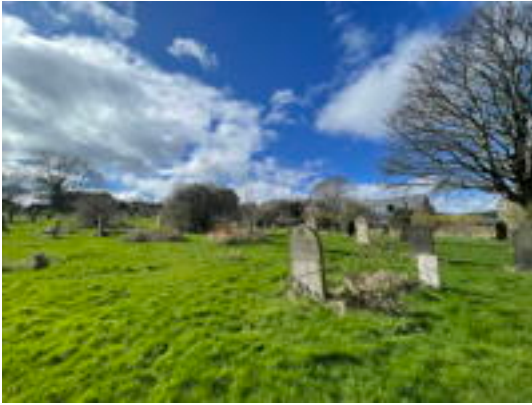
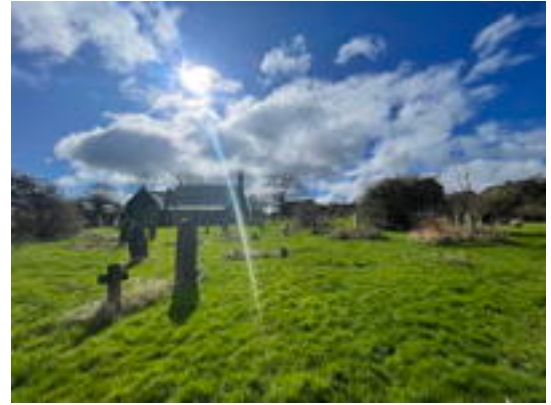
All is generally in satisfactory condition and well-maintained. The planting throughout the site is expertly done and really adds to the location of the church. The north-eastern corner pathway has a lot of moss, making it slippery, which should be cleared.

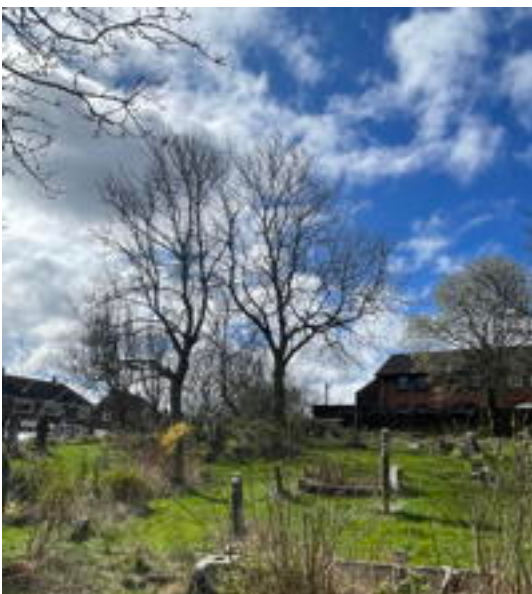
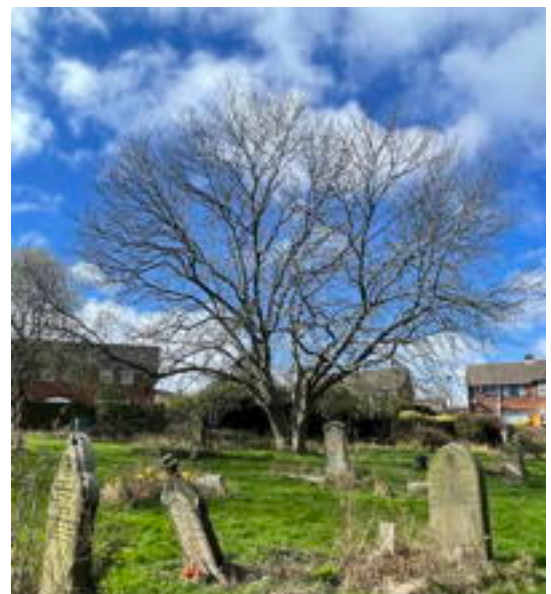
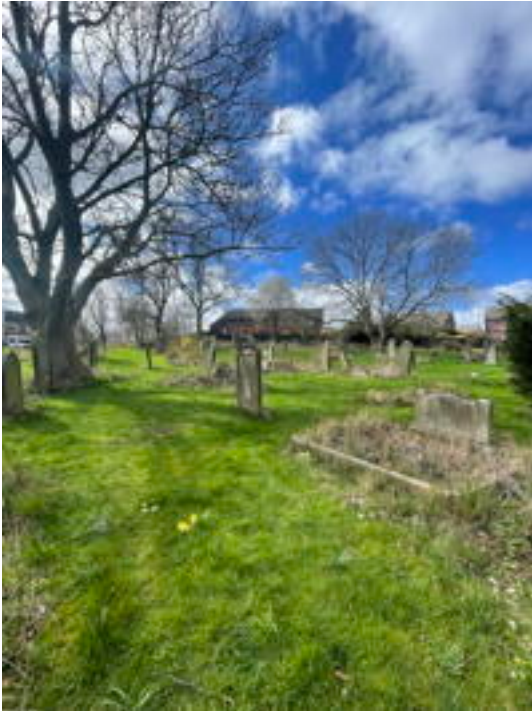
The trees generally all appear to be in satisfactory condition. However, the buddleia and other seedlings should be fully removed before they cause damage to the church structure. The trees should all be inspected by a qualified tree surgeon every five years and pruned in accordance with their recommendations.

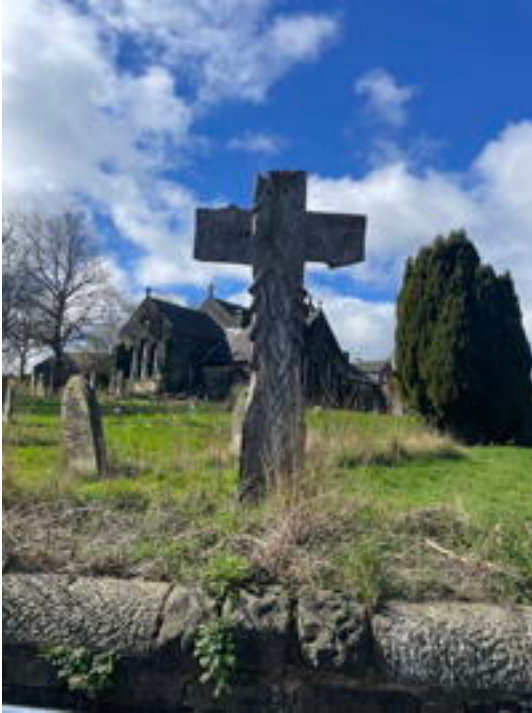
**Carved Timber Cross**

The cross appears in satisfactory condition.

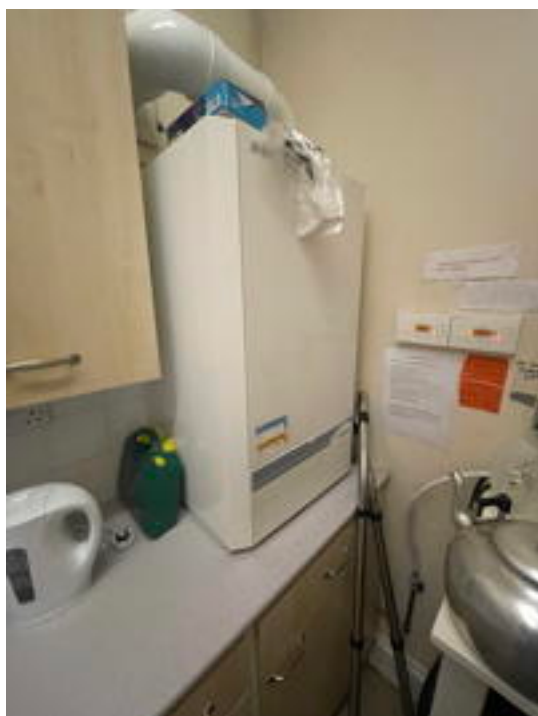
The main church heating comprises an Ideal Imax 45kW combination boiler in the Kitchen, serving two heating circuits and with a flue through the Kitchen east wall. There was no record available as to when the boiler was last serviced. The gas meter is in a cabinet on the right-hand side of the site entrance gateway.

**Boiler in Kitchen**

Carry out a full review of the heating system so that, in the event of failure, a replacement plan is fully in place. Cost Band 1-£0.00-£1,999.

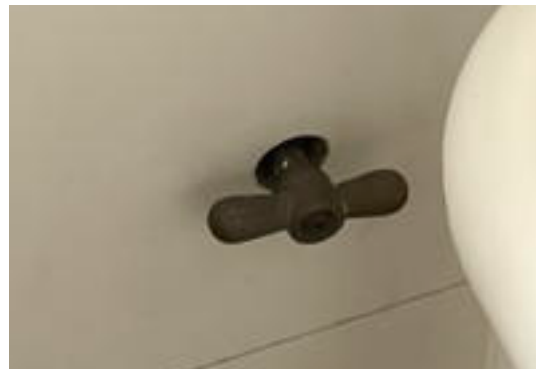
All appears to be in working order.
