Quinquennial Inspection Report

St Mary and St Stephen Wolsingham

For
St Mary and St Stephen PCC
July 2024

QUINQUENNIAL REPORT 2024

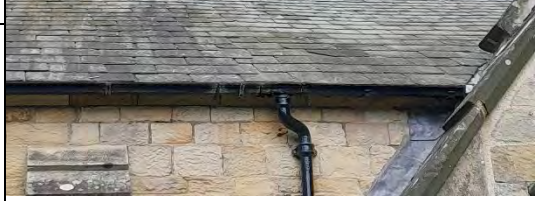
1.3.0	Chancel			
1.3.1	Ridge: gaps to pointing to ridge stones.	Point up ridge stones.	2

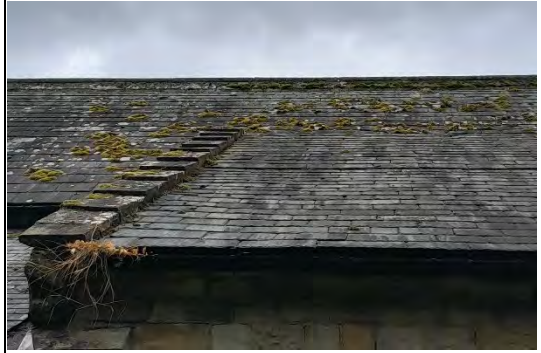
1.3.2	North roof: Mortar fillet to water table to east has loose mortar. Slating generally appears sound. Lead flashing to nave abutment.	Renew the mortar fillet to the water table.	2

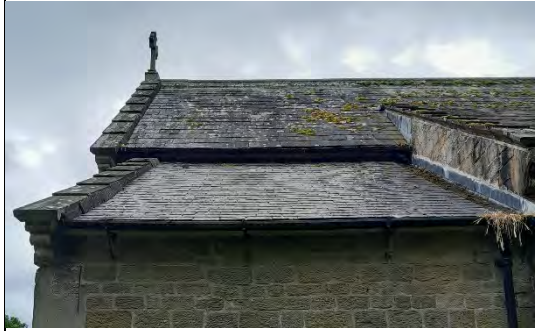
1.4.2	Mortar fillet to water table to east has loose and missing mortar.	Renew the mortar fillet to the water table.	1

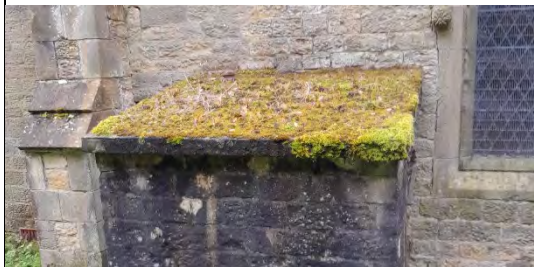
1.9.0	Tank Building			
1.9.1	Rendered brick walls with damaged render in places. In situ concrete roof. Extensive ivy growth.	<p>Remove ivy. Assess condition of concrete slab.</p> <p>Repair slab and render as necessary.</p>	<p>M</p> <p>5</p>

1.9.2	It is assumed the building is redundant, housing the oil tank for now-replaced oil-fired heating system.	Consider demolishing the building instead of repairing.	5

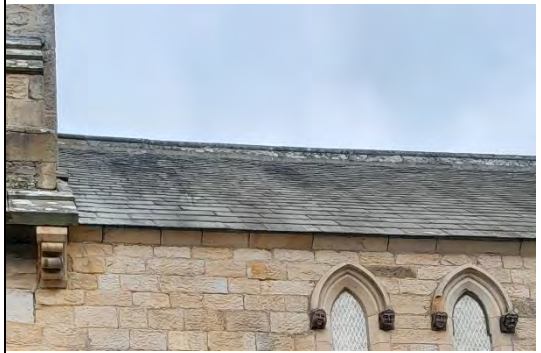
2.2.0	Aisles			
2.2.1	North: the plastic ogee profile gutters are partially blocked with debris and vegetation. There appear to be leaking joints with evidence of dampness on the walls below in these areas.	Unblock gutters. Seal gutter joints. Replace plastic with cast iron.	M 2 5

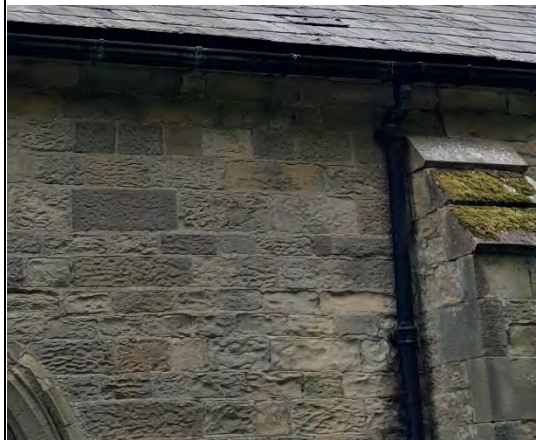
2.2.4	South: the cast iron gutter to the west of the porch by the downpipe is dripping. The gutter to the east is supported on recent galvanised steel drive-in brackets.	Inspect gutters and re-seal joints as necessary.	2

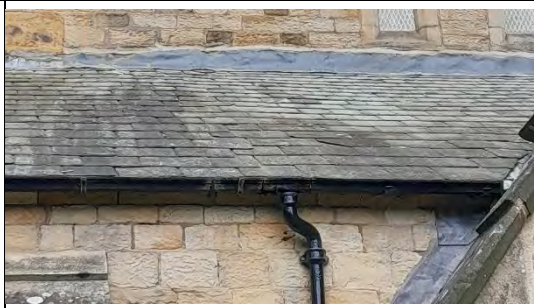
2.3.0	Chancel			
2.3.1	North: cast iron ogee profile guttering with cast iron drive-in brackets. The gutter falls to the centre but the outlet is to the west. Swan-neck outlet discharging into lead-lined channel on vestry roof. There is some debris collecting in the gutter.	Unblock gutter. Re-fix gutters laying to falls to outlet.	M 4

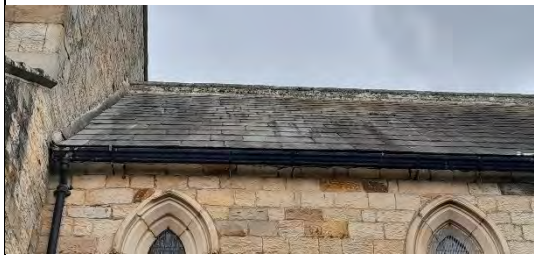
2.4.0	Vestry			
2.4.1	The plastic gutter is blocked with debris and vegetation.	Unblock gutter.	M

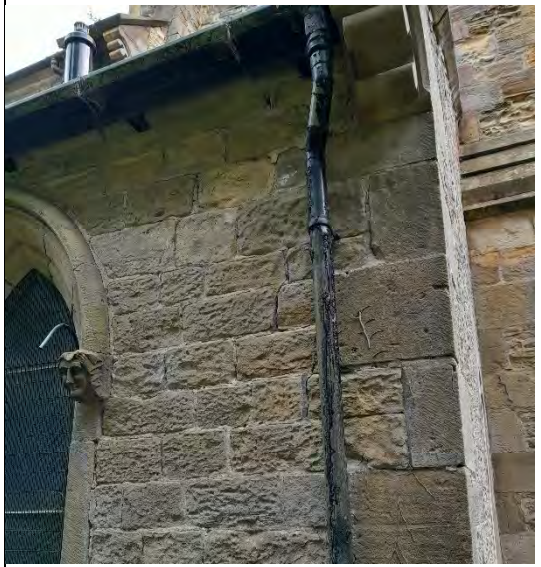
2.5.2	There is a plastic pipe connected to the cast iron tower rainwater pipe. The 90 degree bend to the end has a temporary spout fitted to the end which discharges direct into the choir vestry gutter.	Replace the spout with new cast iron section.	4

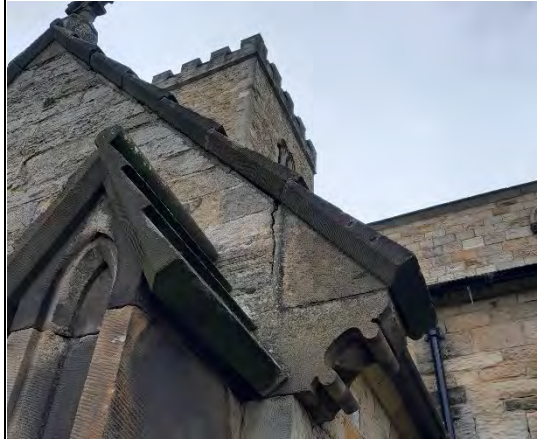
3.1.4	The western kneeler stone appears to have been repointed. There is a hole in the supporting corbel stone that has been pointed up.	None.	N/A

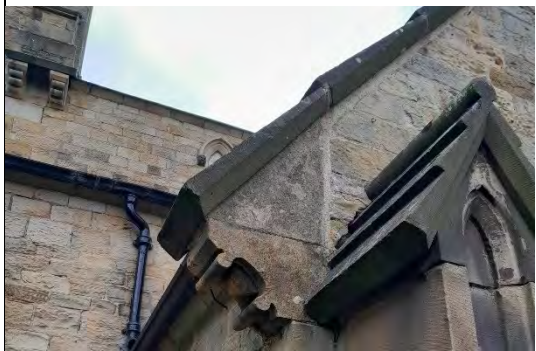
3.1.5	There is a hole in the top surface of the western kneeler stone. Either due to stone erosion or from previous pinning of the kneeler.	Point up the hole.	2

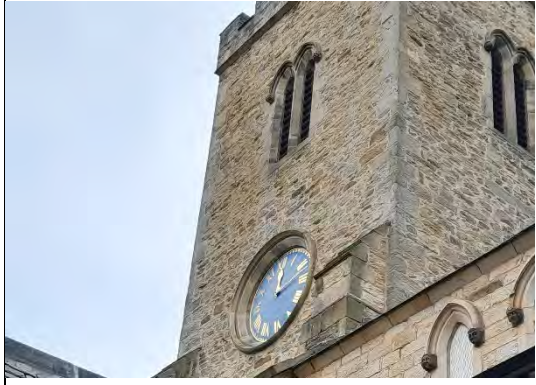
3.2.2	South: right-hand side buttress has lean pointing.	Rake out joints. Re-point buttress with lime mortar.	2

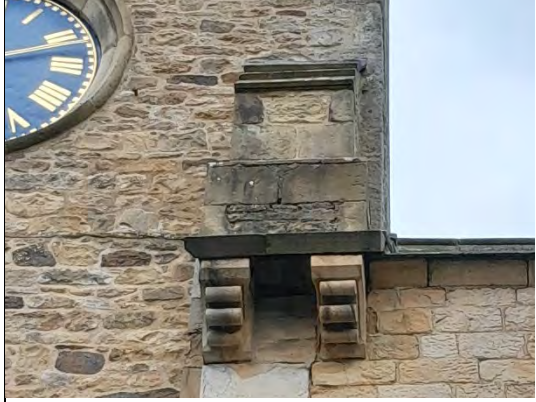
3.2.3	West: there are small areas of missing pointing to the blocked opening.	Rake out and point up the open joints with lime mortar.	3

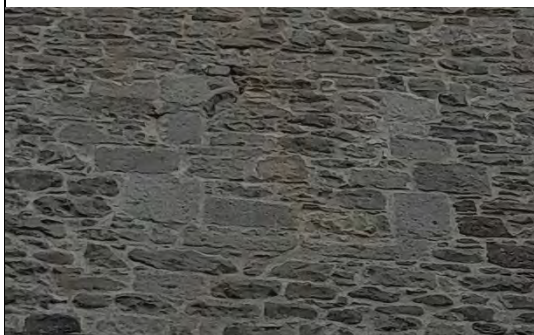
3.2.4	West: there are areas of missing pointing at the wall base.	Rake out and point up the open joints with lime mortar.	2

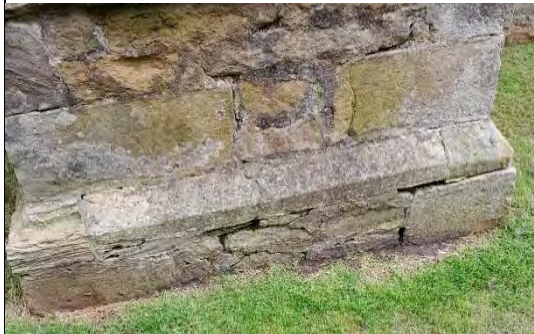
3.2.5	West: there is deeply eroded stone to the buttresses. The quoins are sound. The erosion does not currently appear to be causing structural instability.	Monitor.	M

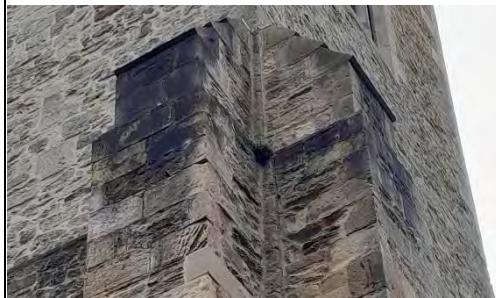
3.2.7	North: there is vegetation growth and lean pointing on the buttresses.	Remove the vegetation. Rake out and repoint the areas of lean pointing with lime mortar.	M 2

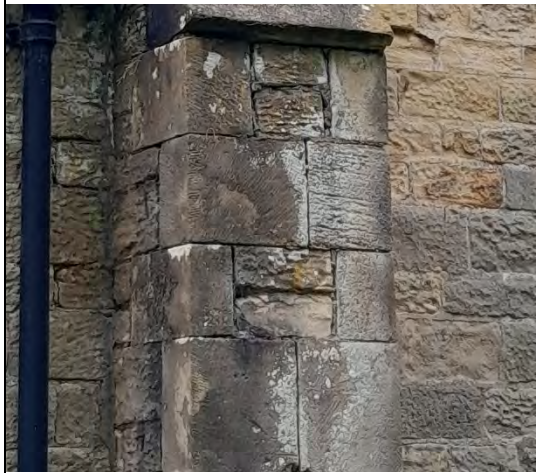
3.3.3	North: there are gaps/holes in the pointing adjacent to the easternmost buttress.	Rake out joints and point up the gaps.	2

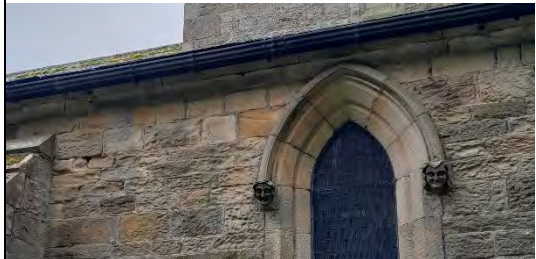
3.3.6	South-west: the kneeler appears to have moved. There are open joints between the kneeler and surrounding masonry.	Point up the open joints.	2

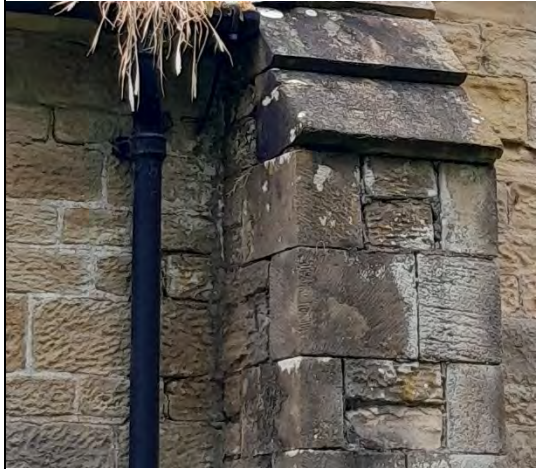
3.4.2	East: the left-hand window jamb has moved.	Point up window jamb.	2

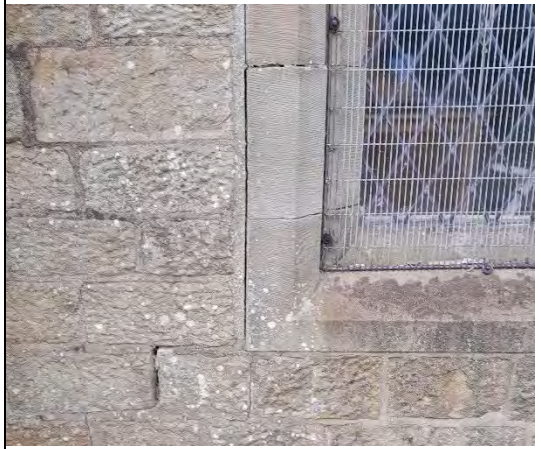
3.4.3	East: the window keystone has dropped slightly with open joints visible in the stonework above.	Rake out and point up open joints.	2

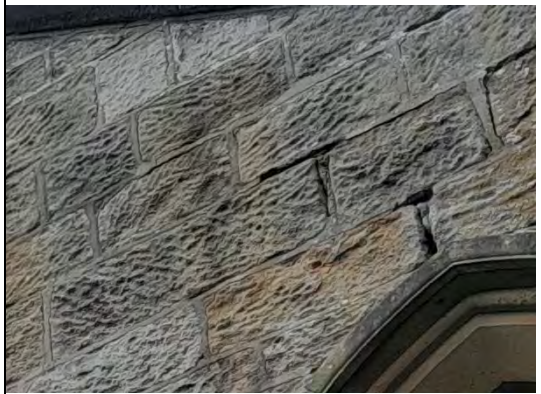
3.4.4	East: the butt joint between the vestry and the chancel has opened up.	Rake out and repoint the joint.	2

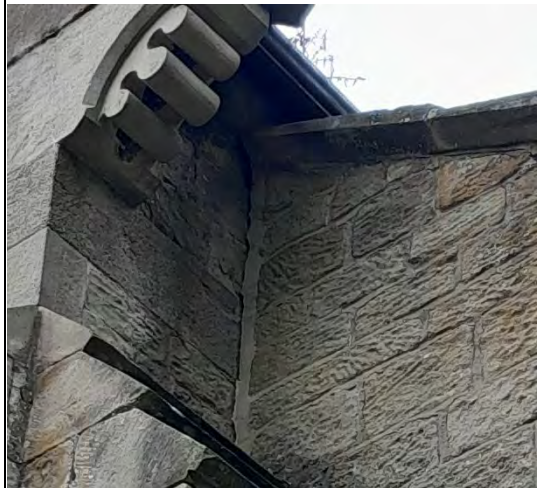
3.5.0	Chancel			
3.5.1	South: the hood moulds to the windows 1 and 4 from the west have disintegrated.	Monitor the erosion.	M

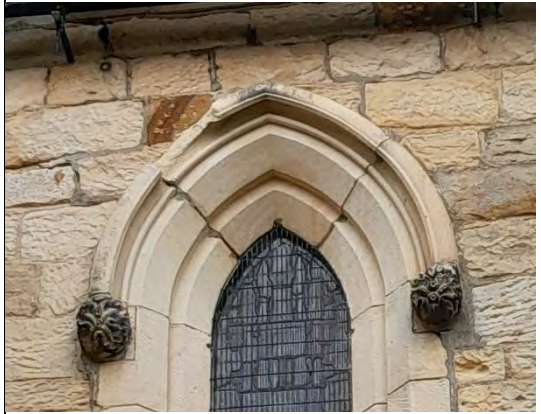
3.5.2	East: there is some shaling of the stone to the north buttress.	Monitor.	M

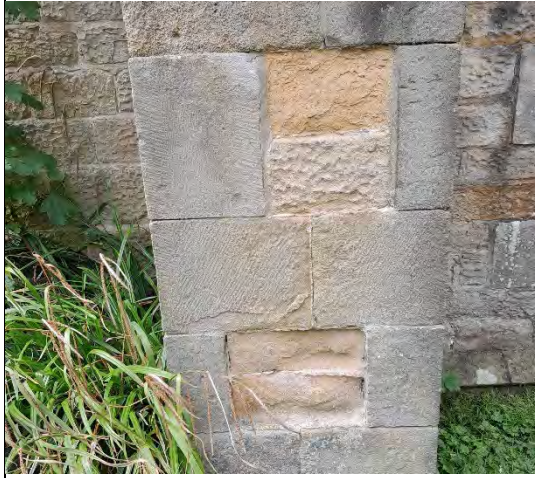
3.6.0	Choir Vestry (New Boiler House)			
3.6.1	North: there are gaps/holes in the pointing adjacent to the aisle buttress.	Rake out joints and point up the gaps.	2

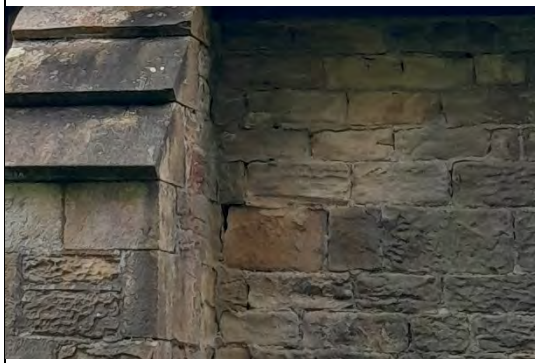
3.6.2	North: the right-hand jamb to the window has moved	Point up around the jamb.	2

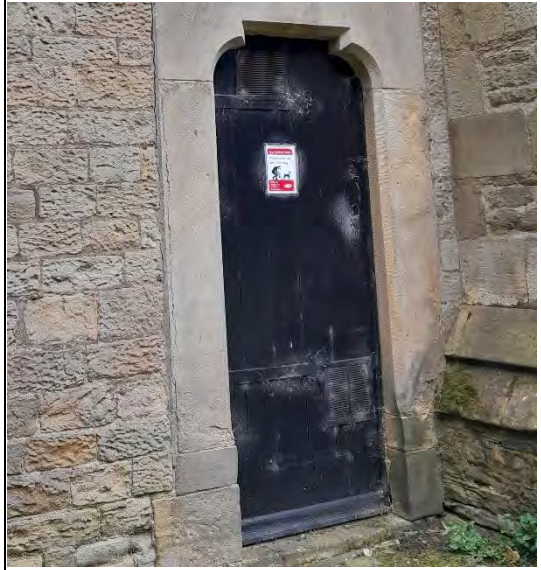
5.4.0	Vestry			
5.4.1	Black-painted timber door with weatherboard. Appears sound.	None.	N/A

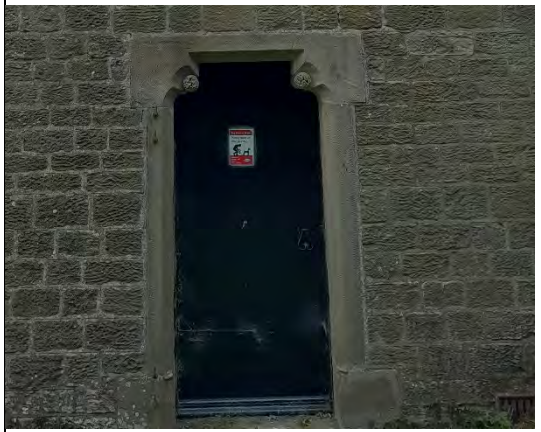
5.5.0	Outbuilding			
5.5.1	Timber boarded battened hatch door with band hinges. Padlock to slide bolt. Appears sound.	None.	N/A

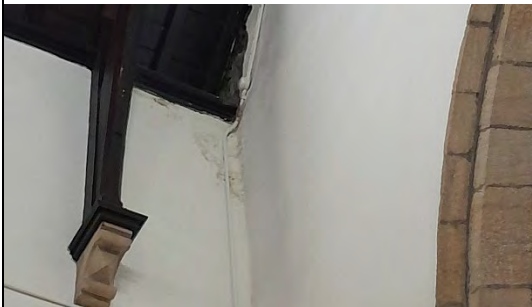
8.0.0		Walls		
The main church walls are plastered and generally sound, except where identified below. The tower walls from first floor level upwards are stone. The accessible WC outer wall is oak-paneled.				
8.1.0		Nave		
8.1.1	South-west: damp area with plaster broken away at high level. This appears to be in better condition than recorded in the previous QI report so could be historic.	Continue monitoring for drying out. Redecorate with appropriate breathable paint when dry.	4

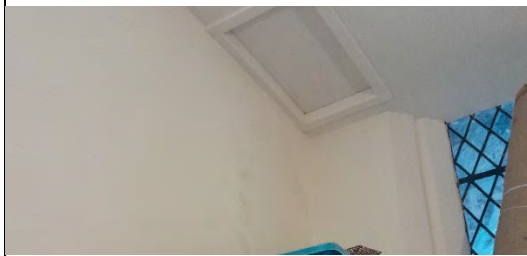
8.3.0	Vestry			
8.3.1	There is a damp patch below the loft hatch in the south-east corner. The damaged mortar flashing to the water table may be the source of the moisture (item 1.4.2).	Monitor for drying out and redecorate.	4

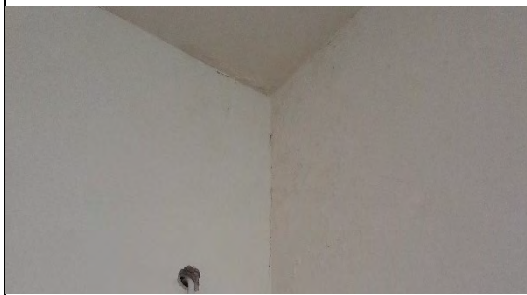
8.3.2	There are signs of dampness to the north-west corner with areas of rough plaster. This was identified as a possible earlier leak in the previous QI report. It appears to have been treated appropriately.	Monitor for continuing drying out. Redecorate when plaster ready to do so.	4

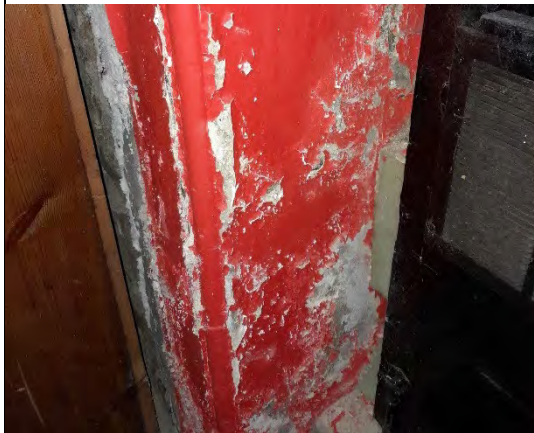
8.5.0	Choir Vestry (New Boiler Room)			
8.5.1	Choir Vestry (New Boiler Room): there is dampness to the left-hand door jamb.	Hack off/rub down plaster/paint in area of dampness. Address damp source (refer to items 3.6.5 and 5.3.1). Re-plaster with lime plaster and decorate. Consider relocating furniture to allow ventilation and drying out of wall.	4

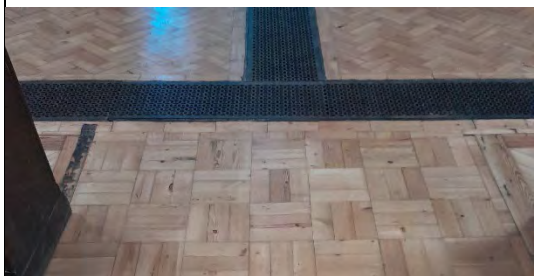
9.1.0	Nave & Aisles			
9.1.1	Wood block in varied laying patterns. In good condition. Has been sanded recently.	None.	N/A

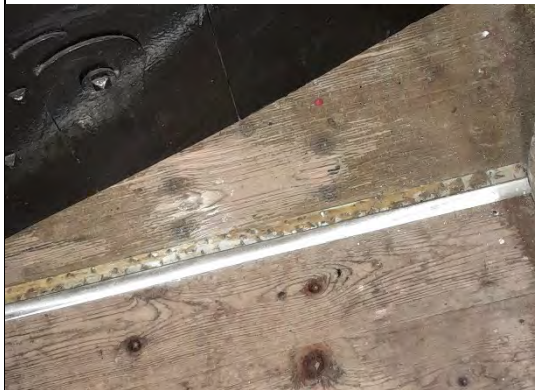
9.3.0	Vestry			
9.3.1	The organ door threshold has a gripper rod with no carpet exposing the sharp spiked surface.	Remove or cover gripper rod.	1

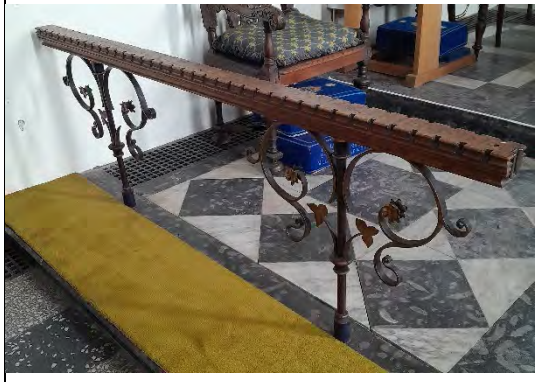
11.0.2	Chancel: the communion rail survives but the gates are missing.	None.	N/A

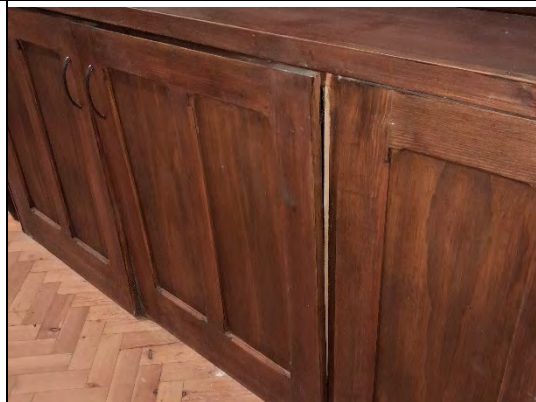
11.0.3	Recent in-built cupboards in former baptistry: one door does not close fully.	Reset hinge to cupboard door.	4

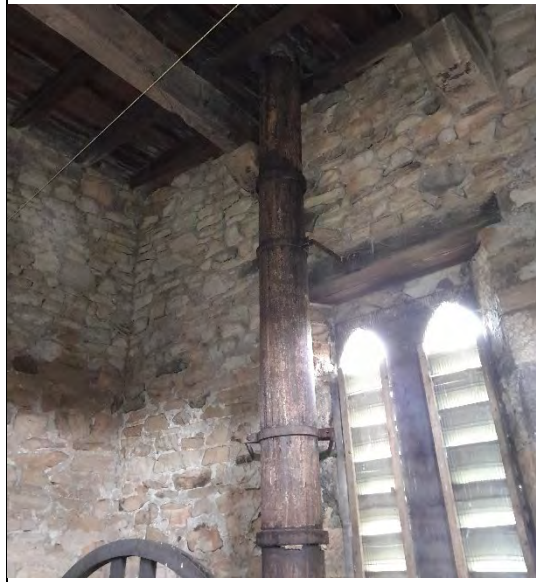
13.1.0	Boiler Room (Basement)			
13.1.1	This houses the oil boiler which is now redundant following the installation of the new gas heating system.	Strip out boiler and associated pipework.	5	
13.2.0	Tower			
13.2.1	There is a redundant flue pipe at the bell level.	Consider removal.	5
