## 2024 QUINQUENNIAL INSPECTION REPORT

### **CHURCH OF ST. CLARE, NEWTON AYCLIFFE** (Ref: 2407)

Diocese of Durham  
Archdeaconry of Auckland  
Deanery of Auckland

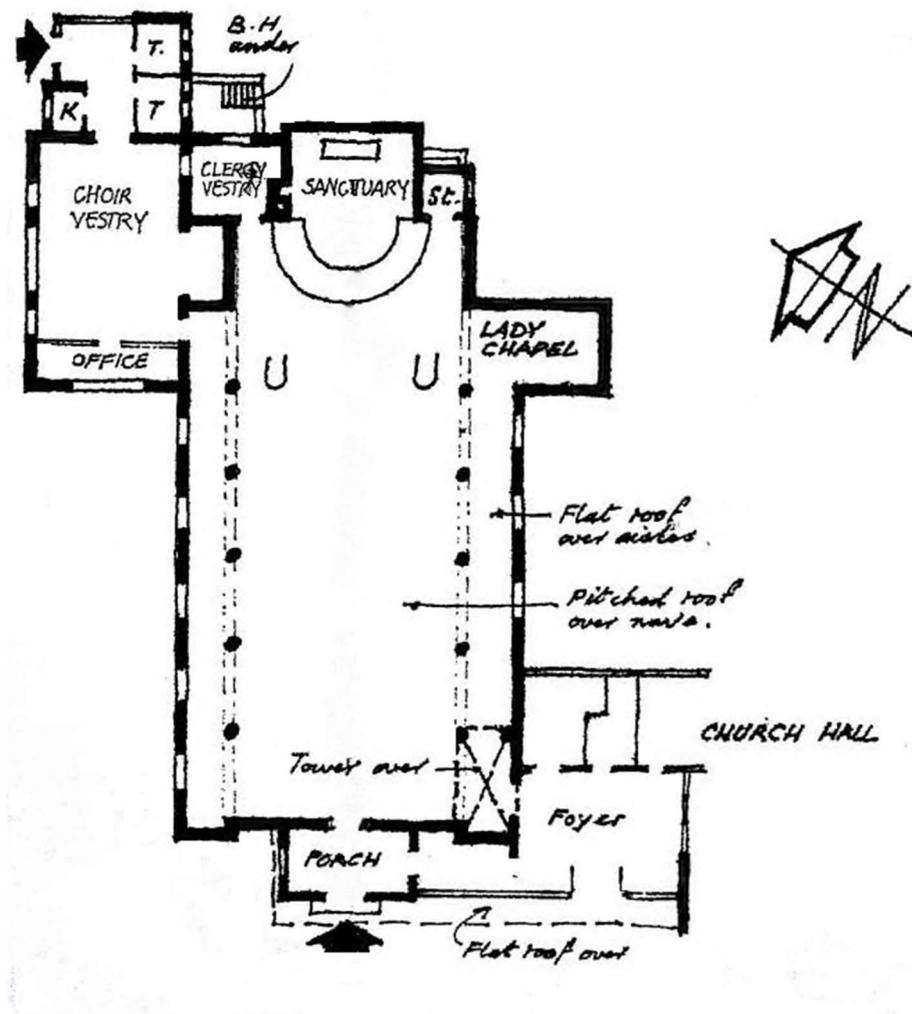
### 4. Plan of the church

St. Clare's is a relatively new church (1955) to the design of Cordingley and McIntyre, with a tower and vestibule added (1966). The Parish Hall dates from 1966 with a kitchen and WC added (c.1980s), a second hall (c.1994) and entrance foyer (c.1998).
