2026 QUINQUENNIAL INSPECTION REPORT

CHURCH OF ST. MARY, WHORLTON

(Ref: 2601)

Diocese of Durham
Archdeaconry of Auckland
Deanery of Barnard Castle

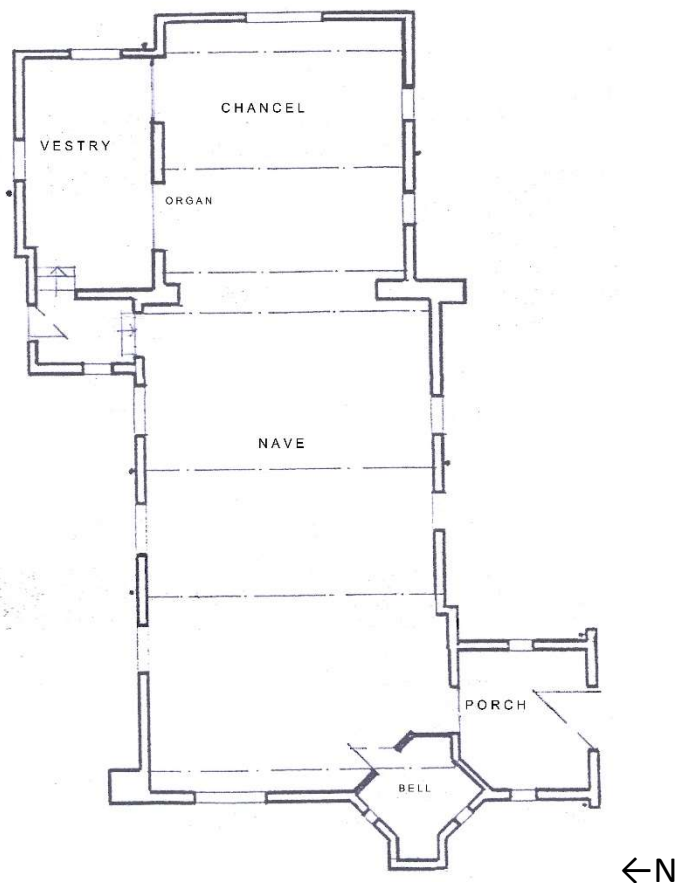
4. Plan of the church

A small unlisted church on the site of an earlier Norman Chapel of ease, comprising aisled Nave and Chancel with north Vestry, south Porch and west Bellcote. In local buff coloured sandstone beneath Westmorland slate roofs. All windows are decorated with stained glass, by both Clayton and Bell, and William Warrington of London. Consecrated by Robert First Bishop of Cape Town 13.05.1853. Seating capacity: 150.
