## QUINQUENNIAL REPORT

*For the Parish Church of*  
Church of the Holy Spirit, Crawcrook

***Report Date: 14<sup>th</sup> July 2026***

Inspecting Architect:  
Becky Smith BA(Hons), MArch, ARB, RIBA

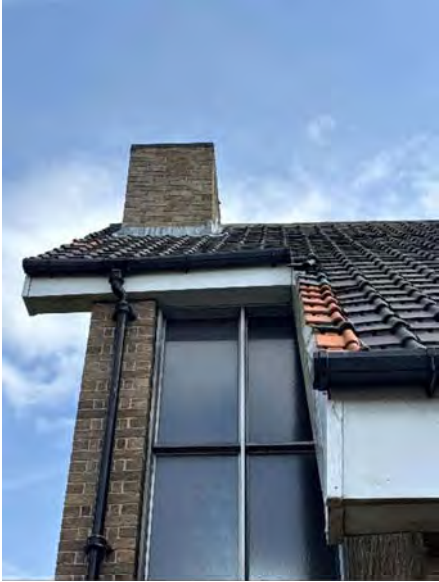
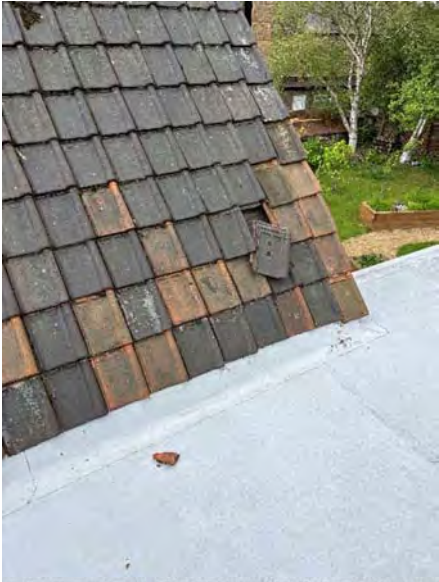
| Image & Location | Description | Condition | Repair Needs | Category |
|---|---|---|---|---|
| <u>Roof</u><br> | <p>Church:<br/>Clay single-lap interlocking pantiles.</p> <p>Hall Block:<br/>Single ply roof membrane with 3 no. roof lights</p> <p>Boiler House:<br/>Mineral felt roof</p> <p>External Store:<br/>Mineral felt roof.</p> | <p><b>West Slope:</b><br/>Overall condition difficult to ascertain due to limited visibility from ground level. However, evidence of missing/slipped pantiles to the eaves at the rear of the church.</p> <p><b>East Slope:</b><br/>1no. Cracked tile and 1no. Slipped tile. Some broken fragments of previously replaced tiles visible on flat roof.</p> <p>Evidence of significant number of replacement tiles which are mismatched in colour, tone and alignment, particularly around lower level of roof and pitched dormer areas.</p> <p>Chimney appears ok from ground level however felt covering has some visible gaps around.</p> <p><b>Boiler House:</b><br/>There is heavy moss, lichen and algae growth to a large portion of the roof felt.</p> <p><b>External Store:</b><br/>Roof appears in satisfactory condition.</p> | <p>Carefully refix/replace the slipped / missing slates to match existing in size, colour and texture and fix securely.</p> <p>Carefully repair the slipped / missing slates to match existing in size, colour and texture and fix securely.</p> <p>Fix felt covering to chimney. Inspect chimney fully whilst undertaking repairs.</p> <p>Carefully remove all moss and organic debris. Once clean thoroughly inspect all laps, seams and upstands and carry out any repairs required.</p> | <p>1</p> <p>1</p> <p>3</p> <p>3</p> |

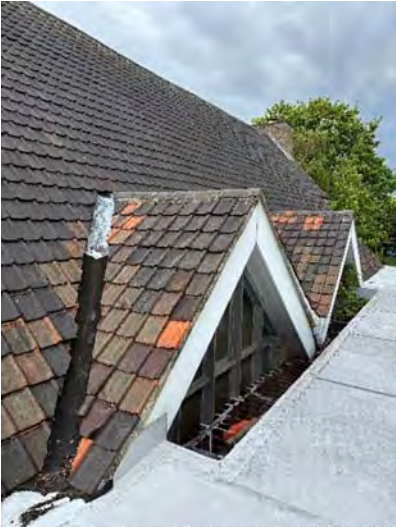
| Image & Location | Description | Condition | Repair Needs | Category |
|---|---|---|---|---|
| <p><u>Light well Void between Church &amp; Hall</u></p> | <p>Full height voids forming light wells between the main church and the later single ply flat roof extension building. The opening has protective steel safety grilles at flat roof level spanning the voids to prevent falls whilst maintaining light penetration.</p> | <p>There are significant mature self seeded saplings and invasive weeds growing aggressively from within the light well voids. There are no photos included within the previous QI (undertaken by others) to ascertain whether this vegetation was growing at the time of the previous QI. The expanding root system and moisture retaining vegetation present a risk to the building fabric and structure.</p> | <p>Remove protective safety grilles to access the light well voids to clear out all vegetation, ensuring roots are completely eradicated. (Alternatively could access be obtained via the window)</p> | 2 |
| | | <p>There appears to be significant quantities of debris (leaves etc) within the void. There are several pieces of timber on top of the grilles and within the void which have likely been left from previous repair works.</p> | <p>Ensure all soil, leaves and debris are cleared from the base of the light well voids. Once area is completely clear a close inspection of the condition of the building fabric to this area should be undertaken.</p> | 2 then M. |
| | | <p>The protective steel safety grilles are showing signs of significant rust and corrosion of the protective coating.</p> | <p>Brush back corroded steel grilles and treat with rust-inhibiting primer and apply durable topcoat.</p> | 3 |

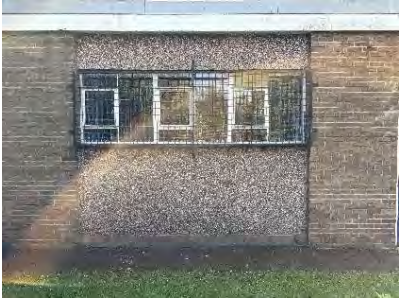
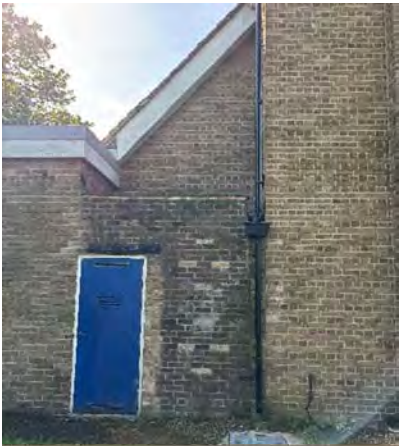
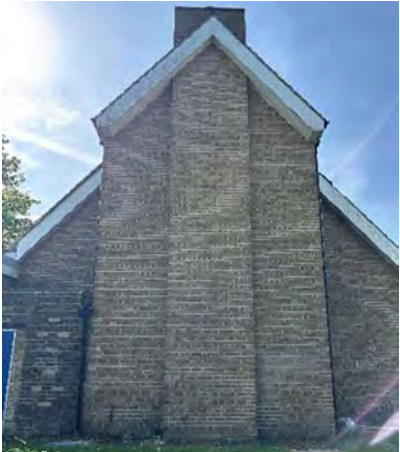
| Image & Location | Description | Condition | Repair Needs | Category |
|---|---|---|---|---|
| | Hall Elevation:<br>Brickwork with pebble dash. | Some loss of pointing to lower 1-2 courses of brickwork. Pebble dash area appears sound. | Rake out loose and decayed mortar to joints and repoint in a traditional, lime mortar mix matching original profile. | 3 |
| | Boiler House Elevation:<br>Brickwork | The elevation appears to be saturated and is showing efflorescence. Possibly partially due to termination of downpipes with no connection to drainage system. | It is suggested that no repairs are undertaken until downpipe is connected to a functional drainage outlet and any other causes are identified and addressed. Once brickwork is dry brush away surface salts, rake out and repoint lower joints with a lime mortar. | 2 |
| | Central Church Elevation:<br>Brickwork | Generally appears ok. Some surface staining. | | |
| | Window Return:<br>Brickwork | Localised area of graffiti to central area of elevation.<br><br>Spalling to concrete cill under window around old fixing hole. Cracking extends from left corner down through area to bottom of lintel. Black paint coating is showing signs of wear. | Clear graffiti from wall.<br><br>Remove all loose and crumbling stone to lintel and patch the void. Recoat entire cill with breathable, weather-resistant external masonry paint to match existing. | 4<br><br>3 |

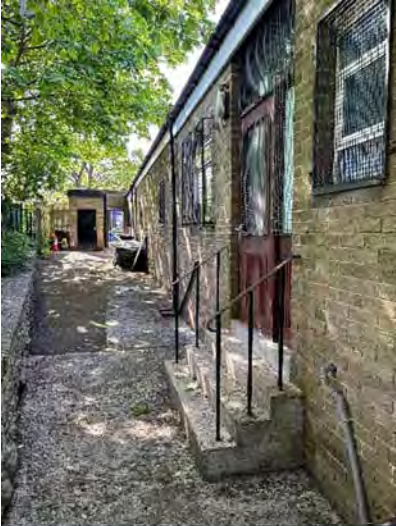
| Image & Location | Description | Condition | Repair Needs | Category |
|---|---|---|---|---|
| <u>East Elevation</u><br> | Brickwork | <p>Brickwork:<br/>There is widespread loss of pointing to the lower courses of brickwork.</p> <p>There are missing areas of pointing in various scattered locations across the middle and upper sections of the elevation, particularly around down pipes, window jambs and window cills.</p> <p>Note: See Rainwater Gutters &amp; Gullies Section for information regarding the mature trees outside of the church boundary and owned by Gateshead Council.</p> | Carefully rake out all loose, failing and missing mortar. Repoint using a lime mortar mix matching the original profile. | 2 |
| | Steps:<br>Concrete steps, painted metal handrails. | <p>Steps:<br/>There are cracks visible to the concrete steps, particular to the bottom step around the fixings of the handrail.</p> <p>This door forms one of the fire escapes identified from the internal fire escape signage. These steps consist of three steps and lacking a compliant ramp which means this escape does not meet current accessibility guidelines for a designated exit.</p> | <p>Rake out lose debris from the cracks and repair.</p> <p>As part of the comprehensive review of escape routes to establish directional clarity during emergency evacuation (described within the Internal Report Section) the emergency exits should be reviewed to consider which may be able to be upgraded to suit a compliant accessible exit. This should be considered within the programme of works the church are intending to undertake to the entrance elevation.</p> | 3<br><br>M |

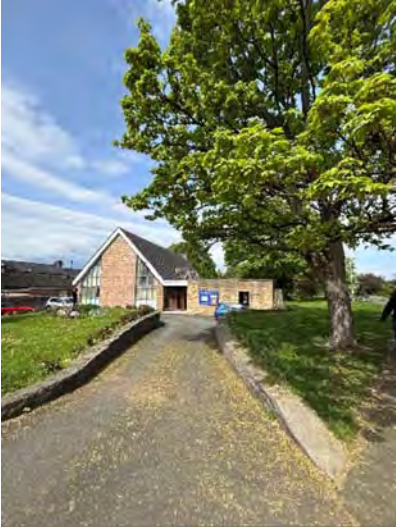
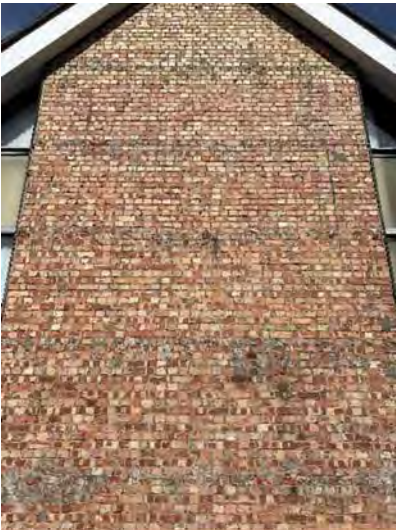
| Image & Location | Description | Condition | Repair Needs | Category |
|---|---|---|---|---|
| <p><u>South Elevation</u></p> | <p><b>Church:</b><br/>Brickwork.<br/>Original slate cladding between windows was removed on recommendation of the previous QI (undertaken by others) as risk of slates falling was identified. This has left exposed brickwork.</p> <p><b>Main Entrance:</b><br/>Floor: Terrazzo tiled</p> <p>Walls:<br/>Brickwork &amp; Stone</p> <p>Ceiling:<br/>Tounge &amp; Groove Timber Soffit</p> <p><b>Hall Extension &amp; Rear Access:</b><br/>Stonework</p> | <p>Church:<br/>Following the emergency removal of vertical slate cladding due to an identified health and safety hazard the underlying masonry substrate remains entirely exposed. This brickwork is in a highly vulnerable state. The mortar joints are degraded, porous and poorly pointed. As this wall section was historically detailed to be sheltered by cladding it does not posses weatherproofing capabilities and therefore will potentially allow moisture to transmit through the wall.</p> <p>Main Entrance:<br/>Floor: Some cracking visible to terrazzo flooring.</p> <p>Walls: Loss of pointing to lower courses of stonework.</p> <p>Ceiling: Flaking, peeling and blistering evident to protective paint finish.</p> <p>Stonework:<br/>Some loss of mortar pointing at the lower masonry courses with some minor hairline cracking to a small number of individual stones. Loss of pointing to coping stones and between stone and brickwork connection.</p> | <p>A permanent protective external finish or cladding solution should be designed to prevent water ingress. Solutions have previously been submitted to the DAC / Planning Pre-App however these were not well received. The church are currently looking to revisit this scheme urgently within some minor amendments.</p> <p>Floor: A monitoring programme should be established to identify whether movement is ongoing. Photographs with dates recorded should be taken at 6-month intervals at representative locations initially over the next 18-24 months to determine whether the cracking is indicative of continuing movement. Opening up may be required to establish whether cracking extends into the slab below. Repairs to be undertaken when reasons for cracking understood.</p> <p>Rake out open and defective joints at lower levels. Repoint using a matching lime mortar mix.</p> <p>Investigate whether potential water ingress to roof area in ongoing. Once resolved, remove all failed paint, sand timber substrate and apply new paint system.</p> <p>Rake out open and defective joints at lower levels. Repoint using a matching lime mortar mix. Monitor cracks during quinquennial period to ensure no progressive movement occurs. Repoint coping stones.</p> | <p>2</p> <p>Monitor/<br/>Investigate<br/>1-2<br/>Repair 3</p> <p>3</p> <p>3</p> <p>3</p> |

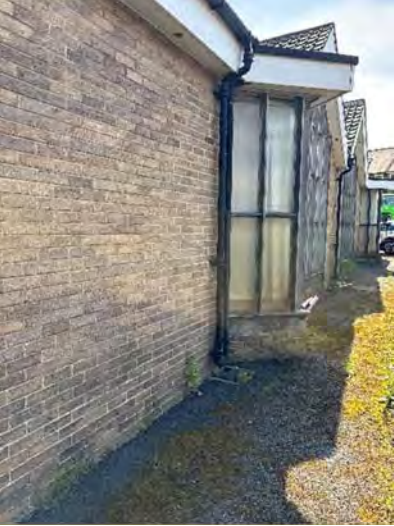
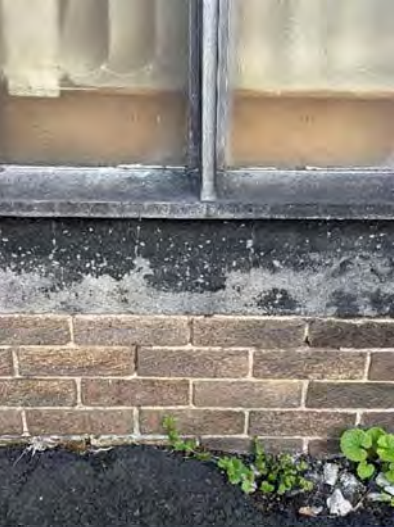
| Image & Location | Description | Condition | Repair Needs | Category |
|---|---|---|---|---|
| <p><u>West Elevation</u></p> | Facing brickwork | <p>Stepped cracking across approximately six brick courses evident to lower north end of wall.</p> <p>Loss of pointing to lower courses of brickwork across whole elevation.</p> <p>Concrete cill below windows are showing significant surface spalling, delamination and loss of face.</p> | <p>Advice from a Structural Engineer should be sought with a visual monitoring programme undertaken using photographs in the meantime. Photographs with dates recorded should be taken at 6-month intervals at representative locations initially over the next 18-24 months as a minimum to determine whether the cracking is indicative of continuing movement.</p> <p>If monitoring confirms the movement to be historic the joints should be carefully raked out and repointed using a matching, lime based mortar.</p> <p>Rake out and repoint using a matching, lime based mortar.</p> <p>Dress back loose, friable concrete to a sound base. Rake out all perimeter joints and repoint using a breathable, lime mortar mix.</p> | <p>Monitor/<br/>Advice<br/>2</p> <p>3</p> <p>3</p> |

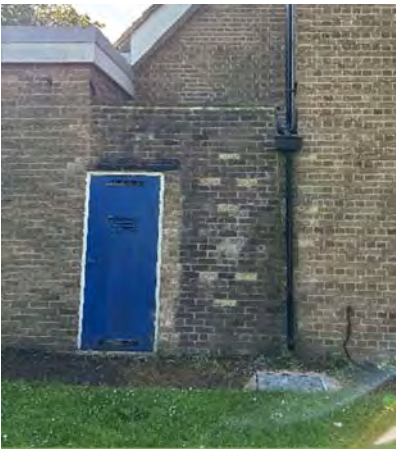
| Image & Location | Description | Condition | Repair Needs | Category |
|---|---|---|---|---|
| <u>Boiler House:</u><br> | Brick built with mineral felt roof. | Boiler house was inaccessible at the time of survey and therefore the internal area was not inspected. | | |
| | | In the previous QI (undertaken by others) it was identified that a Gas Fired Ideal Concord Boiler served the fanned convectors and radiators. | Ensure boiler is serviced annual and gas meter and pipework are tested annually. | M |
| | | It was highlighted that the boiler was over 30 years old at the time of the last survey and therefore the PCC should begin to plan for a new replacement heat source and this should ideally be carbon zero (ground / air-source / solar, electric) ahead of failure, as any new application will require the PCC to show that they have considered options. | Begin considering future heat source options. See Church of England guidance on Heating for more information. | 4 |

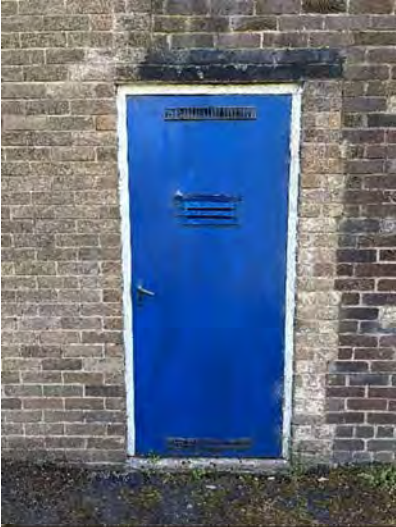
| Image & Location | Description | Condition | Repair Needs | Category |
|---|---|---|---|---|
| | Boiler House Door:<br>(North Elevation) | Blue paint finish to door is heavily weathered and faded with some damage to timber to central area of door. | Sand doors and repaint with weather resistant paint coating. | 3 |
| | | Timber door frame is showing some signs of areas of rot with flaking paint to full frame. | Rake and clean and failing mortar and splice repair timber where required. | 3 |
| | | Ironmongery is showing surface rust and flaking paint. | Scrape loose rust and flaking paint and repaint. | 3 |

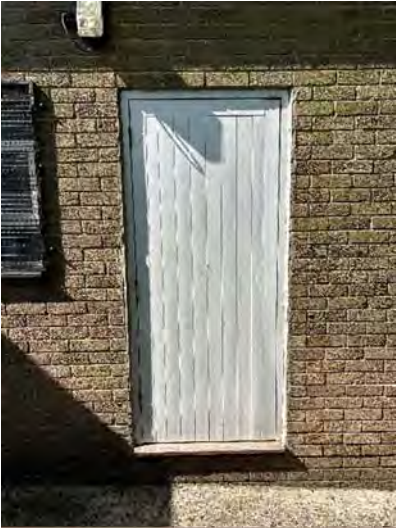
| Image & Location | Description | Condition | Repair Needs | Category |
|---|---|---|---|---|
| | Door leading from Foyer / Storage (East Elevation)<br>White painted timber door. | <p>Some minor damage to centre of door. Some flaking paint to timber surround.</p> <p>Flaking paint to the door threshold.</p> <p>Door hinges are showing rust staining.</p> | <p>Scrape flaking paint to door and surround and repaint.</p> <p>Clean off rust to hinges, apply rust inhibitor and lubricate.</p> | <p>3</p> <p>3</p> |
| | External Store: | Door showing some signs of blistering paint. However appears ok. | Monitor blistering of paint and repaint when required. | M |

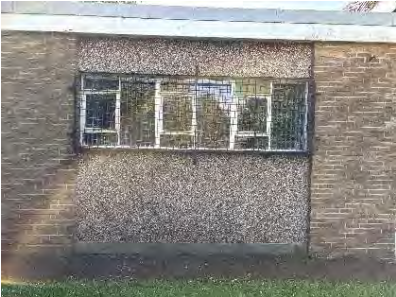
| Image & Location | Description | Condition | Repair Needs | Category |
|---|---|---|---|---|
| | NW1 (Meeting Room)<br>Timber framed window with metal security grille. | Flaking paint and rust evident to metal grille security cover. Some loss of paint to frames and loss of sealant in various locations. One pane of glass in a yellow colour. | Remove all grilles to this elevation, clear debris, brush down rust, treat, repaint and reinstate with new non-ferrous fixings. | 4 |
| | NW2 (Return of Nave Left)<br>Metal single glazed window. | Not visible from ground level, visible from hall roof area. Some of window is concealed by roof covering edge. Difficult to ascertain whether this was providing adequate waterproofing into boiler house area. The window is generally tired and weathered however functioning ok. There is a loss of protective finish and some widespread dulling. | Maintenance:<br>Carefully clean back metal frames and apply metal primer followed by high durability weather resistant external paint system. Rake out and replace perimeter mastic joints where necessary. | 4 |
| | NW3 (Return of Nave Right)<br>Metal single glazed window. | <p>The large multi-light aluminium window is generally tired and weathered. The metal framing displays widespread dulling, loss of paint finish and surface wear.</p> <p>Additionally, this large window as many others within the nave are entirely single-glazed. This creates a large area of high heat loss and poor acoustic insulation from external traffic noise. The lack of thermal performance across the large surface area acts a major energy drain.</p> | Replacement:<br>Consider future replacement (especially if a new energy efficient heating system is installed) which provide high-performing double/triple glazing. Solar-control glass would additionally assist with excessive overheating during summer months. | 5 |

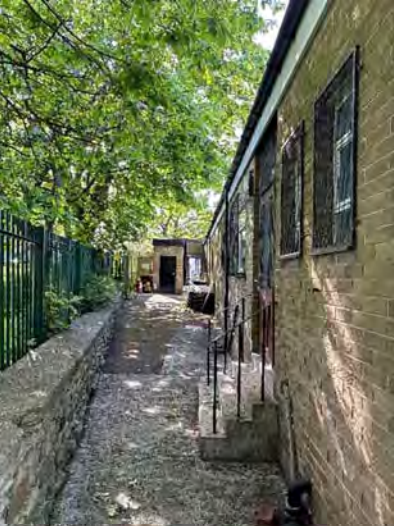
| Image & Location | Description | Condition | Repair Needs | Category |
|---|---|---|---|---|
| <p><u>Windows</u></p> <p><u>East Elevation:</u><br/>(in order from rear garden of church to entrance)</p> | Timber framed windows with metal grilles. | Flaking paint and rust evident to all metal grille security covers on this elevation. Missing bolt from top right of EW1. | Remove all grilles to this elevation, clear debris, brush down rust, treat, repaint and reinstate with new non-ferrous fixings. | 4 |
| | EW1 (WC) | Debris behind grille. Some flaking paint to timber frame, more obvious at window head. Glass appears ok. | To EW1, EW2, EW3, EW4, EW5, EW6, EW7 & EW8: | 2/3 |
| | EW3 (Kitchen) | Significant areas of flaking paint to window frame. Rot and areas of timber cill missing. Loss of paint. Loss of putty to window surround. Rot of timber to upper window. Glass appears ok. | | |
| | EW4 (Hall) | Loss of paint to upper openable window and missing section of timber. Flaking paint and loss of paint to frame and cill. Cracked putty to window frame. | | |
| | EW5 (Hall) | Some flaking paint to cill and frames. Cracked putty to windows. Glass appears ok. | | |
| | EW07 (Acc. WC) | Metal cill. Some flaking of paint to frame. Evidence of rotting to head with missing elements of timber and significant paint flaking. Glass appears ok. | | |
| | EW08 (Acc. WC) | Metal cill. Some flaking of paint to frame. Rust staining and flaking of paint to head. Glass ok. | | |

| Image & Location | Description | Condition | Repair Needs | Category |
|---|---|---|---|---|
| | EW2 (WC Sink) | Debris behind grille. Some evidence of flaking paint to frame. Glass appears ok. Some missing sealant around frame. | Remove all loose, flaking and failing paint. Carefully remove all rotten timber and splice in new treated timber sections where rotting or missing. Rake out and replaced failed or cracked putty and sealants. Prepare, prime and apply new paint system to all frames and cills. | |

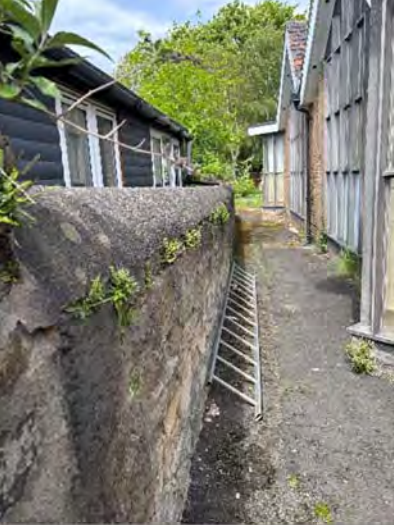
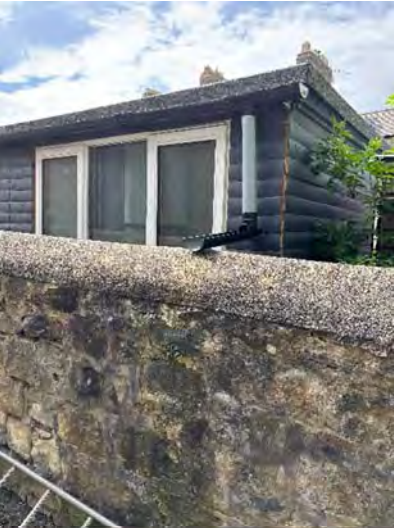
| Image & Location | Description | Condition | Repair Needs | Category |
|---|---|---|---|---|
| <p><u>West Boundary Access Path:</u></p> | <p>Metal gated access with narrow access path into rear of churchyard.</p> <p>Stone boundary wall with capping.</p> <p>Tarmac paving to ground floor. Housing estate adjacent.</p> | <p><b>Metal Gate:</b><br/>There is widespread rust showing to gate. The protective paint coating has peeled away in multiple areas leaving the raw iron exposed.</p> <p><b>Stone Boundary Wall:</b><br/>Vegetation growth within mortar joints of upper courses of stone. Some</p> <p>Large sections of the wall appear to have been repointed using a hard cement based mortar which has caused widespread spalling. There are some areas of significant mortar loss.</p> <p><b>Tarmac/Asphalt Floor:</b><br/>Significant growth of moss, lichen and vegetation. Some uneven areas of floor finish. Ladder stored against west boundary wall.</p> <p><b>Neighbours Outbuilding Drainage:</b><br/>A modern uPVC downpipe has been installed on the neighbouring's property outbuilding / shed to terminate abruptly just above the boundary line and discharged rainwater directly onto the church's stone boundary and into the church yard. Concentrated rainwater is being discharged directly onto the stone wall and tarmac which will accelerate the stone decay, cause pooling against the church foundations and create potential sheet ice during winter months.</p> | <p>Prepare gate surfaced by wire-brushing to remove all loose rust and failed paint layers. Treat all exposed iron surfaces with rust inhibiting primer and apply new durable, weather-resistant paint system.</p> <p>Carefully remove all vegetation from the stone wall to prevent further root expansion.</p> <p>Carefully rake out all loose and decayed mortar ideally remove all hard non-breathable previous cement repointing. Consolidate the internal structural voids and re bed any loose or shifting stones. Repoint entire wall face using a breathable lime based mortar.</p> <p>Remove all moss, lichen and vegetation. Remove and relocate ladder as currently a trip hazard.</p> <p>The PCC should discuss this with the neighbouring property and there should be immediate removal of the overhanging pipe and re-routing of their surface water system entirely within their own legal boundary and away from the church boundary.</p> | <p>3</p> <p>2</p> <p>4</p> <p>2/M</p> <p>1</p> |

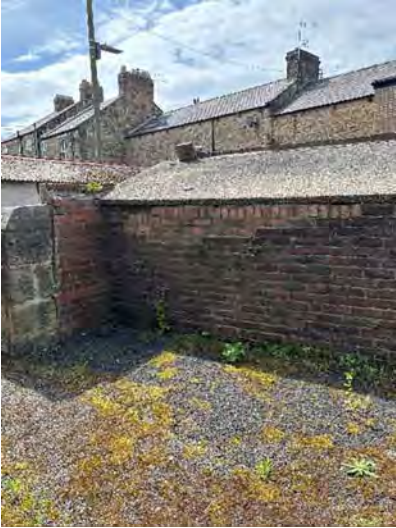
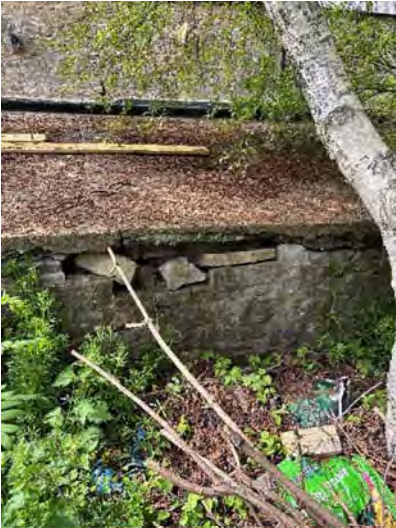
| Image & Location | Description | Condition | Repair Needs | Category |
|---|---|---|---|---|
| <p><u>West Boundary to Rear Churchyard:</u></p> <br> | <p>The West boundary continues along the path to a brick flank wall which forms the rear of a neighbouring outbuilding with a mono-pitch roof.</p><br><p>The wall then continues in a stone boundary wall.</p> | <p><b>Brick Flank Wall:</b><br/>The roof over sailing the brick flank wall lacks any guttering or fascia details. Runoff from the roof slope discharged directly over the edge down the face of the brickwork and onto the church grounds.</p> | <p>The church should discuss with the neighbour the installation of a proper eaves gutter and downpipe system within their property boundary. Although this has been like this for a while, condition of the boundary wall is deteriorating.</p> | 2 |
| | | <p>The top 3-4 courses are showing significant cracking, displacement and loss of mortar.</p><br><p>The lack of controlled drainage will likely be causing heavy water pooling along the base of the wall which is accelerating moss and weed growth at ground level.</p> | | 2 |
| | | <p><b>Stone Flank Wall:</b><br/>The roof over sailing the stone flank wall lacks any guttering or fascia details. Runoff from the roof slope discharged directly over the edge down the face of the stonework and onto the church grounds. This is less visible at ground level as there is an overgrowth of vegetation to the area therefore access was limited.</p> | <p>The church should discuss with the neighbour the condition of this wall and the repair and the installation of a proper eaves gutter and downpipe system within their property boundary. Although this has been like this for a while, condition of the boundary wall is deteriorating.</p> | M |
| | | <p>The top 2-3 stone courses have failed completely. There are multiple large stones which have slipped out of position, rotated or fallen entirely. This has resulted in a large hollow void spanning across the wall.</p><br><p>There is significant vegetation to the base of the wall with weed growth, nettles, brambles and a tree growing immediately adjacent to the masonry.</p> | <p>This area should be fenced off with temporary barriers to protect from falling masonry or collapse. Rebuild wall ideally in conjunction with a suitable rainwater disposal system for the roof over (by neighbour)</p><br><p>Clear area of vegetation of weeds to allow for access to stone wall.</p> | 2 |

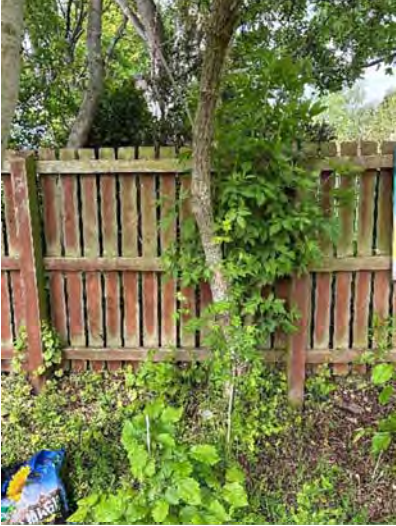
| Image & Location | Description | Condition | Repair Needs | Category |
|---|---|---|---|---|
| <u>North Boundary Wall:</u><br> | Vertical timber palisade fence panels fixed to timber posts. | <p>The timber has weathered significantly over time losing its original protective finish.</p> <p>There are many saplings, ground weeds and mature tree stems growing directly through, behind and against the fence line. There are trees which are positioned extremely close to the fence which may eventually cause damage to the fence.</p> | <p>Consider recoating with new stain / protective coating.</p> <p>Carefully cut back and clear and self-seeded trees, saplings immediately adjacent to the fence line which you are not intending to allow to grow to mature trees (check any local guidance on sizes).</p> | <p>4</p> <p>2</p> |

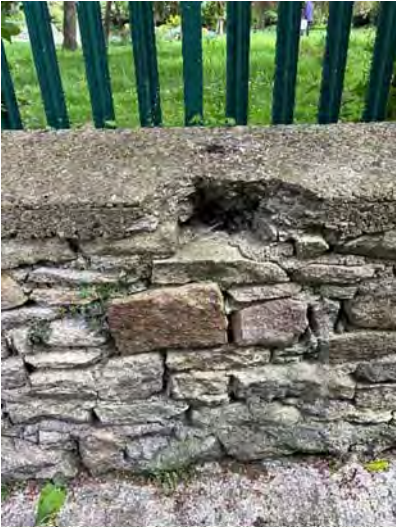
| Image & Location | Description | Condition | Repair Needs | Category |
|---|---|---|---|---|
| <u>East Boundary Wall:</u><br> | <p>Low stone wall to boundary with coping stone. Modern green painted metal palisade security fence is installed directly behind stone wall, assumed to be ownership of Local Authority.</p> <p>South end of East Boundary Wall is vertical timber palisade fence panels fixed to timber posts.</p> | <p>There are areas along this stone boundary wall where there is loss of stone and fractured capping which is evidence in areas where there has been what are heavily rusted historic iron fixing installed into the top of the wall – assumed to support a previous fence.</p> <p>There are significant areas of loss of pointing which appears to be a hard, non-breathable pointing. The existing mortar joints show cracking and detachment from the stone faces.</p> <p>The farthest north section of this stone wall is showing significant cracking due to position of tree directly in front of wall from pressure.</p> <p>Fence to South end of East Boundary wall is fenced and showing evidence of rot.</p> | <p>Carefully remove the loose, fractured pieces of stone and concrete to prevent them from falling. Cut out / treat the corroding historic iron fixing to stop further rust-induced splitting. Reinstate the missing capping section.</p> <p>Carefully rake out all loose, decaying mortar and if possible remaining hard non-breathable pointing to a depth equal to twice the width of the joint using manual tools. Repoint the stonework using a lime mortar.</p> <p>Consult a qualified arborist to assess the trees health, stability and root spread. Consider whether this tree may need to be felled (subject to whether tree is covered by TPO). Carry out repairs to wall.</p> <p>Replace rotten timber panels to this area.</p> | <p>3</p> <p>4</p> <p>2</p> <p>3</p> <p>3</p> |

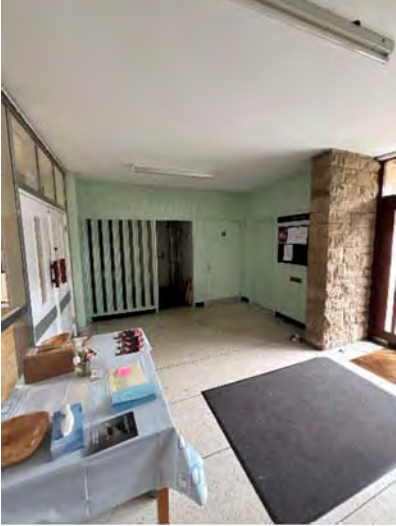
| Image & Location | Description | Condition | Repair Needs | Category |
|---|---|---|---|---|
| <u>Foyer / Storage Area</u><br> | <p>Floor to Foyer:<br/>Terrazzo tiled.<br/>Floor to Storage Area: Carpeted</p> <p>Walls:<br/>Majority plaster painted. One area of exposed stonework. One wall of timber panelling with glazed elements.</p> <p>Ceiling:<br/>Plaster painted.</p> | <p>Flooring:<br/>Cracking is evident within the floor finish, comprising of a series of interconnected cracks extending across a number of floor tiles. The previous QI Inspection (undertaken by others) identifies some fine cracks to flooring, however no photographic evidence of this is included. This assumed same area around entrance matting is more pronounced than would be typically be described as hairline and appears more visible than recorded previously.</p> <p>Walls:<br/>Generally appear ok. Some minor grazing of paint.</p> <p>Ceiling:<br/>Generally appears ok.</p> | <p>A monitoring programme should be established to identify whether movement is ongoing. Opening up may be needed to establish whether cracking extends to the subfloor / slab to inform repair proposals. Advice from a Structural Engineer may be required to establish repair requirement. Monitor visually (photos taken at recorded intervals) in the meantime.</p> <p>To be addressed during next period of decoration.</p> | <p>3</p> <p>5</p> |

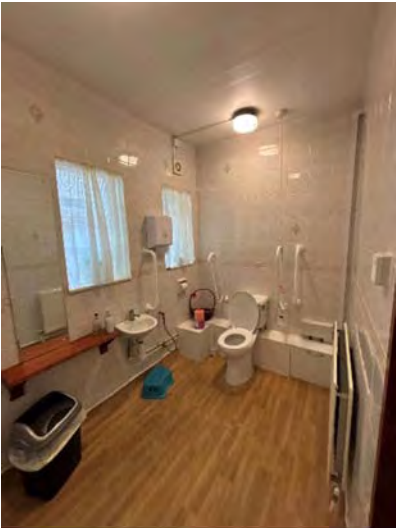
| Image & Location | Description | Condition | Repair Needs | Category |
|---|---|---|---|---|
| <u>Accessible WC</u><br> | <p>Floor:<br/>Laminate</p> <p>Walls:<br/>Tiled to full height.</p> <p>Ceiling:<br/>Plaster painted.</p> | <p>Generally appears in sound condition.</p> | | |

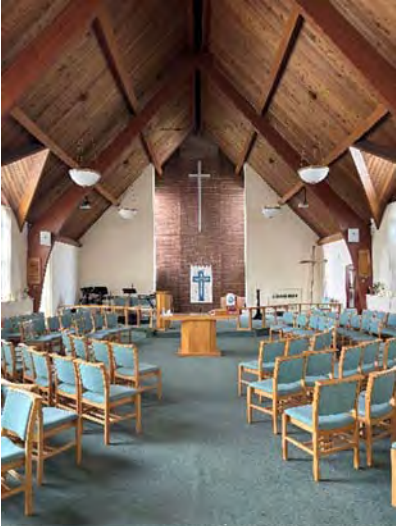
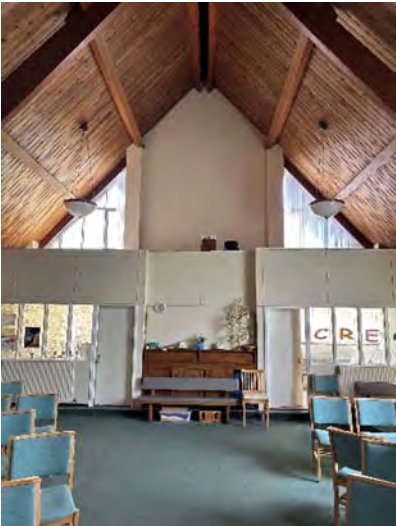
| Image & Location | Description | Condition | Repair Needs | Category |
|---|---|---|---|---|
| <p><u>Nave</u></p> | <p>Floor: Carpeted.</p> <p>Walls: Brickwork &amp; Plaster Painted.</p> <p>Ceiling: Timber Boarded.</p> | <p>Walls:<br/>Brickwork to high level of nave generally appears ok. Plaster painted walls generally appear ok. Some minor blistering of paint to areas.</p> <p>Windows:<br/>Large expanses of single glazing throughout the nave limit thermal efficiency and offer poor acoustic insulation against external traffic noise. Generally, metal frames are showing loss of protective finish and metal looking dull indicating age of windows. Debris is building up to some frame edges.</p> <p>Temporary white boarding used for privacy are deteriorating, showing active signs of damp and warping.</p> <p>WW4: Fractured glass pane and loss of metal facing to frame. A visible crack runs up the window surround. Water staining on the right side indicates active or historic water ingress.</p> <p>WW1 &amp; WW2: Visual evidence of mould growth on the window heads and frames suggesting moisture retention.</p> <p>Carpet:<br/>Some areas of staining but generally appears ok. Area to rear of Nave for audio controls has raised floor area with significant drop towards window which is a health and safety hazard. Stepped access to various locations (crèche, office) requires more clarity.</p> | <p>Blistering of paint to be addressed during next period of redecoration.</p> <p>Clean and clear corner joints and accumulated dirt. Sand, treat with rust inhibitor and repaint metal frames. Consider possible future glazing improvements as discussed in Windows Section.</p> <p>Remove the damp privacy boarding, treat the localised mould and improve ventilation to prevent recurrence. Consider alternatives is replacement screening is required.</p> <p>Investigate the water ingress, monitor the crack in the surround and repair the fractured glass.</p> <p>Mould to be removed from windows and monitor to ascertain whether ongoing issue.</p> <p>Install safety marking tape to edges of raised platform to warn users of change in level and prevent trips and falls.</p> | <p>5</p> <p>3</p> <p>2</p> <p>2</p> <p>1 then M</p> <p>1</p> |

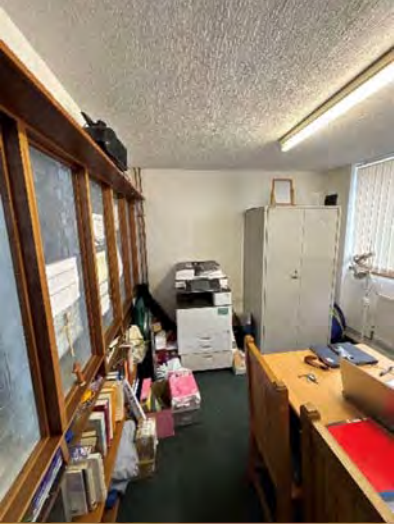
| Image & Location | Description | Condition | Repair Needs | Category |
|---|---|---|---|---|
| <u>Office</u><br> | <p>Floor:<br/>Carpeted</p> <p>Walls:<br/>Plaster painted</p> <p>Ceiling:<br/>Artex textured coating ceiling</p> <p>Internal Windows:<br/>Wooden frame glazed.</p> | <p>Floor:<br/>Generally sound condition.</p> <p>Walls:<br/>Generally ok condition.</p> <p>Ceiling: Showing some areas of wear.</p> <p>Internal Windows:<br/>Generally ok condition.</p> <p>External Windows:<br/>Timber cills are showing some evidence of paint flaking internally</p> | To be addressed during next period of decoration. | 5 |

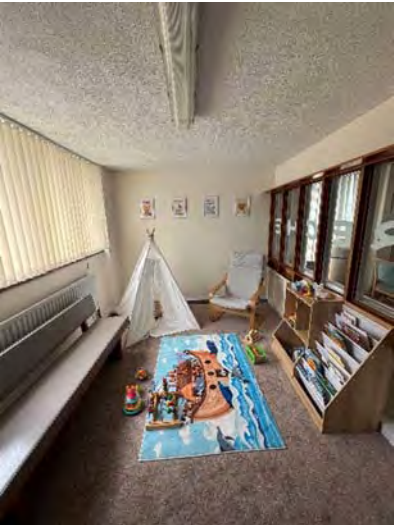
| Image & Location | Description | Condition | Repair Needs | Category |
|---|---|---|---|---|
| <u>Creche</u><br> | <p>Floor:<br/>Carpeted</p> <p>Walls:<br/>Plaster painted</p> <p>Ceiling:<br/>Artex textured coating ceiling to most, flush finish to area with loft hatch access.</p> <p>Internal Windows:<br/>Wooden frame glazed.</p> | <p>Floor:<br/>Some minor staining but generally sound condition.</p> <p>Walls:<br/>Generally ok condition.</p> <p>Ceiling:<br/>Generally ok with some minor areas of wear.</p> <p>Internal Windows:<br/>Generally ok condition.</p> <p>External Windows:<br/>Timber cills showing some evidence of paint flaking.</p> | <p>To be addressed in next period of decoration.</p> <p>To be addressed during next period of decoration.</p> | <p>5</p> <p>5</p> |

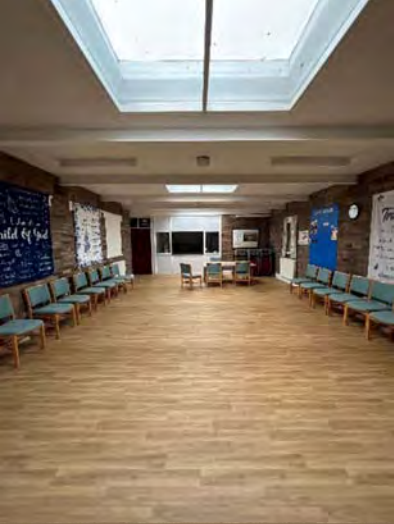
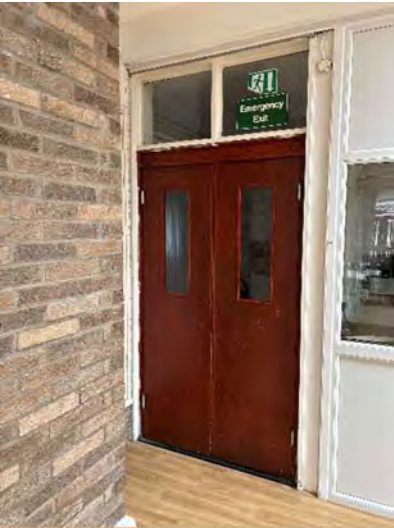
| Image & Location | Description | Condition | Repair Needs | Category |
|---|---|---|---|---|
| <p><u>Hall:</u></p> | <p>Floor:<br/>Wooden<br/>Laminate</p> <p>Walls:<br/>Exposed Brick<br/>Walls</p> <p>Ceiling:<br/>Plaster Painted<br/>with 3 no. Roof<br/>Lights</p> | <p>Floor:<br/>Generally sound condition. Some general wear and markings to skirting boards.</p> <p>Walls:<br/>The internal exposed brick walls appear ok.</p> <p>Ceiling:<br/>Showing some areas of wear and uneven finish to textured surface. Some flaking paint visible to beams.</p> <p>Internal Windows:<br/>Showing some dirt / paint markings to glazing. Some minor cracking around frames.</p> <p>Internal Doors:<br/>Double doors leading to kitchen circulation area has flaking paint and some minor areas of damage including some overpainting from previous decoration onto frames.</p> <p>The clear opening in front of doors into hall is insufficient for escape and accessibility provision. Whilst emergency exit signage is present, the current position lacks clarity. The complex compartmentalised layout of the surrounding area creates a labyrinthine environment.</p> <p>Internal Cupboards:<br/>The internal shelves to the cleaning supplies cupboard is sagging and warping across multiple shelves under load. These shelves are at risk of collapse which poses a safety hazard.</p> | <p>Skirting boards to be repainted during next period of redecoration.</p> <p>Address during next period of decoration.</p> <p>To be addressed during next period of decoration.</p> <p>To ensure the safety of occupants unfamiliar with the premises a comprehensive review of the escape routes should be undertaken to establish unambiguous directional clarity during an emergency evacuation and suitability of routes. Single swing / single leaf door would be a better solution to this opening as mentioned in previous QI.</p> <p>Remove all heavy items, particularly liquid cleaning chemicals. Remove existing shelving and any failing wall supports. Install heavy duty moisture-resistant replacement.</p> | <p>5</p> <p>5</p> <p>5</p> <p>2</p> <p>2</p> |

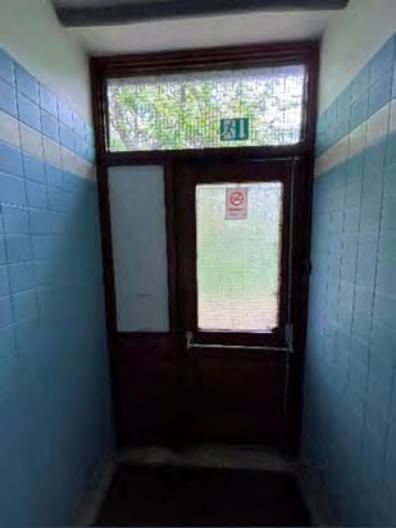
| Image & Location | Description | Condition | Repair Needs | Category |
|---|---|---|---|---|
| <u>WC's Foyer &amp; Fire Escape</u><br> | <p>Floor:<br/>Terrazzo floor finish with entrance matting.</p> <p>Walls:<br/>Plaster painted with ceramic tiling to 3/4 height</p> <p>Ceiling:<br/>Plaster painted.</p> | Crack in floor below entrance matting. | Monitor to establish if historic or ongoing movement. | Monitor |

| Category Scale | Area | Works Summary | Cost Band |
|---|---|---|---|
| 3 | Foyer | Structural Engineer monitoring programme of cracking to floor entrance. | 1-2 |

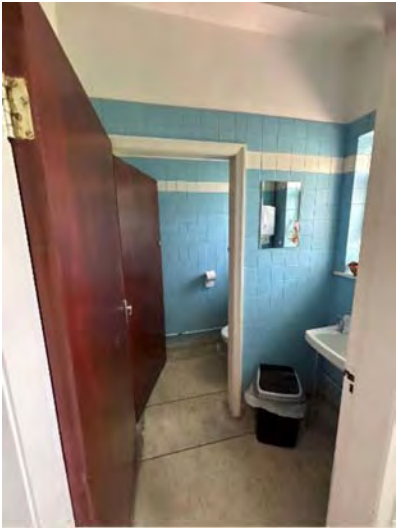
| Image & Location | Description | Condition | Repair Needs | Category |
|---|---|---|---|---|
| <u>WC's</u><br> | <p>Floor:<br/>Terrazzo floor finish.</p> <p>Walls:<br/>Plaster painted with ceramic tiling to 3/4 height</p> <p>Ceiling:<br/>Plaster painted.</p> | Generally appears ok. | | |

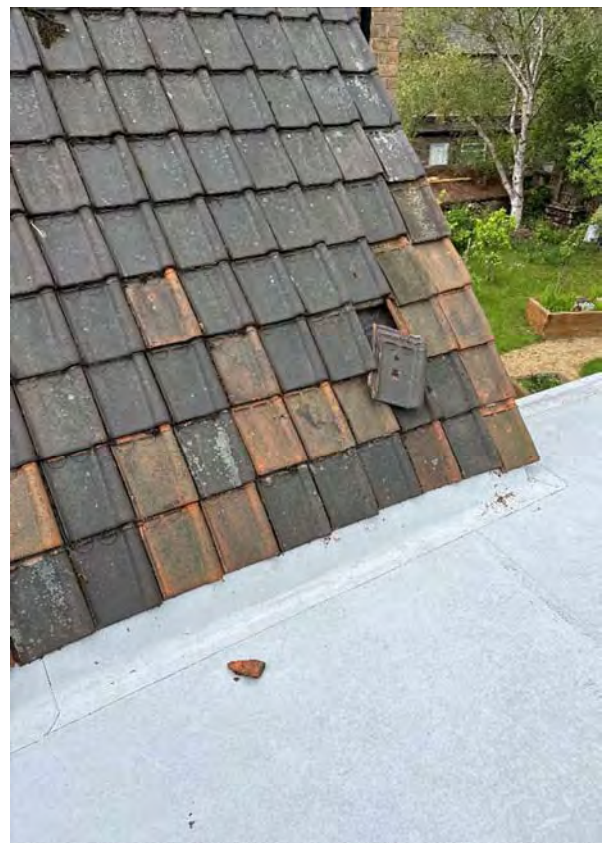
Slipped Slate

| Category Scale | Area | Works Summary | Cost Band |
|---|---|---|---|
| 2-3 | Roof | Undertake repairs to slipped / missing roof slates to both roof slopes. Fix felt covering to chimney and undertake visual inspection whilst repairing. Removal of moss and debris to boiler house roof and inspect. | 1-2 |

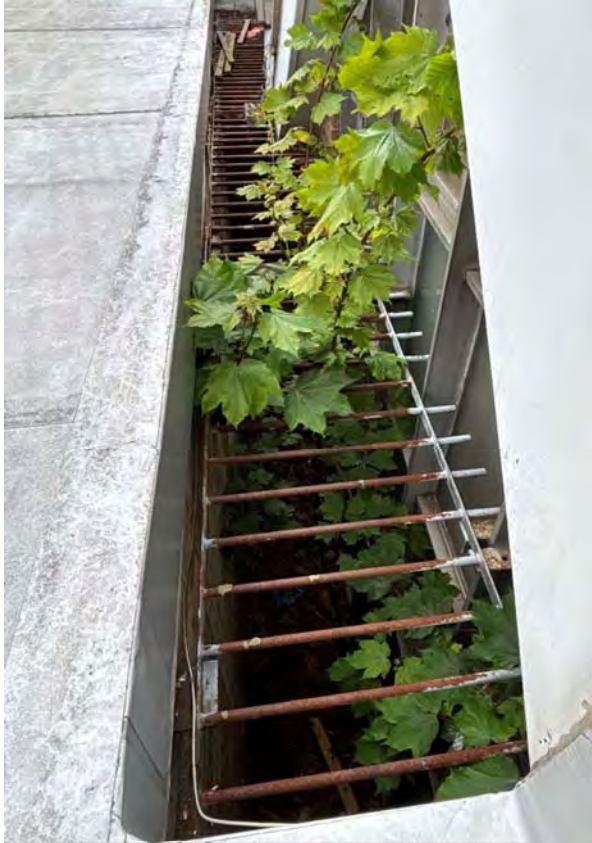
Vegetation to Lightwell Void

| Category Scale | Area | Works Summary | Cost Band |
|---|---|---|---|
| 1-2 | Light well Void | Clear vegetation, inspect internal wall conditions, treat grilles and install additional bird proofing system. | 2 |

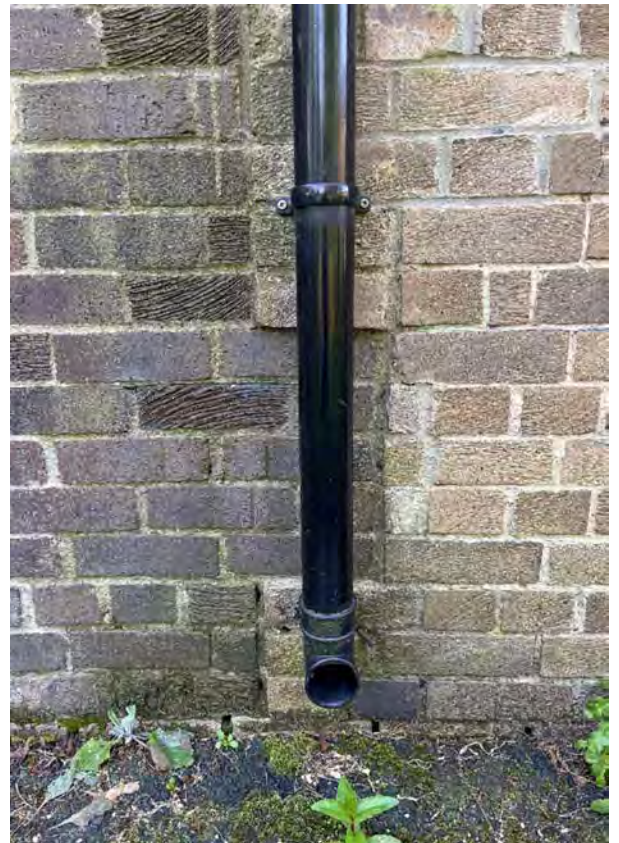
North Elevation terminates onto ground.

| Category Scale | Area | Works Summary | Cost Band |
|---|---|---|---|
| M/2/3 | Gutters | Clear all vegetation and debris from gutters. North Elevation downpipe to be connected to functional drainage outlet. Remove all loose, flaking paint and rust to rainwater goods to church and repaint. | 2 |

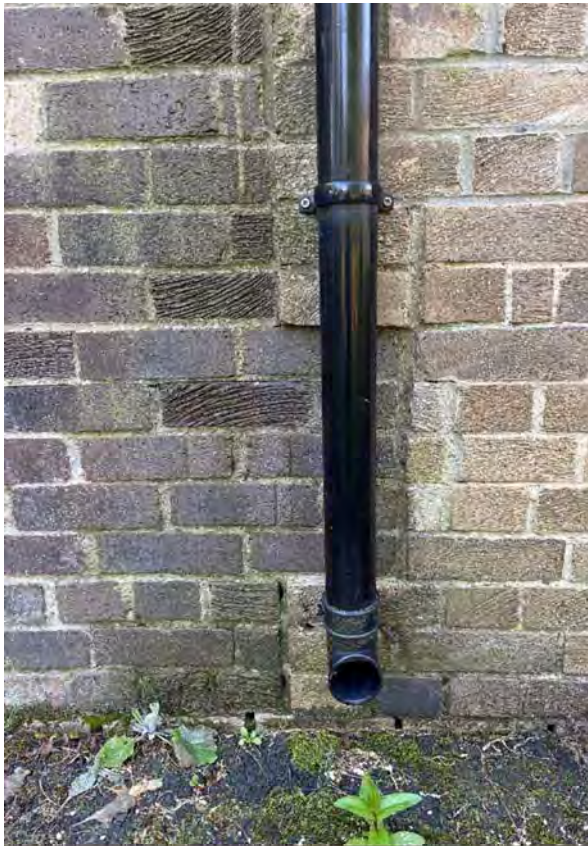
Downpipe to Boiler House Elevation discharges directly onto ground.

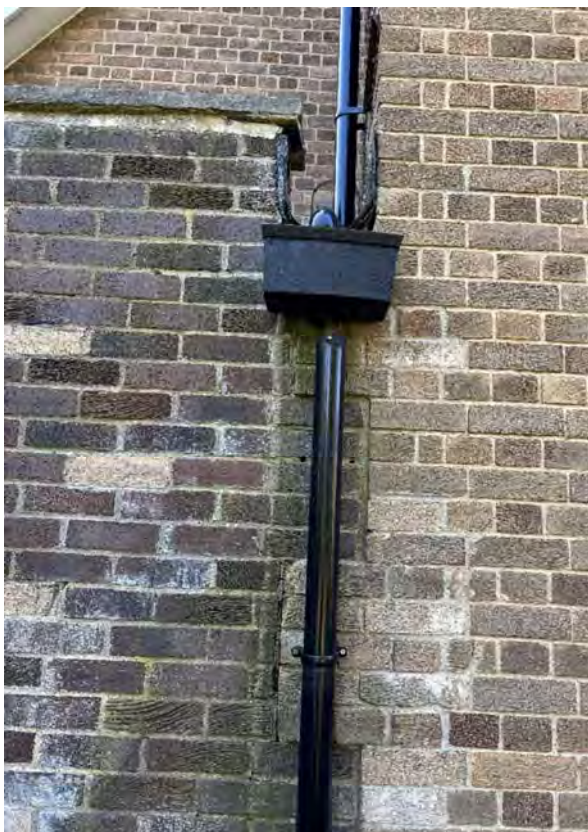
Areas of loss of pointing behind downpipe.

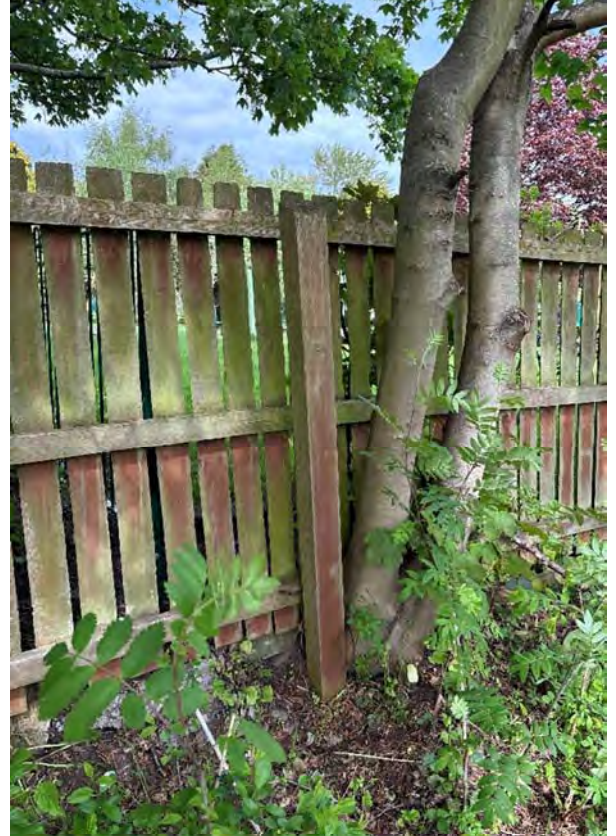
Example of tree in close proximity to fence boundary
