**QUINQUENNIAL REPORT on the  
THE CHURCH OF ST THOMAS**

**HARELAW**

**Inspected by Bryony Roff BSc. BArch. MA, RIBA, AABC**

Date of inspection and weather conditions: 1<sup>st</sup> April 2026    Weather was cool and overcast, becoming sunnier later  
Date of report: 12<sup>th</sup> August 2026  
Date of previous report: January 2020

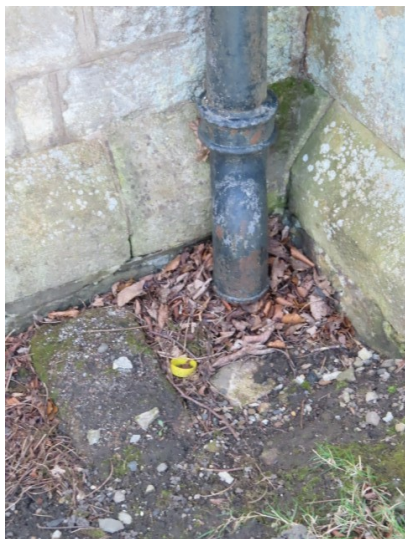
Rusting downpipes, vegetation growth, leaf build up (above and below left) and to the top left, downpipe not fully discharging over gully

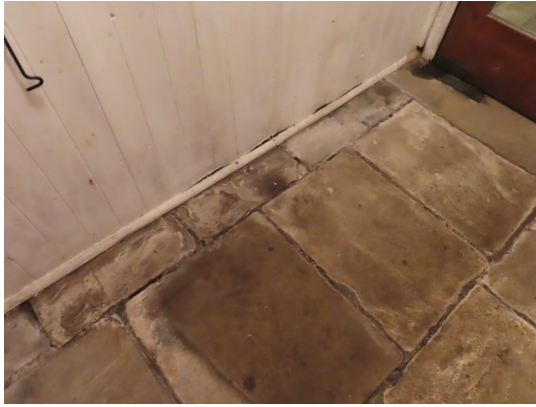
Lower edge of the porch boarding is warped lining of the porch

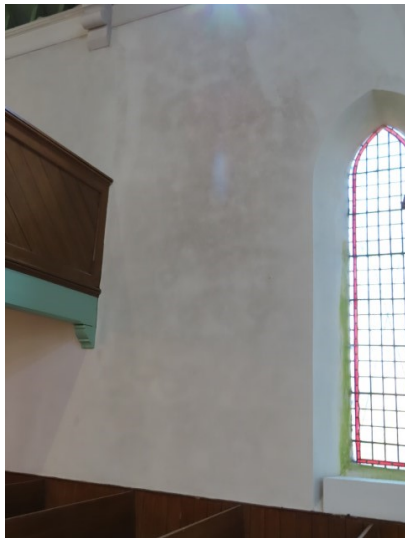
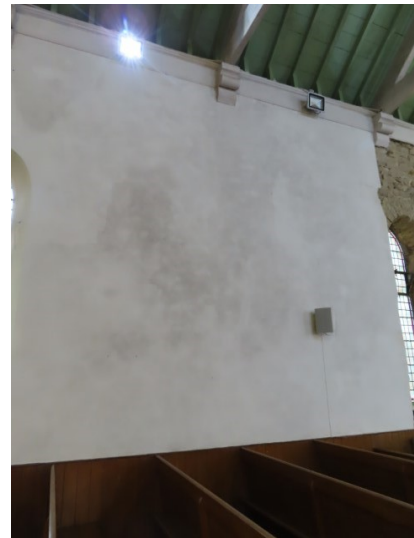
Mildew growth to the North Nave wall above and below left

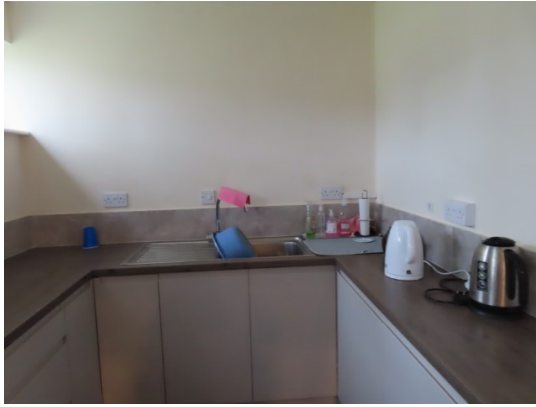
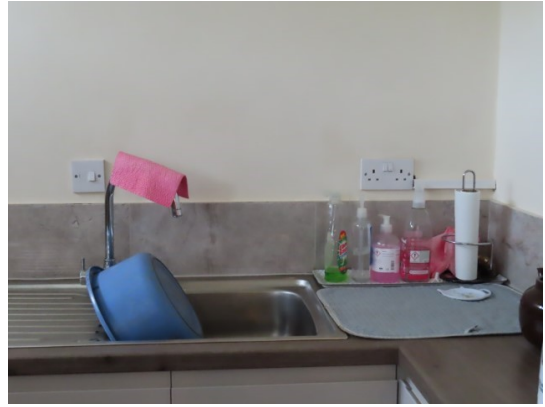
Sockets in the kitchen are very close to the sink/water source

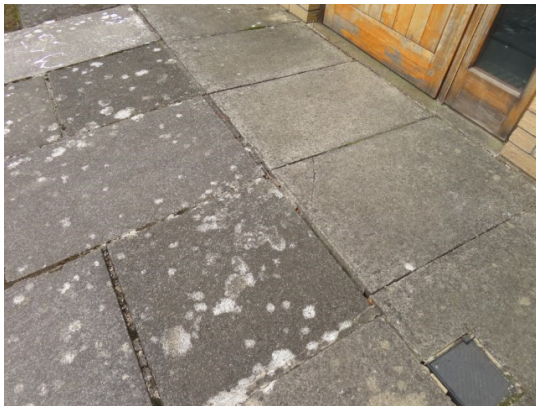
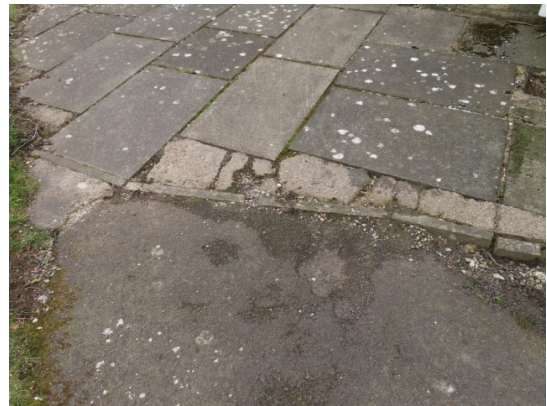
Open joints to paving up to Parish room and the concrete to the edge of the ramp (non-compliant) is breaking up

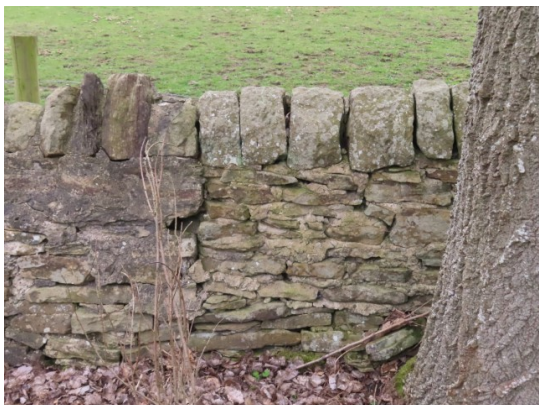
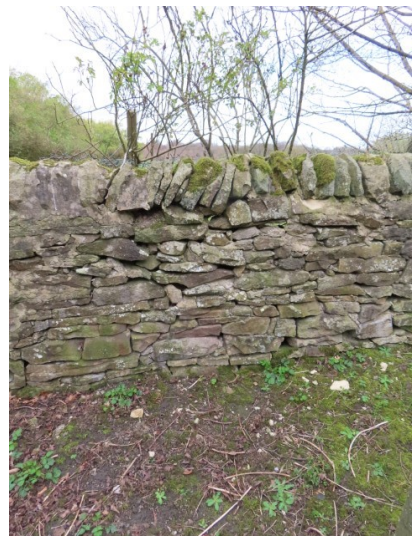
The following photos show defects to the East, South and West boundary walls including bowing (and other damage around mature trees), loss of stones, open joints, vegetation growth and cracking:
