**Quinquennial Inspection Report  
Holy Trinity Church, Southwick, Sunderland  
Diocese of Durham**

David Jowett - Architect, BA, DipArch, RIBA  
25 Roseworth Avenue  
Gosforth  
Newcastle upon Tyne  
NE3 1NB  
Tel: 07788 710 204  
email: [david@davidjowett-architect.co.uk](mailto:david@davidjowett-architect.co.uk)

6 May 2026

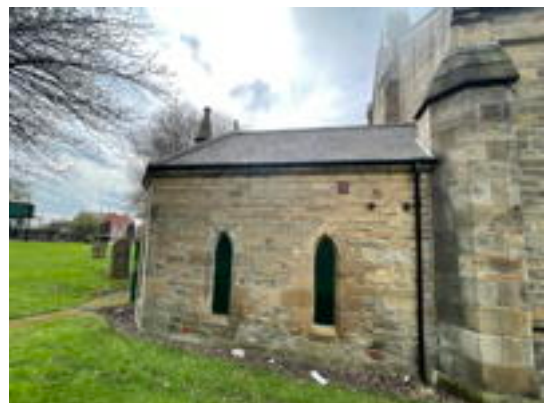
**Vestry RWP**

Lead lined concealed gutter to north and south nave and chancel. UPVC guttering to Vestry. A mixture of black painted cast iron and UPVC rainwater pipes which generally discharge over and sometimes, incorrectly, away from gullies. Two rainwater pipes to both north and west Nave elevations. One rainwater pipe to Chancel east elevation. One rainwater pipe to Tower south elevation fed from a lead shoot. Two rainwater pipes to Vestry roof.

Replace UPVC rainwater goods with cast iron or aluminium. Cost Band 2— £2,000.00-£9,999.

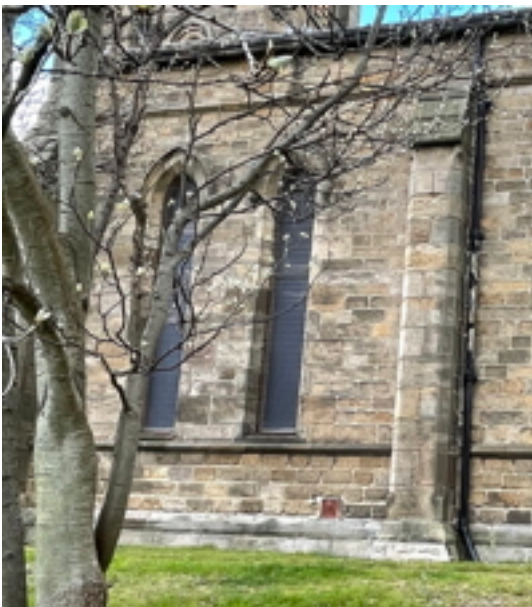
**W23 and 24 Nave South Elevation  
West End Vandalite Security**

Vandalite Security Glazing should be replaced, ideally with double glazing to reduce heat loss.  
Four broken quarries evident in the gallery area.  
Loose Louvre, now removed, to fourth stage, needs refixing.

Replace Vandalite Security Glazing. Cost Band 3: £10,000 – £29,999

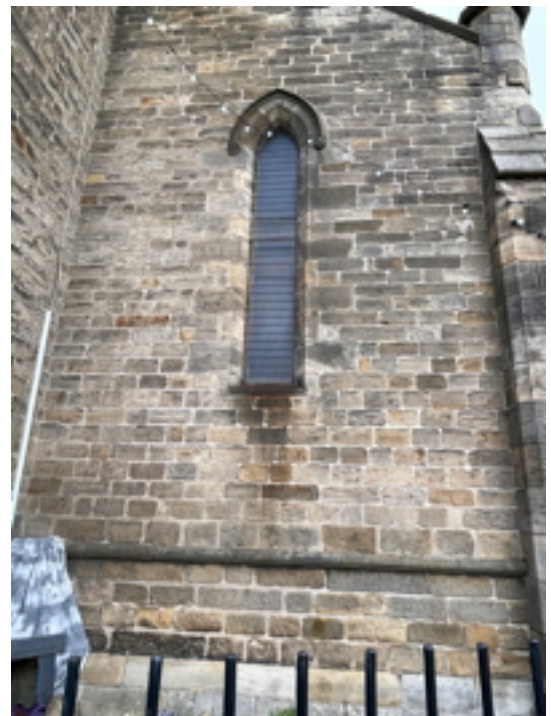
**W25 and 26 Welcome Room South  
Elevation Vandalite Security  
Glazing**

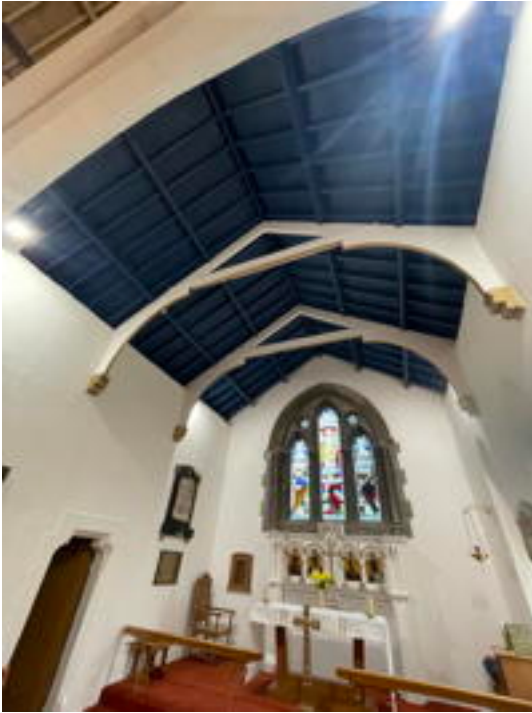
**Chancel Ceiling**

All appear in good condition. The Nave ceiling would benefit from decoration.

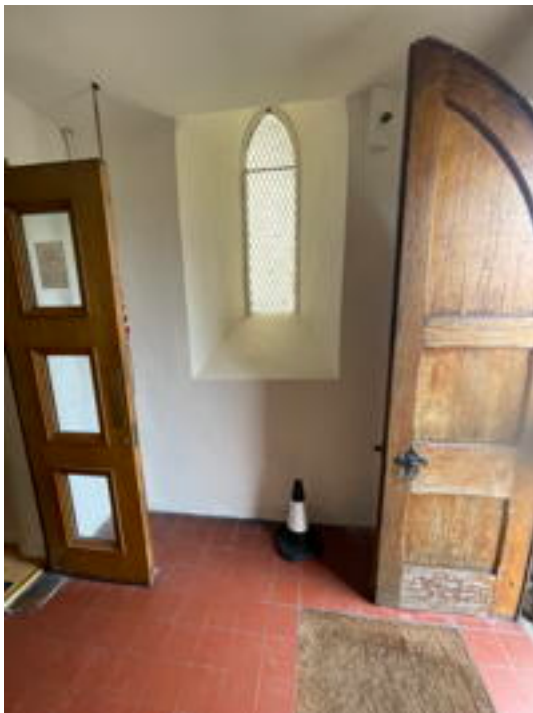
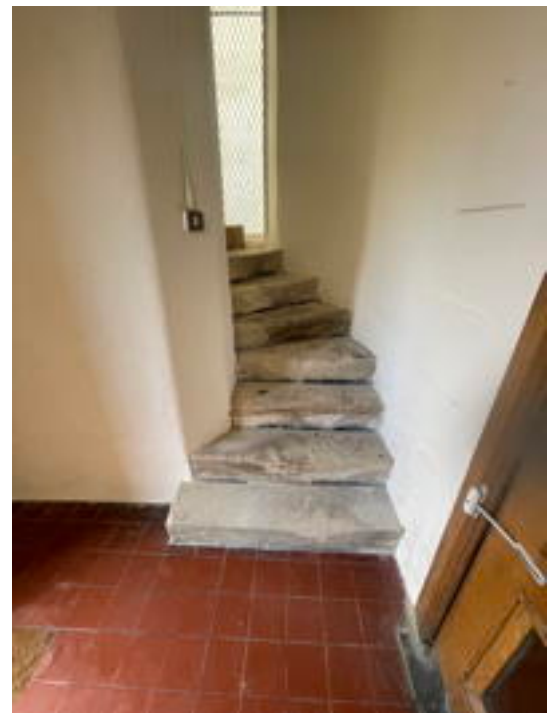
**Porch Looking South**

All decorated since the last quinquennial with clay paint and looking very good.

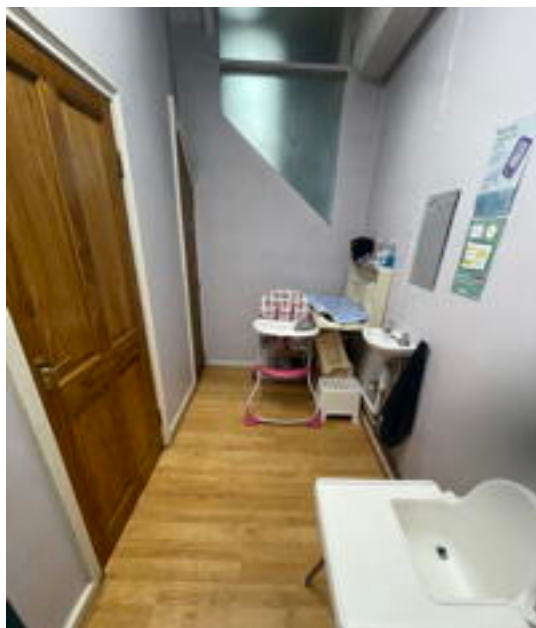
The WC Lobby is generally in satisfactory condition, although, in terms of its layout, it could be organised better. The glazing between the Lobby and staircase would be better with fire-resistant glazing or removed altogether, as it compromises the means of escape for the Gallery and privacy within the WC area.

Agree scheme to reorganise west end. Cost Band 5: £50,000 - £249,999.

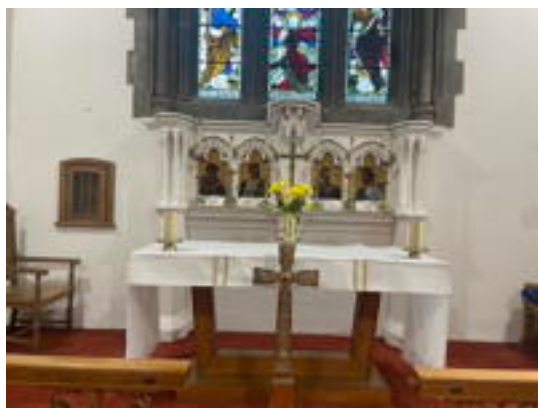
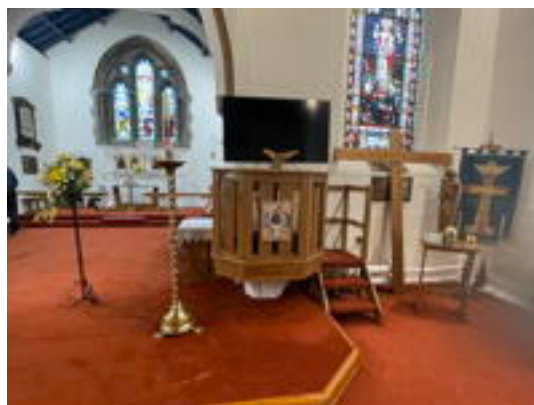
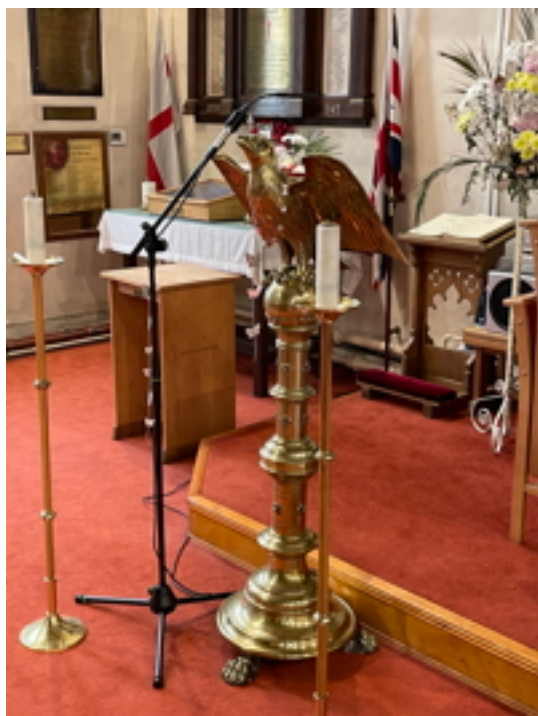
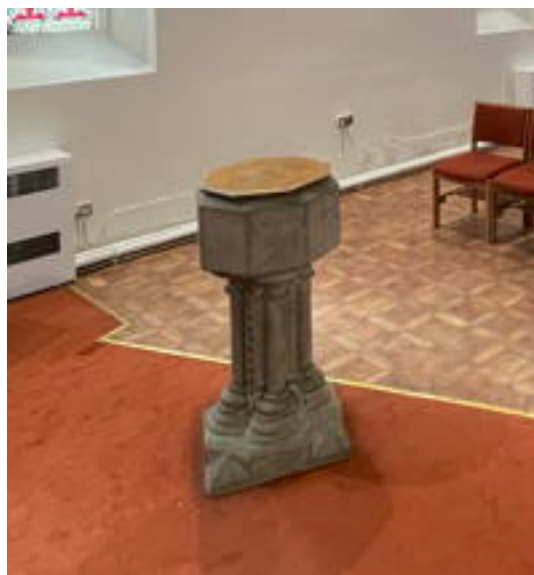
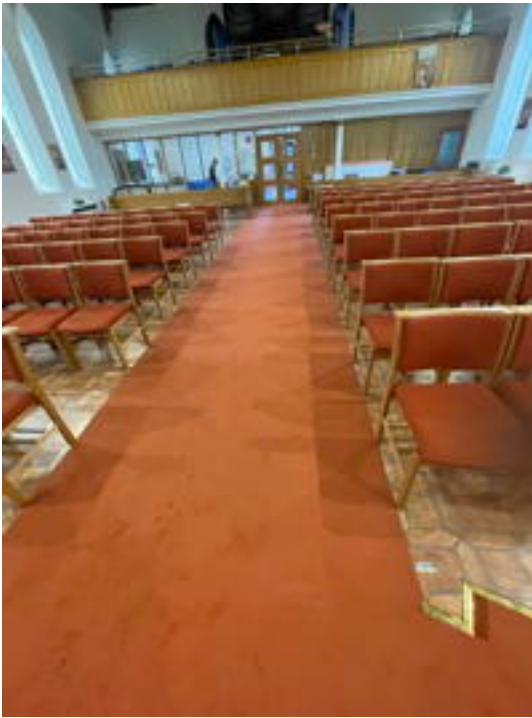
All are in satisfactory condition.

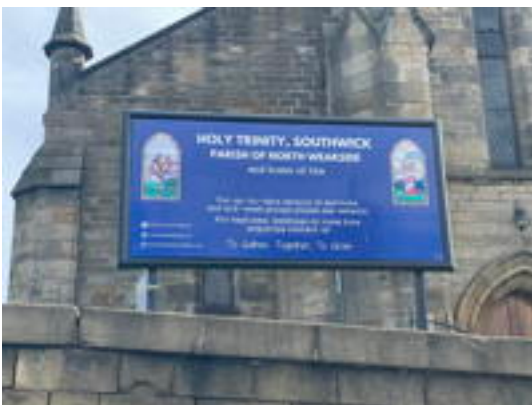
The Noticeboards are in excellent condition.

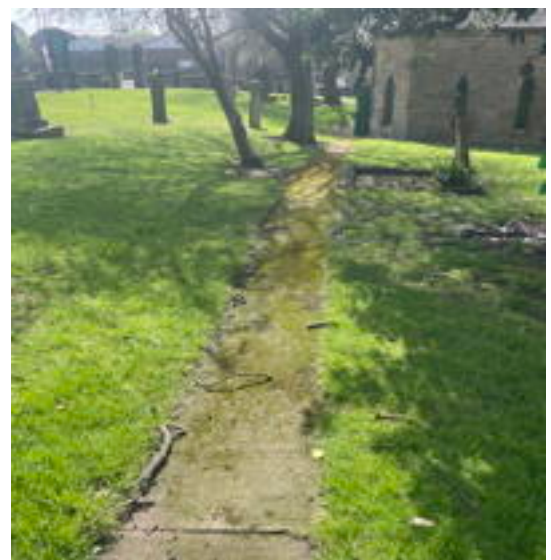
Most is generally in satisfactory condition. The paving to the pathways, especially at the east boundary, has some uneven and broken flags that could cause a trip hazard and should be levelled. There is broken section of concrete pathway adjacent to the Vestry door.

Arrange repair of pathways with the Local Authority. Cost Band 1– £0.00-£1,999.

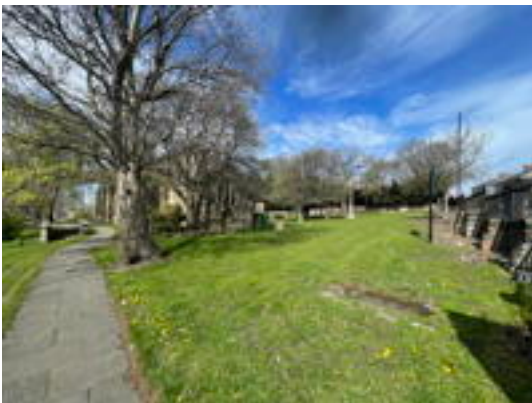
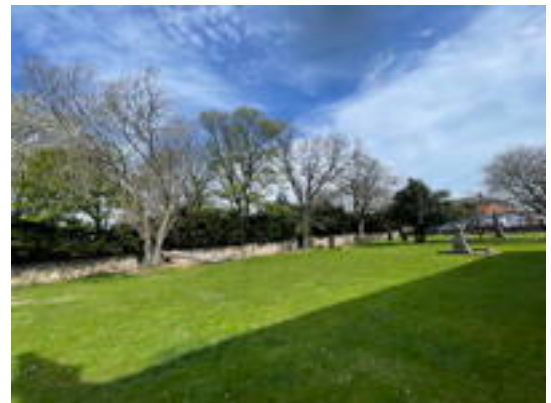
The trees generally all appear to be in satisfactory condition and are reported to be maintained by the local authority. The trees should all be inspected by a qualified tree surgeon every five years and pruned in accordance with their recommendations.

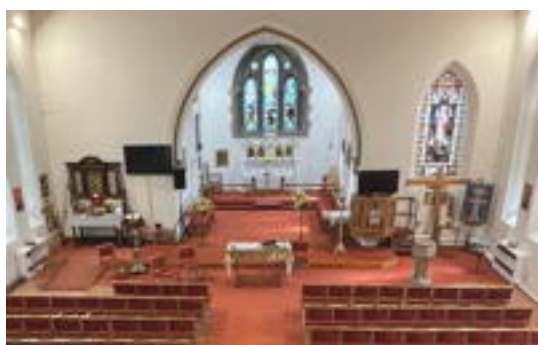
**Nave TVs**

There is a visual display system with wall mounted TV on the wall of the nave north east corner and a second mounted in the pulpit.
